# Timber Pest Report

Inspection Date: 21 Apr 2021

IBC Property Inspections

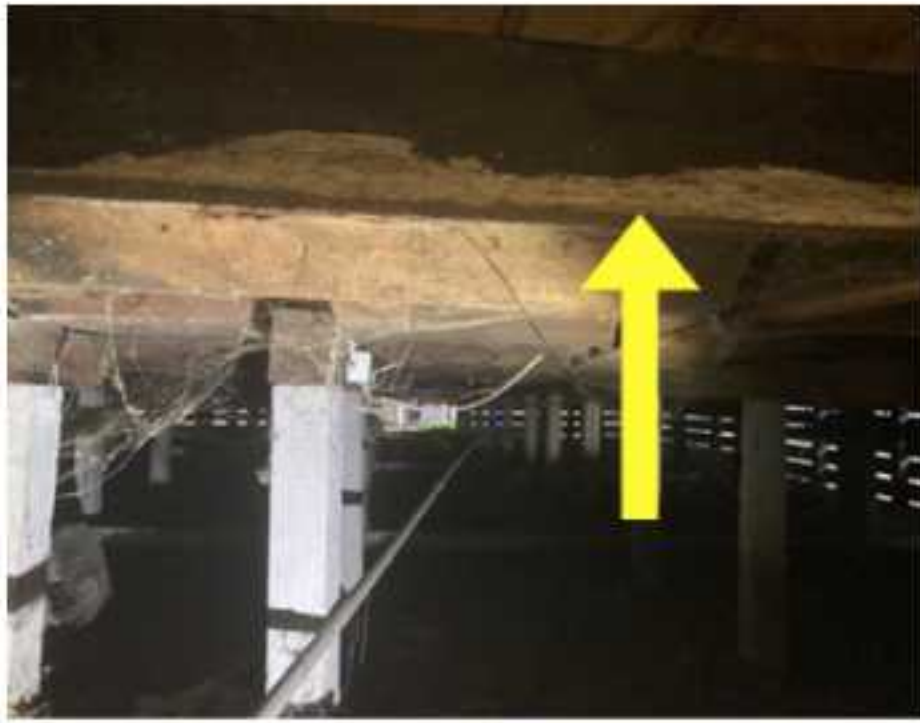
## **Timber pest attack 1.01**

Location: Subfloor

Finding: Powder post beetle damage to hardwood

At the time of the inspection, it has been found that powder post beetles have damaged the hardwood joists. The strength of the structural timber might be significantly affected if over 25% of timber is damaged. Treatment is recommended.

5. At the time of the inspection, it has been found that powder post beetles have damaged the hardwood joists. The strength of the structural timber might be significantly affected if over 25% of timber is damaged. Treatment is recommended.

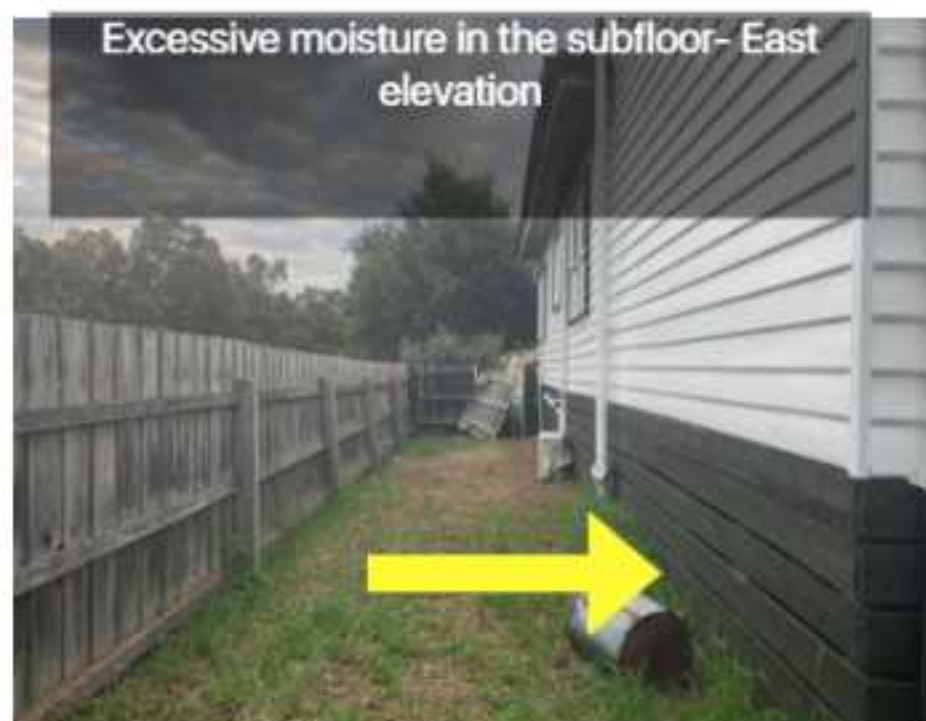
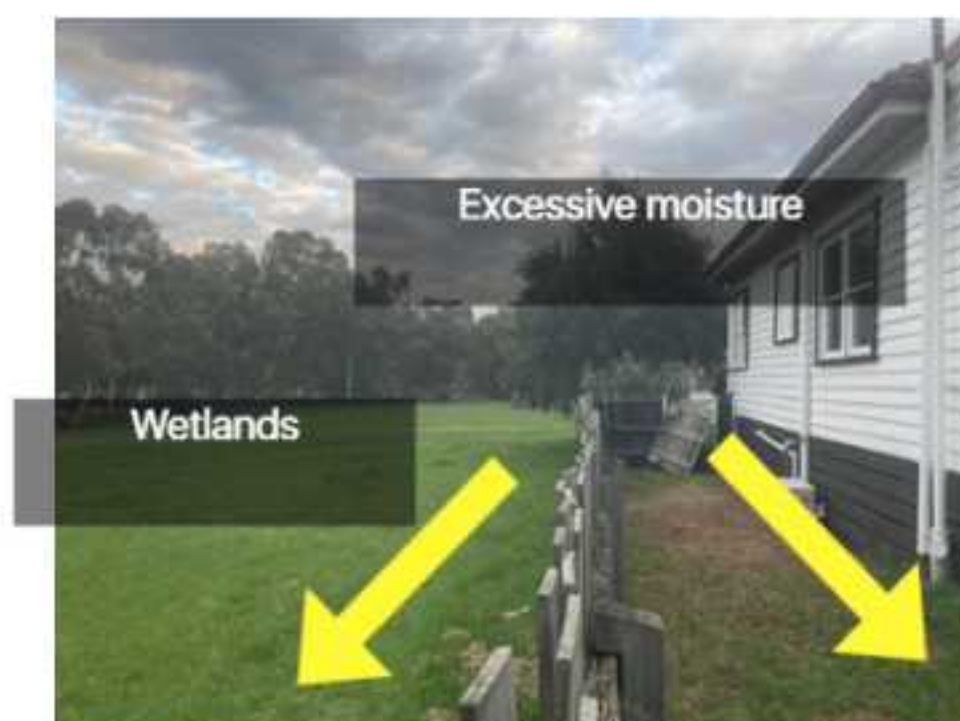
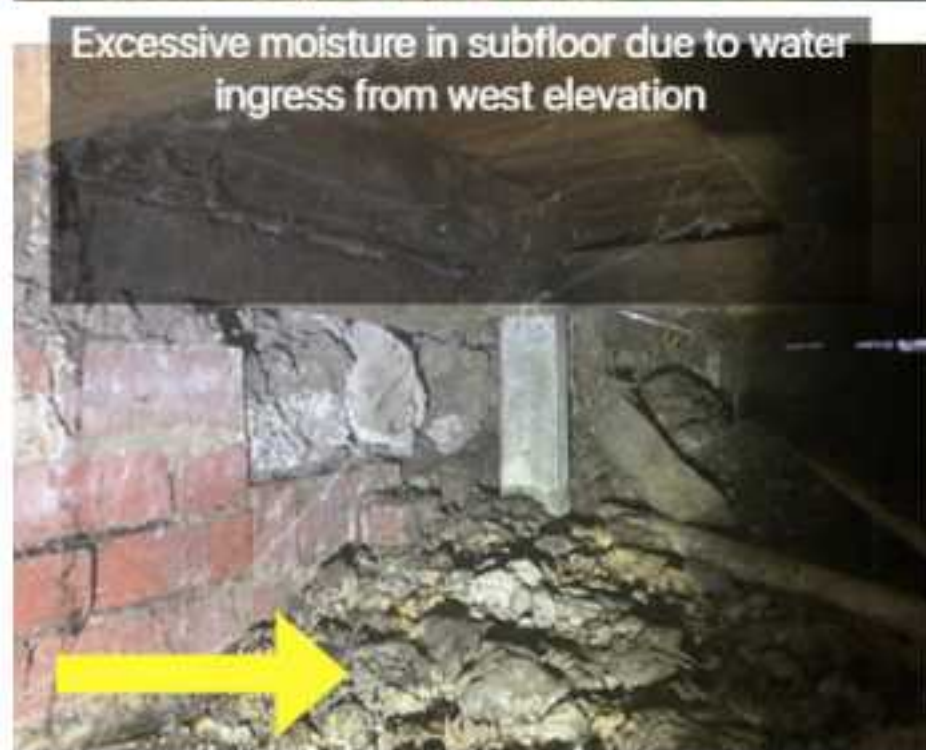
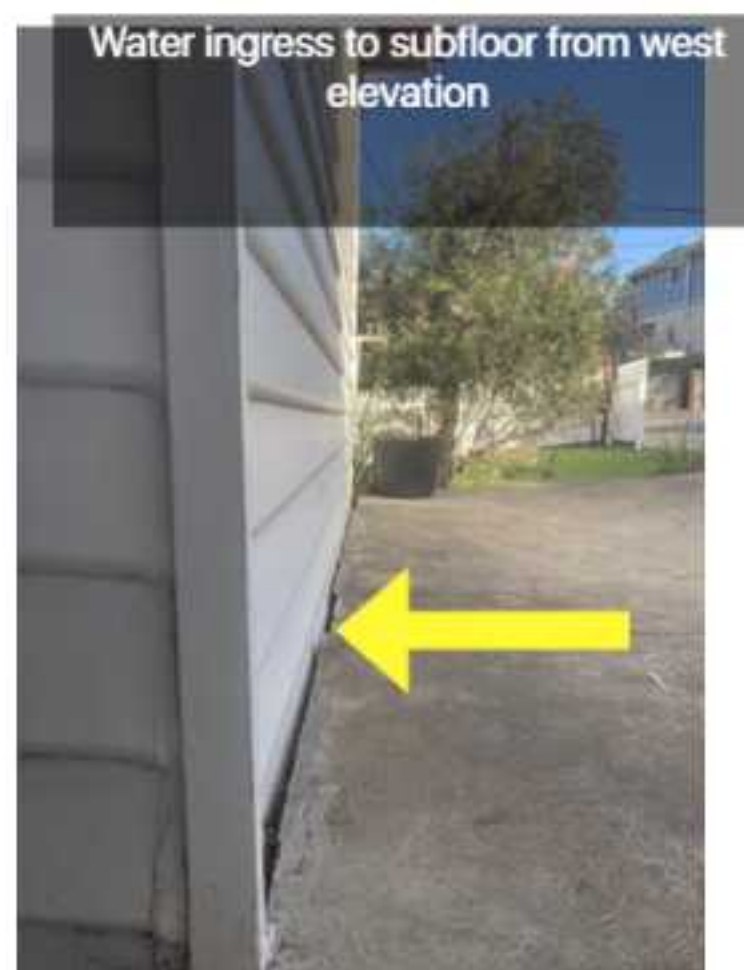
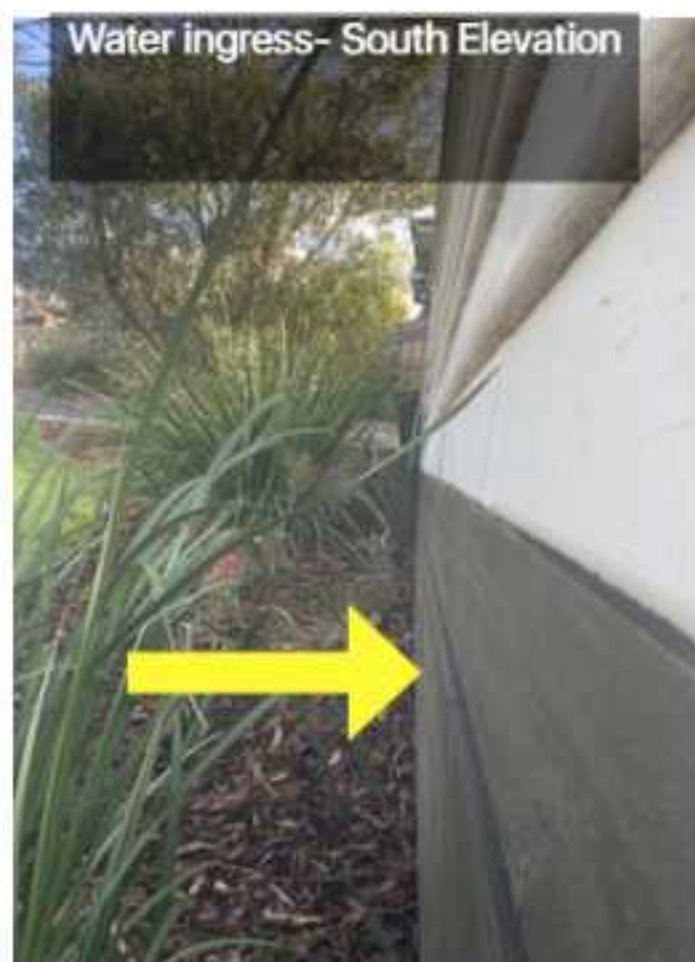
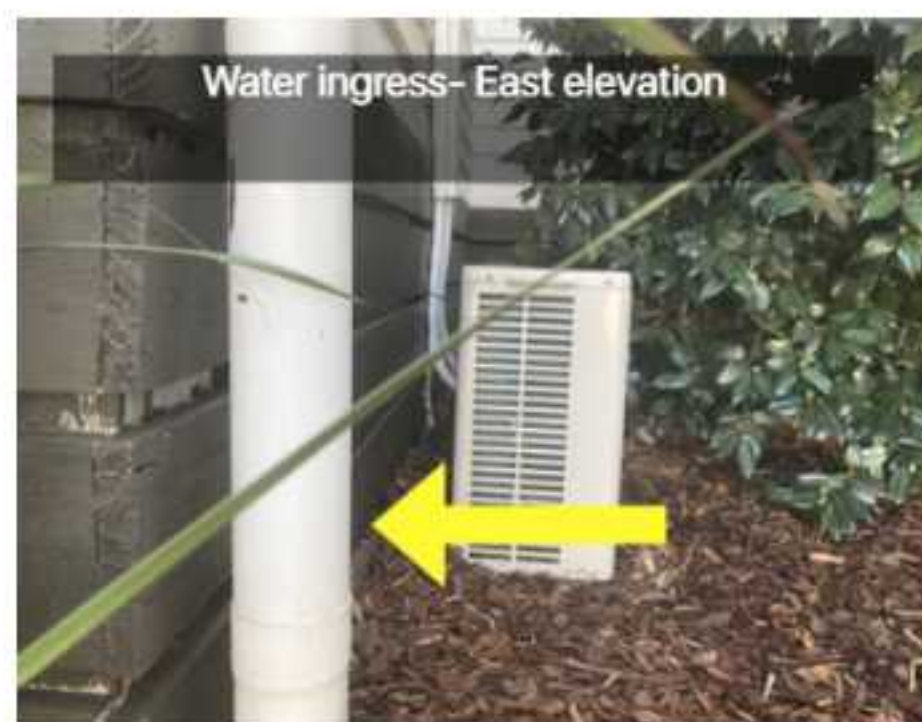
## Conditions conducive to timber pest attack 1.02

Location: East Elevation Around Subfloor

Finding: Evidence of excessive moisture was present at the time of inspection

The ground area of East elevation of the property has been found to contain excessive moisture due to it's close proximity to wetlands of Merri creek.

Excessive moisture can attract termites and produce conditions that promote termite attack, fungal growth and wood decay. Excessive moisture is generally caused by deteriorated inadequate or missing roof drainage, leaking plumbing pipes or fixtures poorly plumbed such as HWS overflows or condenser units and poor site drainage. It is highly recommended that all plumbing and drainage fixtures and fittings be maintained regularly in order to prevent excessive moisture being present in the external of the property.

3. Excessive moisture was present at the time of inspection due to inadequate site drainage. Further high moisture condition was noted in and around subfloor on east elevation of the property due to it's close proximity to wetlands of Merri creek. High moisture condition may create decay of timber structural members and promote termite infestation.

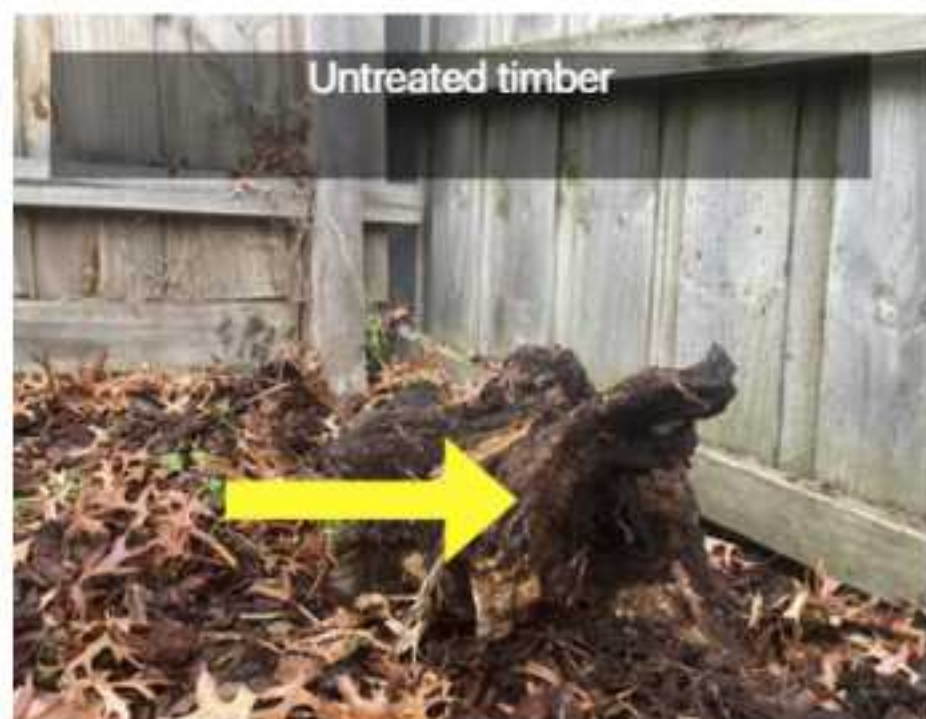
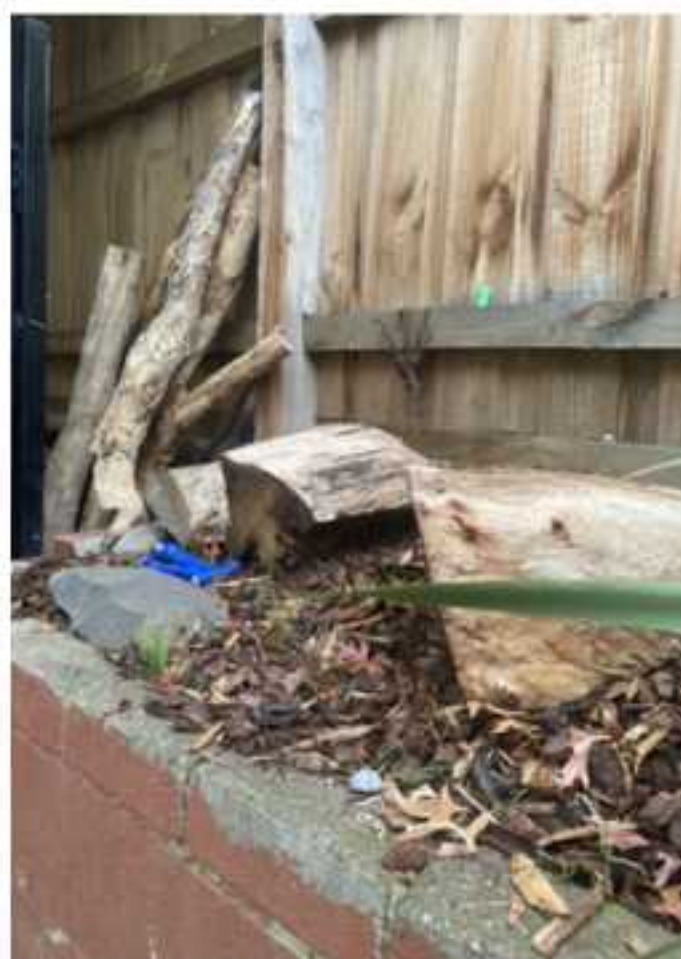
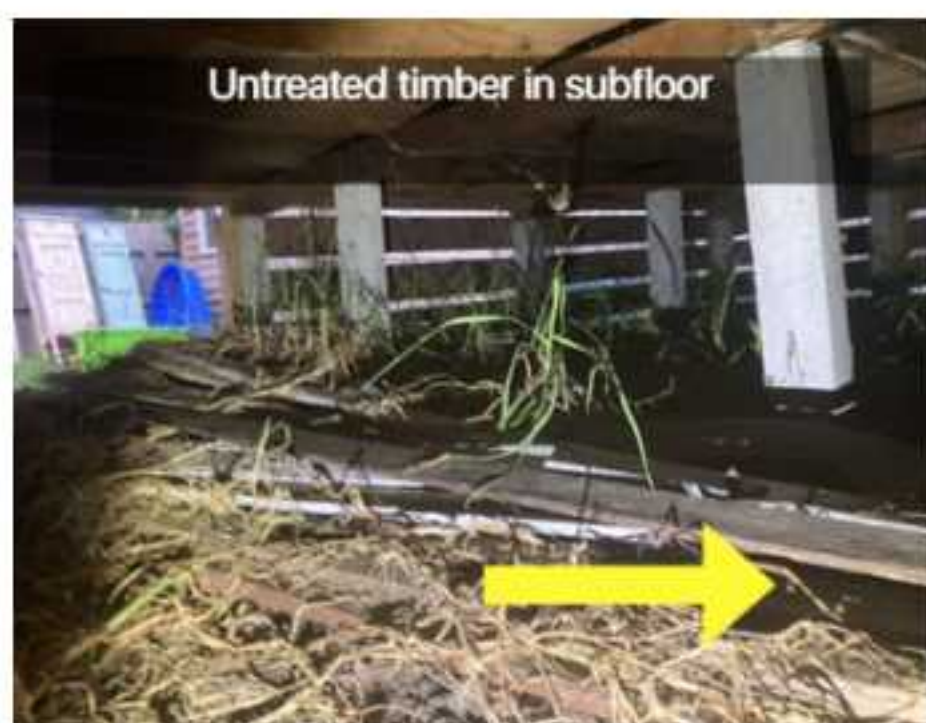
## Conditions conducive to timber pest attack 1.03

Location: Subfloor And External Areas

Finding: Stored timbers - subfloor space or external area

The storing of timbers in the subfloor space or around the external property increases the risk of termite activity being present. It is highly recommended that any stored timbers be immediately removed from areas in which they may attract any termite / timber pest attack.

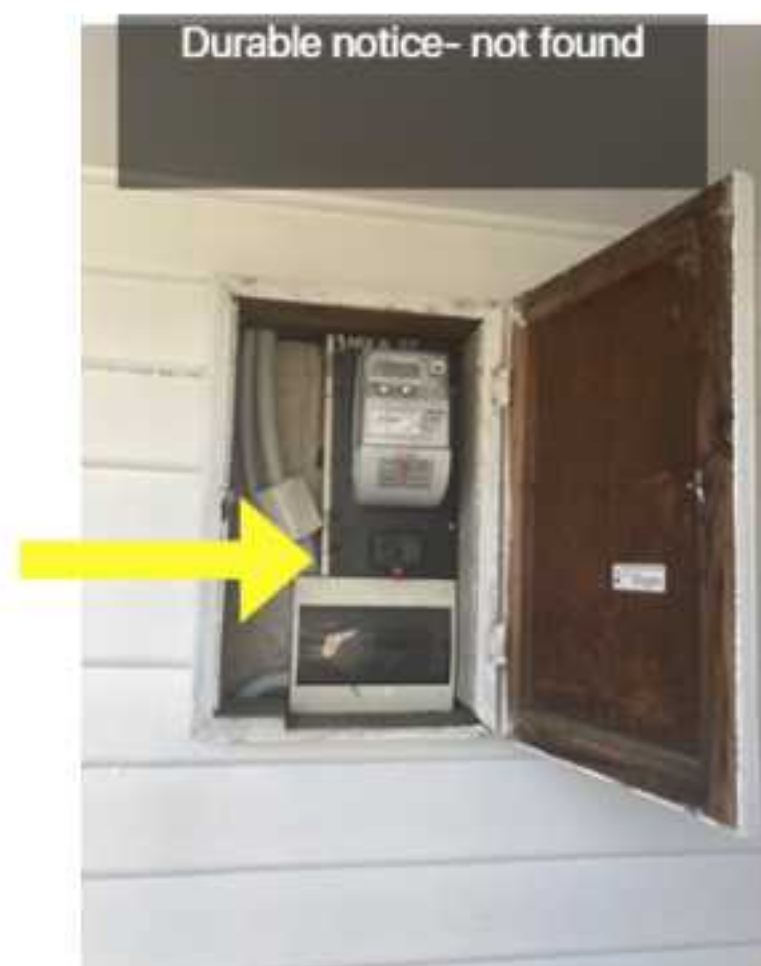
## For your information 1.05

Location: Subfloor  
 Finding: Termite Management System - no evidence of installation

A durable notice should be placed in the switchboard unit to indicate current termite barriers. At the time of inspection, it appeared as though no termite management system has been installed, with no evidence to suggest preventative works taking place. The client may consider gaining further advice from a pest controller as to the costs and procedures involved with this application. It is recommended that obtaining such advice be a short-term priority.

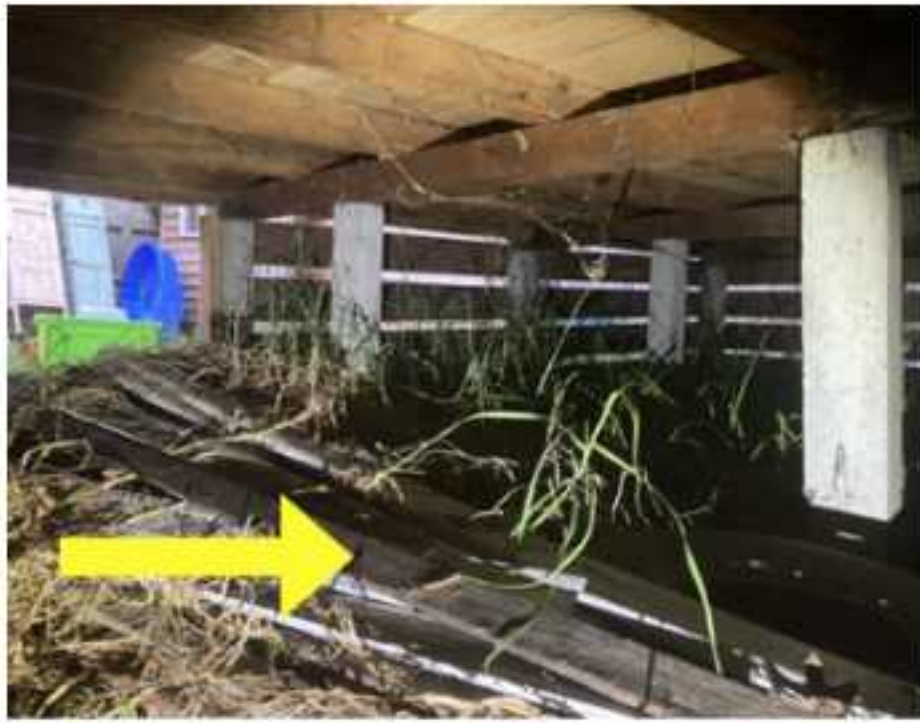
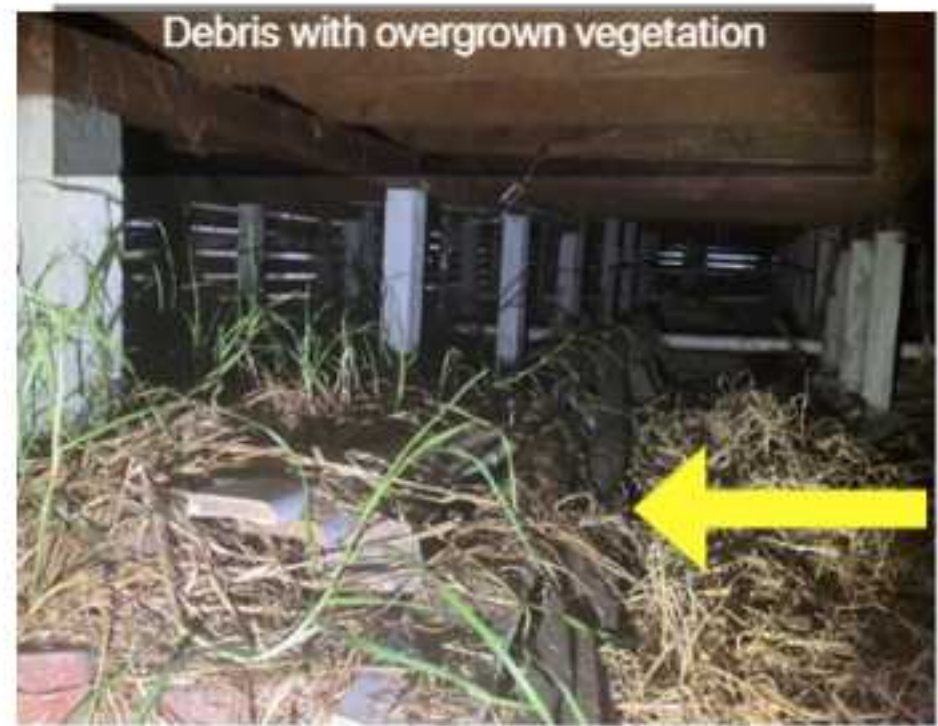
## For your information 1.07

Location: Subfloor  
 Finding: Subfloor - Debris

Debris in this area restricts subfloor ventilation and creates potential for concealed pest entry. Stored timbers and other materials may also make the area susceptible to termite activity and wood rot. A clear and empty subfloor will be better ventilated and easier to maintain in a dry condition. The removal of any timber debris is vital in minimising the risk of termite or wood borer activity. Debris in the subfloor should be removed as soon as possible.

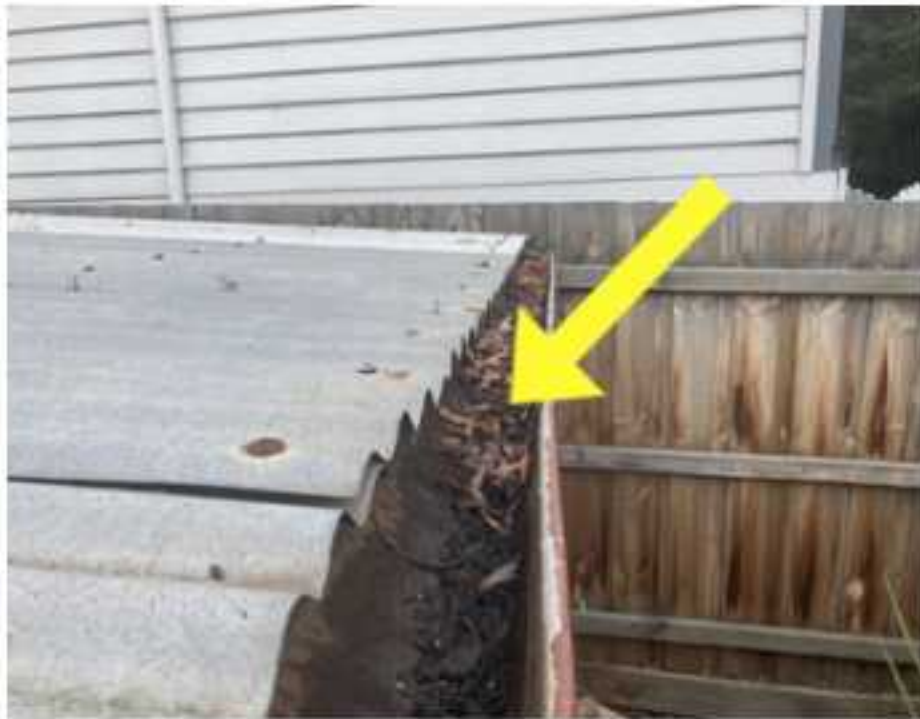
### For your information 1.08

Location: Roof exterior

Finding: Gutters - Blocked

Roof plumbing structures such as guttering and downpipes should be free of all debris to prevent blockages. Blocked gutters are likely to lead to high levels of moisture in the affected areas and will not only cause rust and decay but can also provide conditions that are conducive to termite and timber pest activity. Blockages in gutters should therefore be removed immediately to ensure dry conditions are maintained. It is highly advised that blocked gutters be removed by the homeowner or a general handyperson as a matter of urgency.

4. Blocked roof gutters were noted during the inspection. Roof plumbing structures such as guttering and downpipes should be free of all debris to prevent blockages. Blocked gutters are likely to lead to high levels of moisture in the affected areas and will not only cause rust and decay but can also provide conditions that are conducive to termite and timber pest activity. Blockages in gutters should therefore be removed immediately to ensure dry conditions are maintained. It is highly advised that blocked gutters be removed by the homeowner or a general handyperson as a matter of urgency.

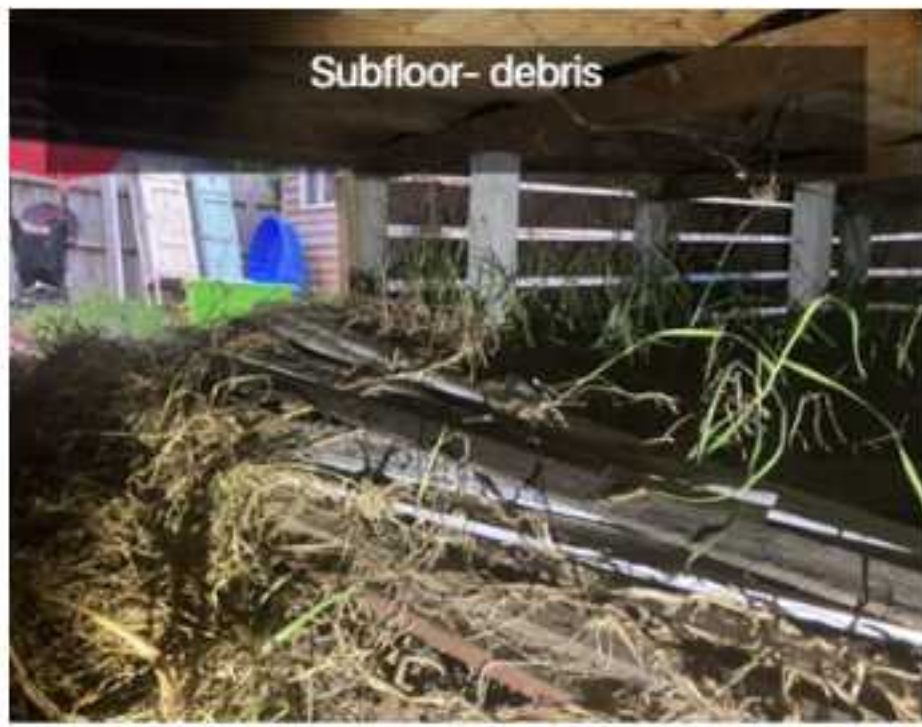
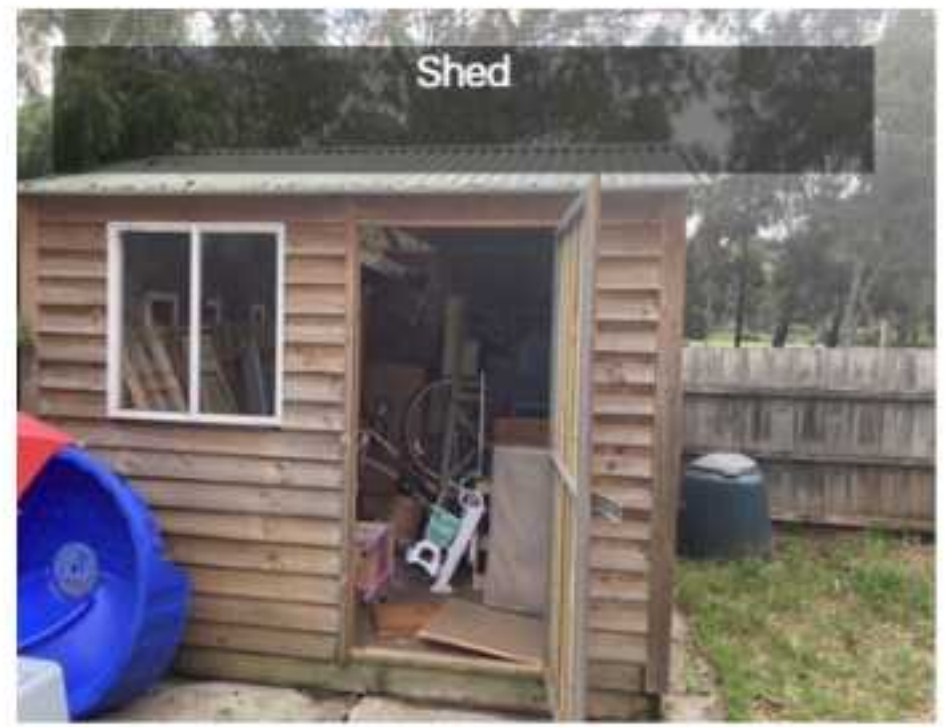
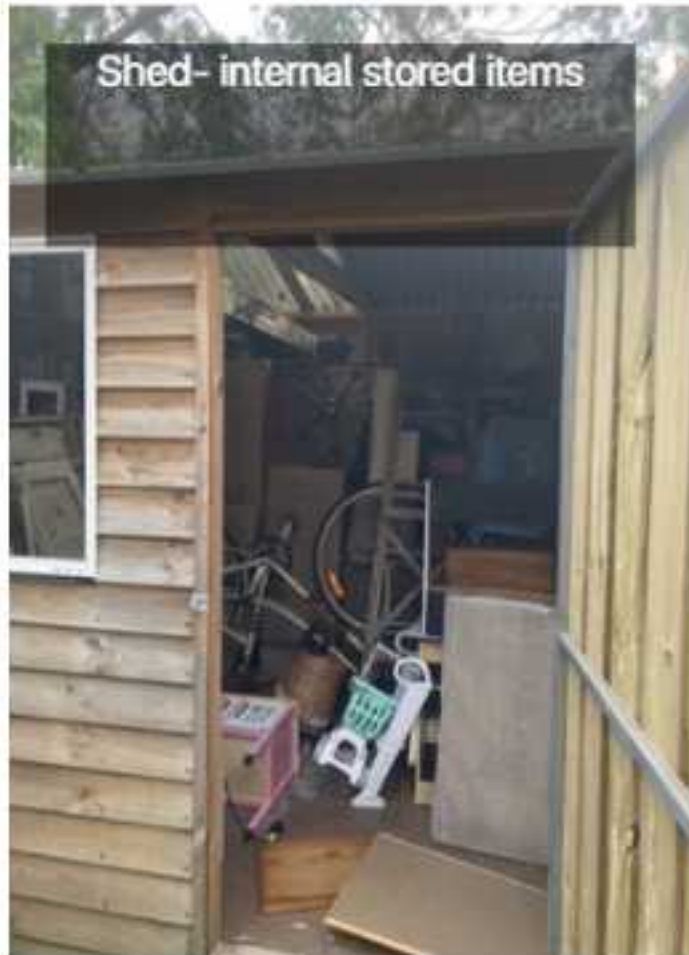
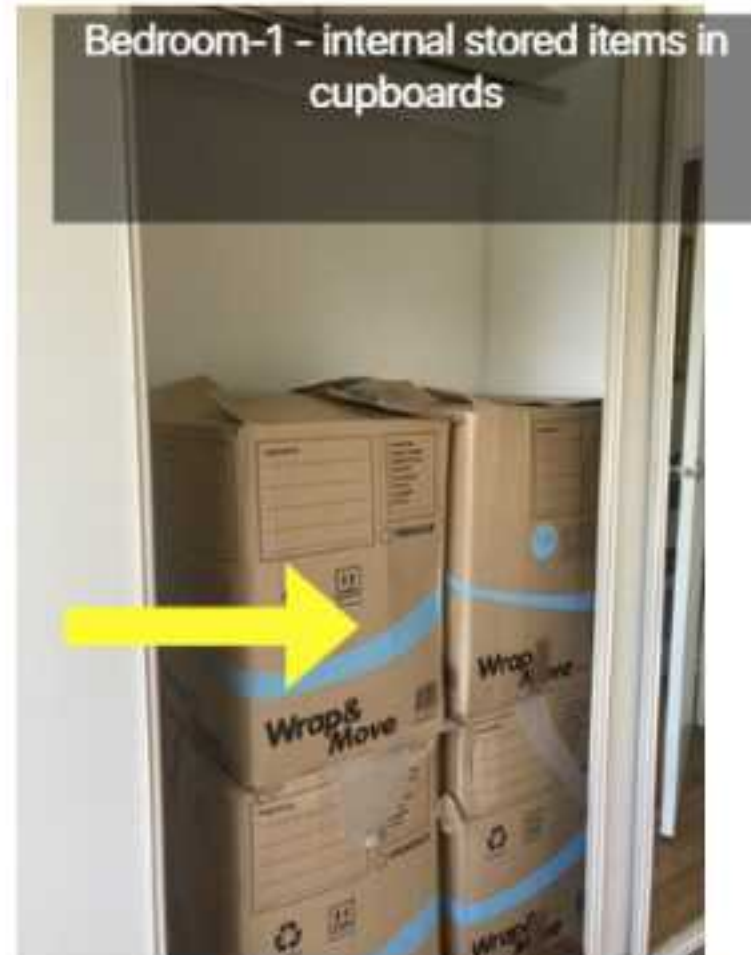
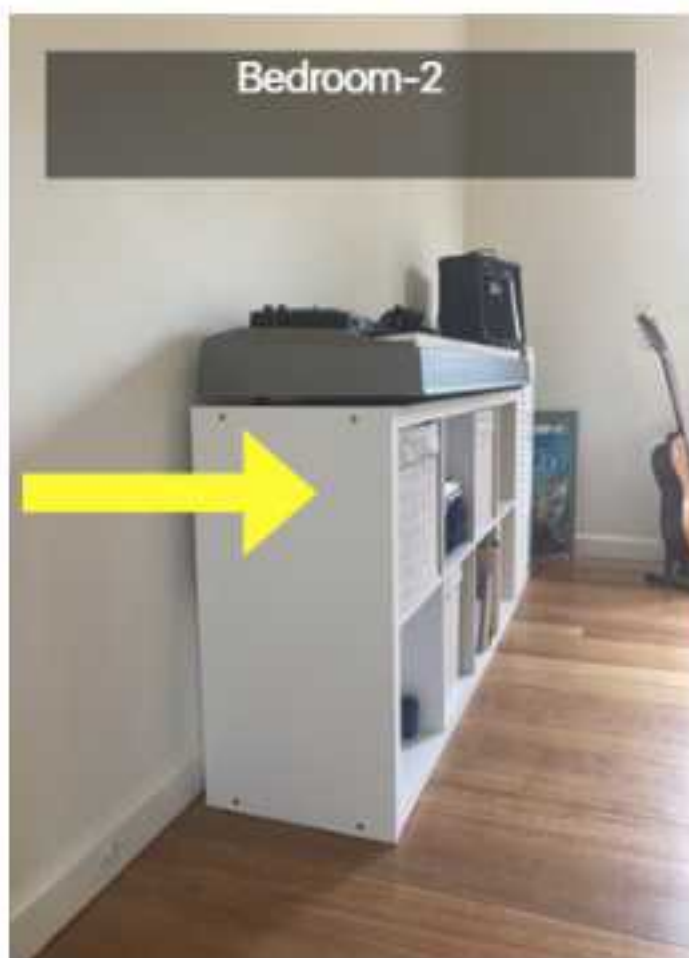
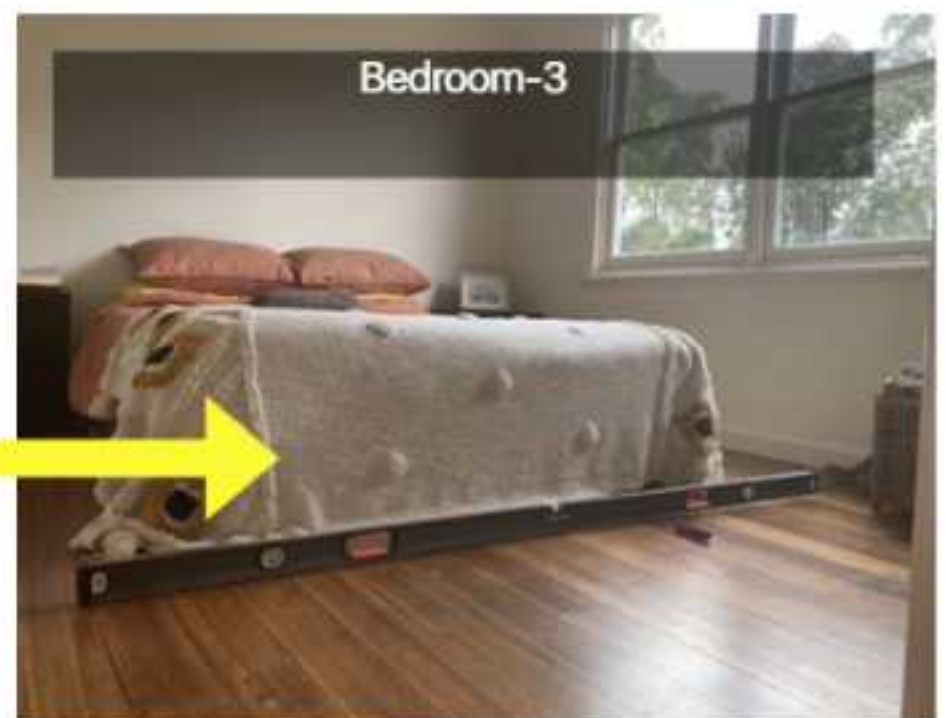
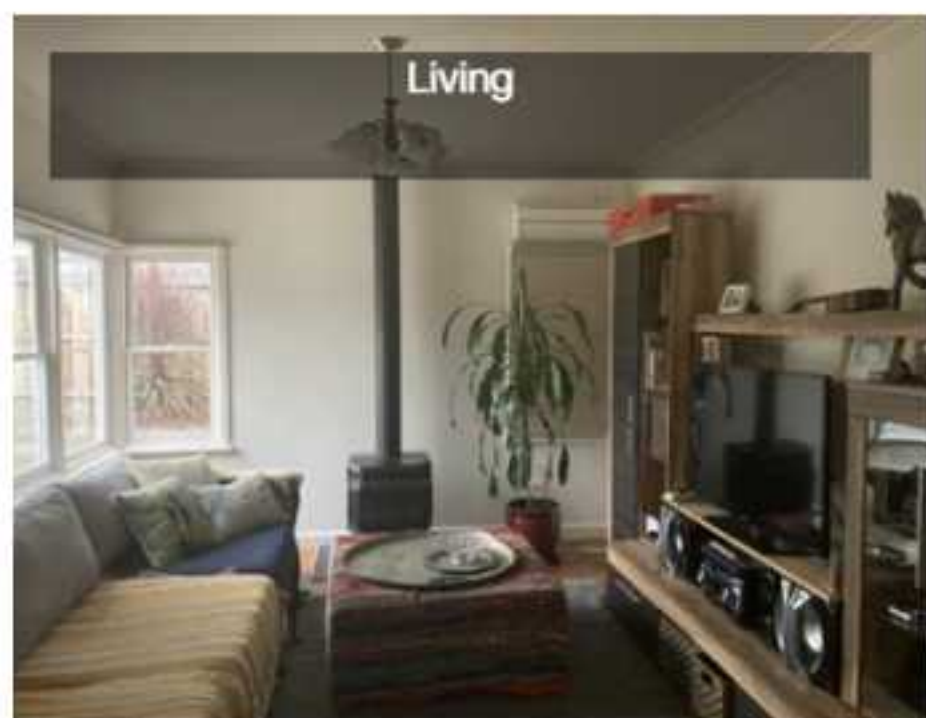
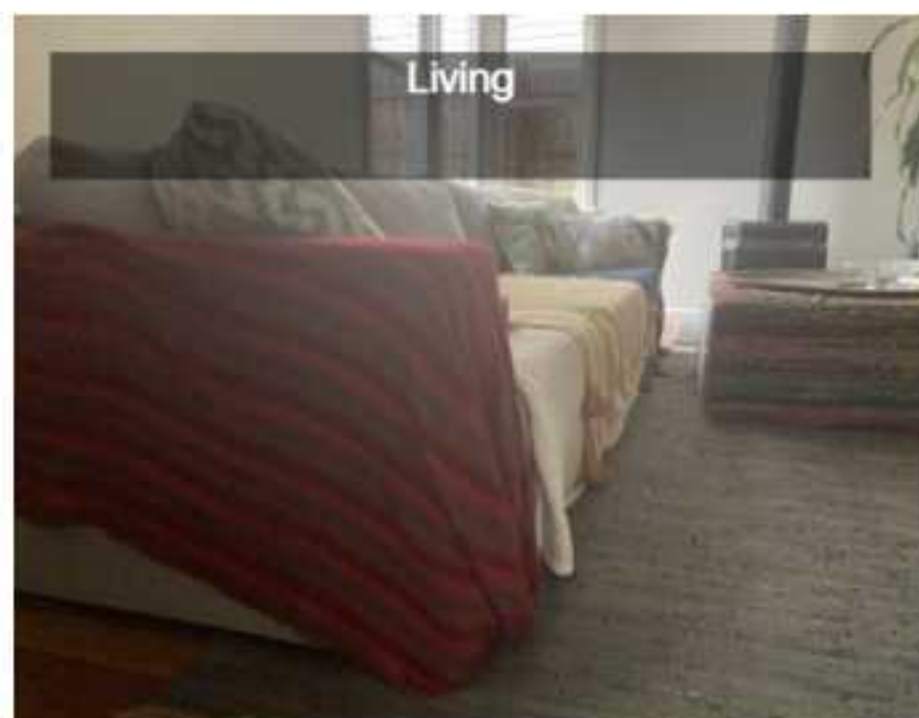
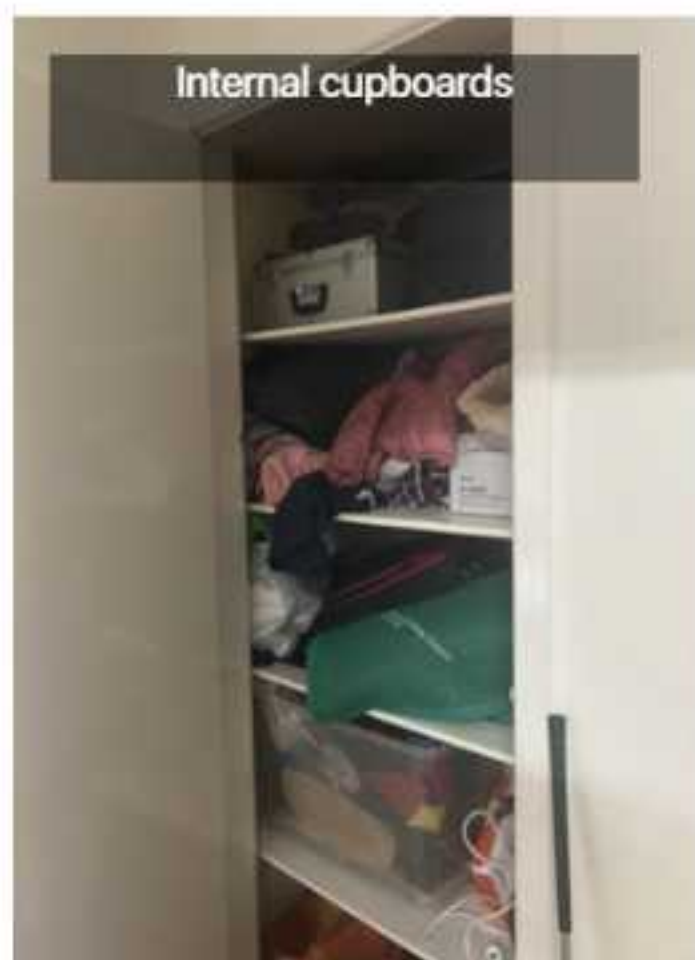
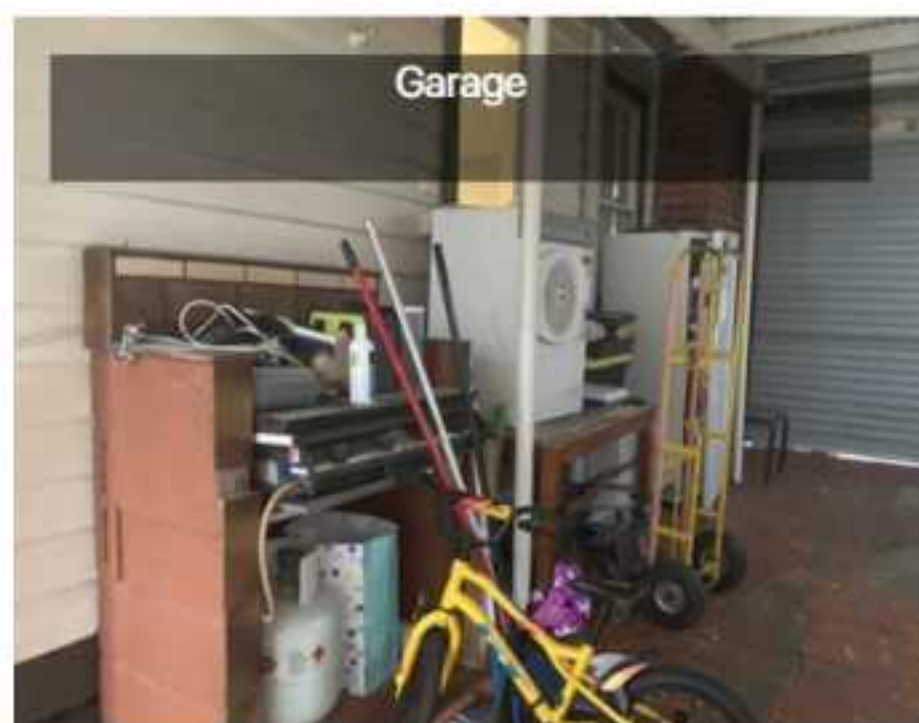
### For your information 1.09

Location: All areas

Finding: Obstructions

Photographic evidence is submitted to show obstructions to this inspection.
