# Defects Liability Period Inspection Report

Inspection Date: 28 Apr 2021

Property Address: 8 Flaubert Rd Craigieburn 3064

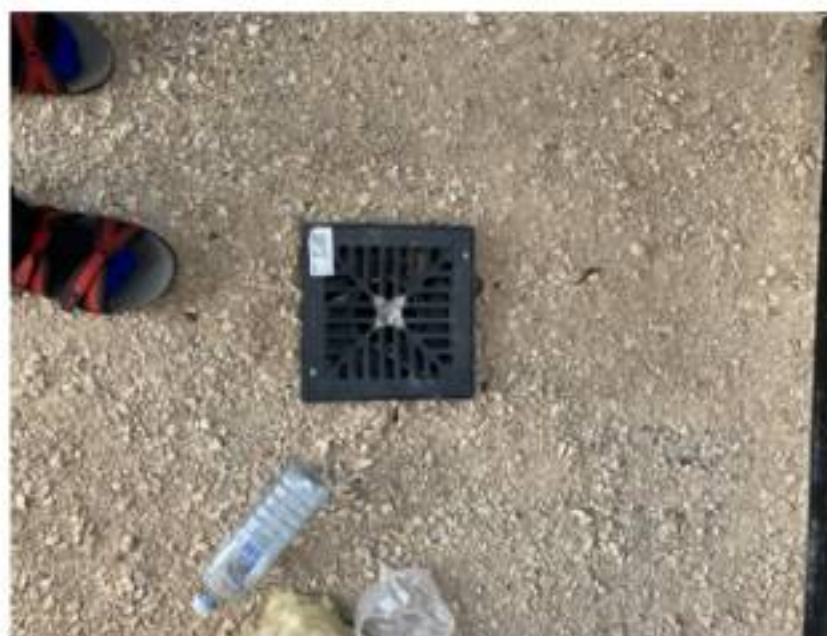
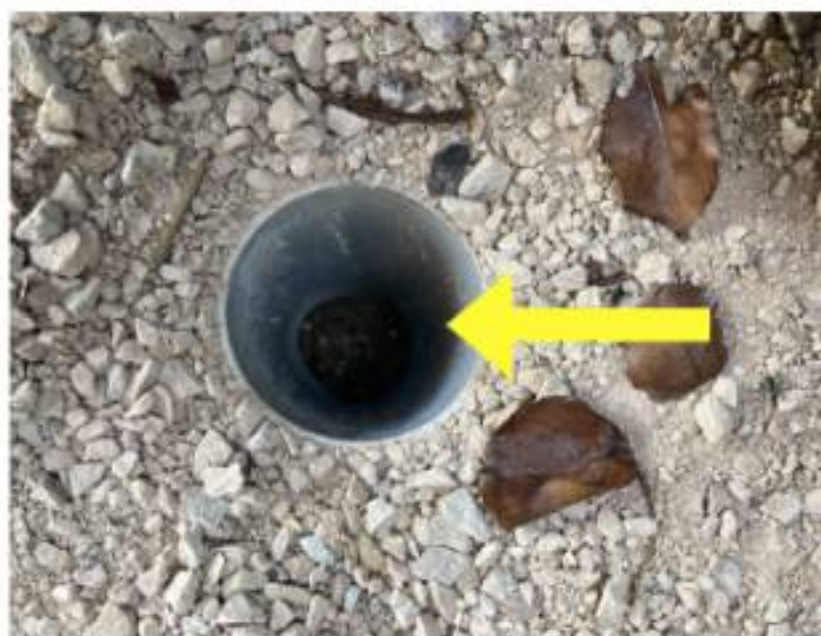
### Non Compliant 2.01

Location: East Elevation

Finding: Surface drain pipe- blocked

Storm water drainage pipe has been blocked with debris inside the pipe. As per plumbing code of Australia- NCC 2016 volume 3- section DP 2.3(b) blockage of storm water drainage system is a defect.

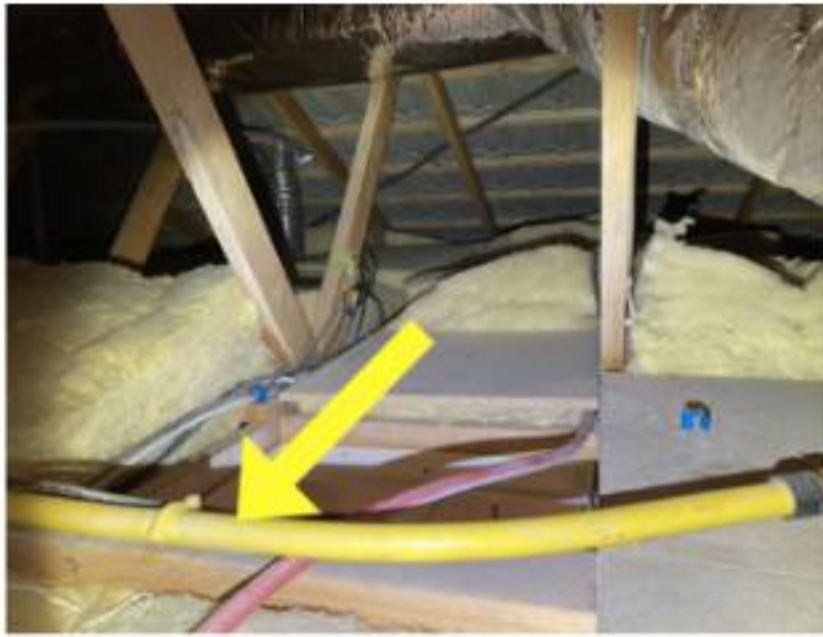
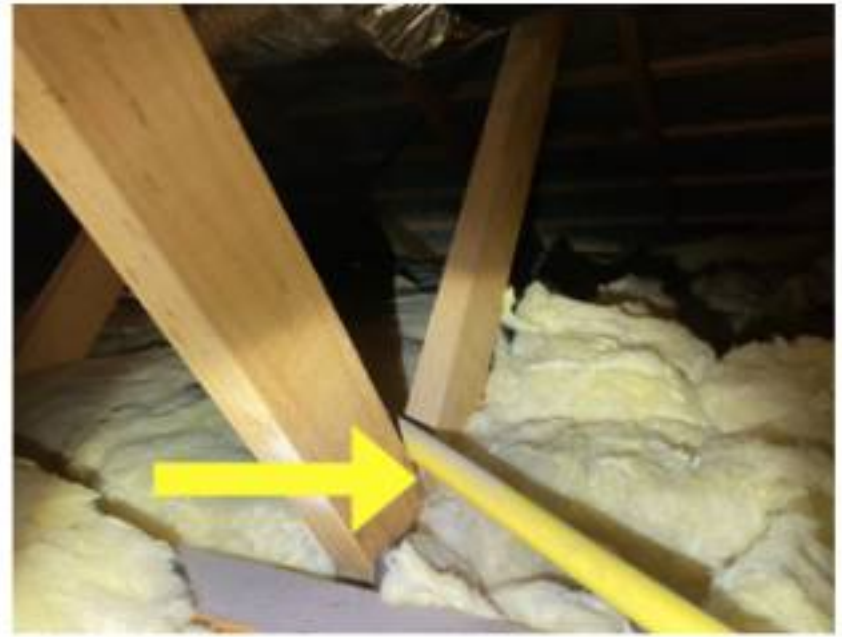
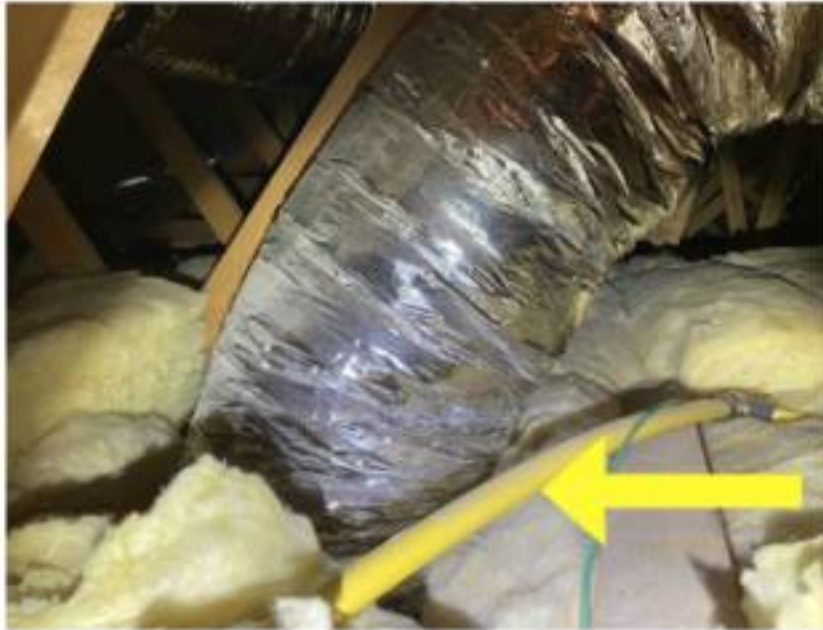
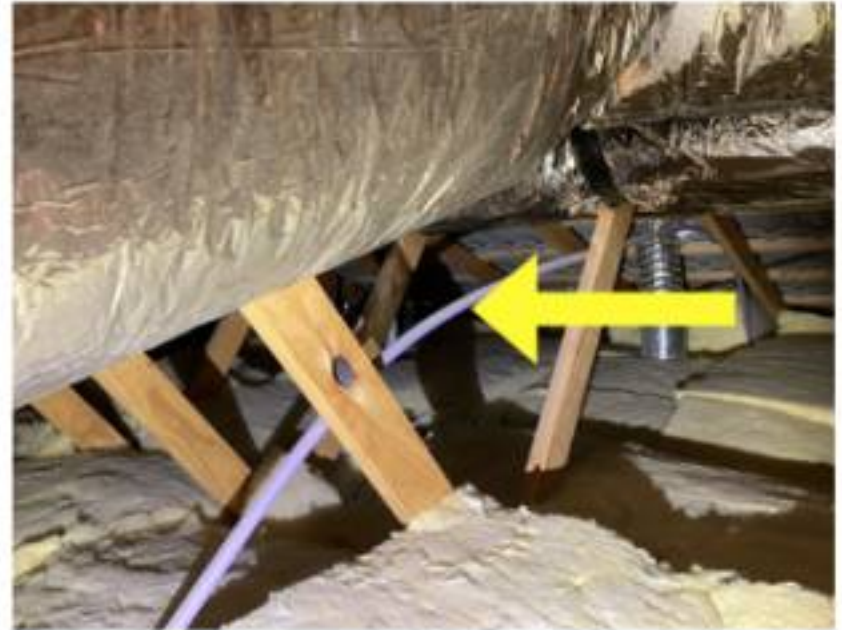
### Non Compliant 2.02

Location: Roof Space

Finding: Pipe work- Not clipped

The pipework in this section of plumbing was found to have been not clipped adequately.

Lagging and clipping is used to contain pipe-wall vibrating noise and to insulate the pipework. AS3500.5 clause 2.13.2 calls for the area around pipework to be filled, including the area around penetrations in associated walls.

Where uninsulated pipes are used, a collar of lagging material or a neutral cure silicone sealant shall be used to fill the annular space.

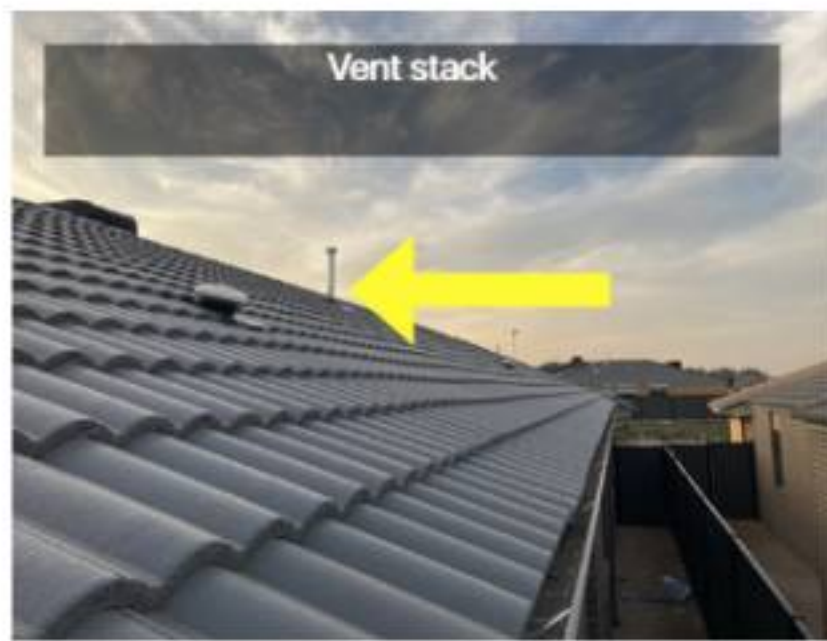
## Non Compliant 2.03

Location: Ensuite- Sanitary Plumbing System

Finding: Installation of AAV

At the time of the inspection, metallic tapping noise has been heard from roof space when water is drained from WC and bath in Ensuite.

Installation of AAV should comply with AS/ NZS 4936: Air Admittance valves for use in sanitary plumbing and drainage systems.

AAV should be adequately sized to meet the determined air flow capacity in order to equalise the air pressure within the drainage system.

This report suspects that the AAV s installed has not been adequately sized or adequate air is not available within the roof space.

This inspection report advises to investigate further whether AAV is adequately sized and whether adequate air is available within the roof space.

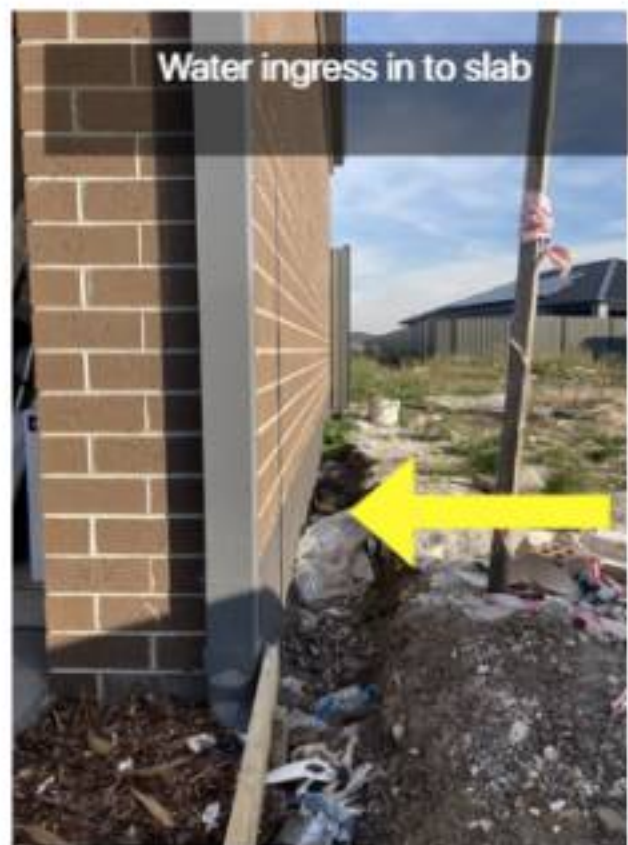
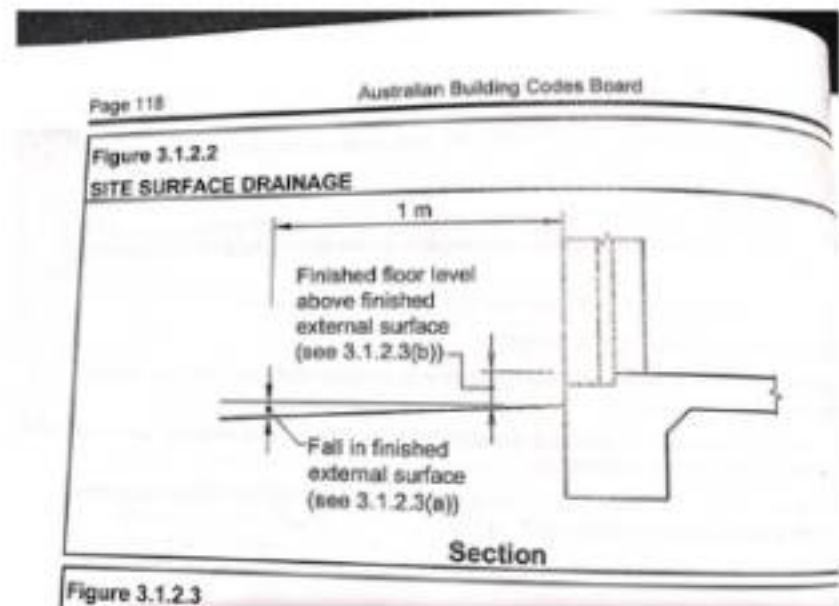
## Non Compliant 2.04

Location: West Elevation- Garage Slab

Finding: Site drainage- Inadequate

The poor site drainage has been observed on west elevation. Surface water should be directed away from the building.

Surface water drainage is defective if it is not in accordance with the requirements of the Building Code of Australia.

Refer to BCA 3.1.2.3- surface water drainage

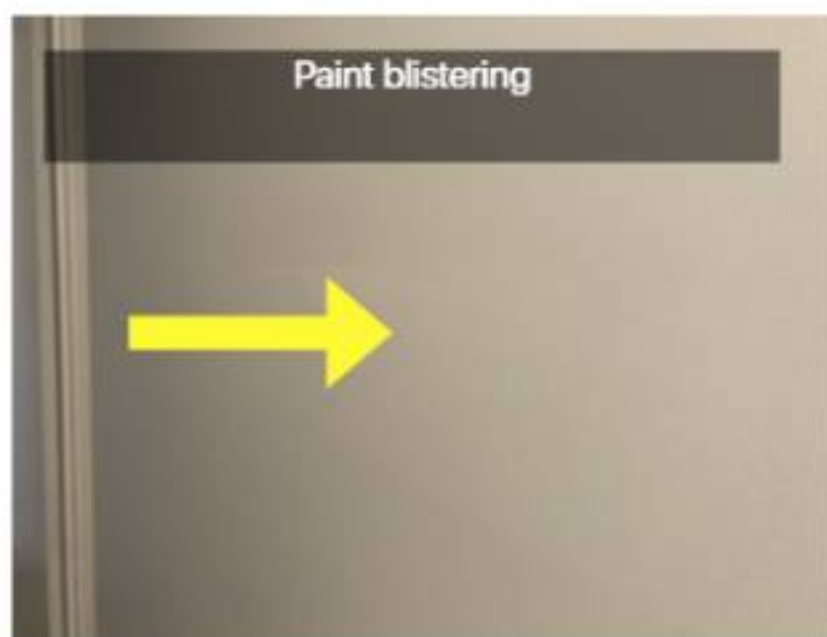
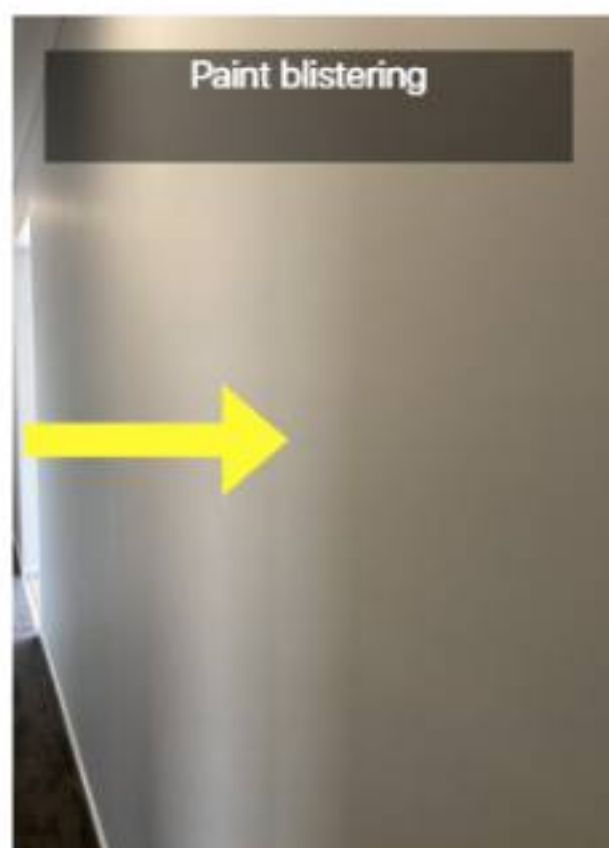
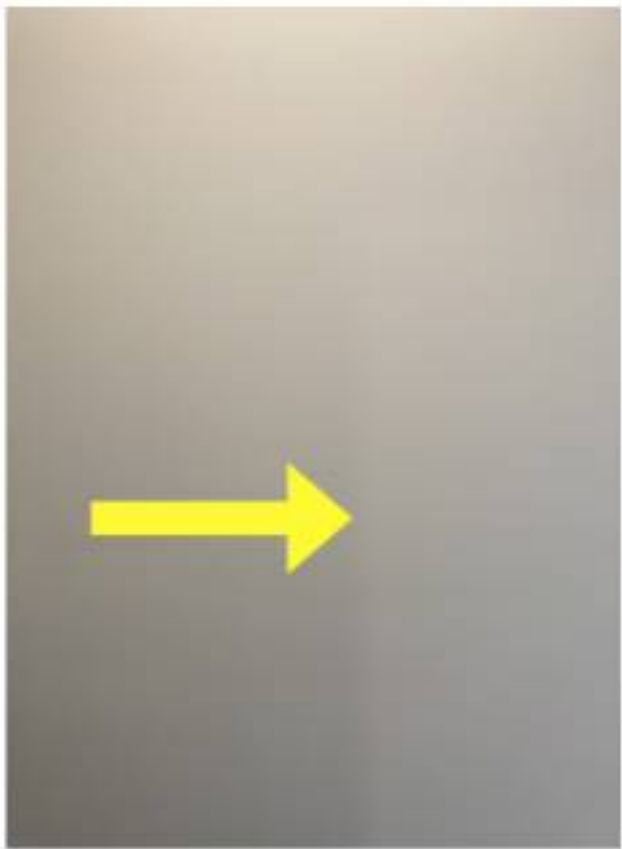
## Non Compliant 2.05

Location: All Internal Areas  
Finding: Coated paint Finish- defective with starved painted areas

Coatings used are to be suitable for the relevant conditions and relevant wear and tear.  
Painting is defective if it does not comply with the manufacturer's installation instructions or AS/NZS 2311.

Paintwork is defective if the application has blemishes such as paint runs, paint sags, wrinkling, dust, bare or starved painted areas, colour variations, surface cracks, irregular and coarse brush marks, sanding marks, blistering, non-uniformity of gloss level and other irregularities in the surface that are visible from a normal viewing position.

Paintwork is defective if the application results in excessive over-painting of fittings, trims, skirtings, architraves, glazing and other finished edges

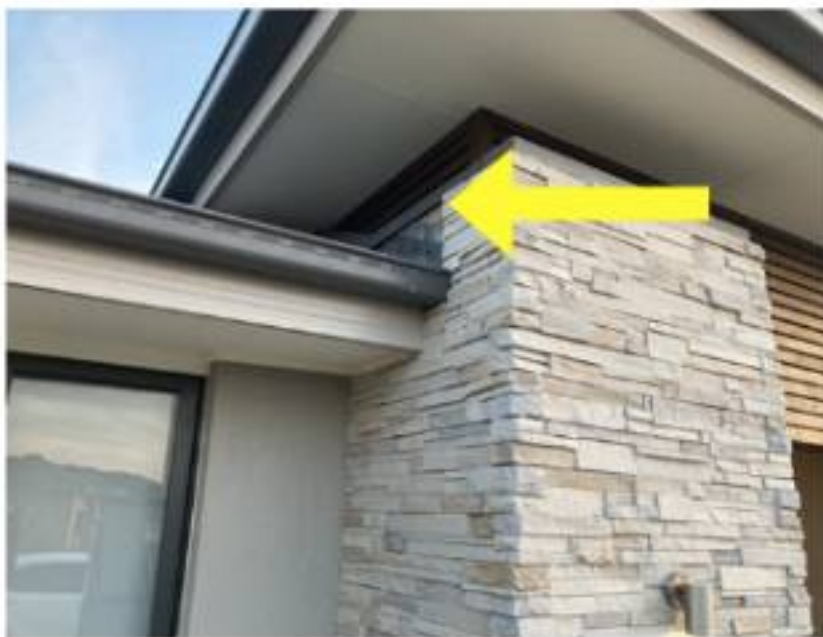
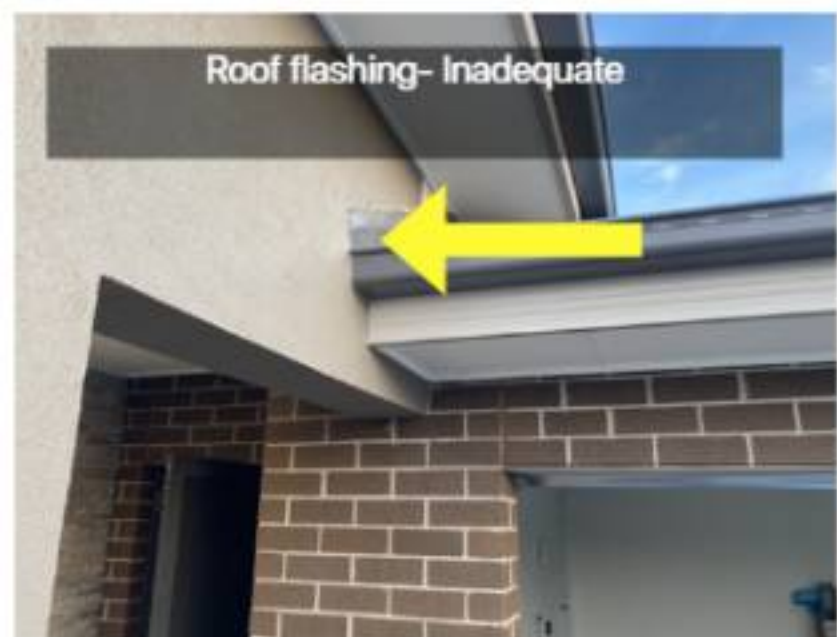
## Non Compliant 2.06

Location: Roof exterior

Finding: Flashings- Inadequate

Refer to Diagram 7.06 in Victorian Guide to Standards and Tolerances 2015.

Flashings are defective if they are not provided in accordance with the requirements of the Building Code of Australia.

Wall and step flashings, and sloping flashings cut into walls are defective if they do not incorporate weathering folds, anti-capillary breaks and sealing, or do not enter the masonry walls by at least 15 mm as shown in Diagram 7.06(A) and Diagram 7.06(B).

Pressure flashings are defective if they are not fixed on appropriate surfaces, or are not fixed in accordance with Diagram 7.06(C).

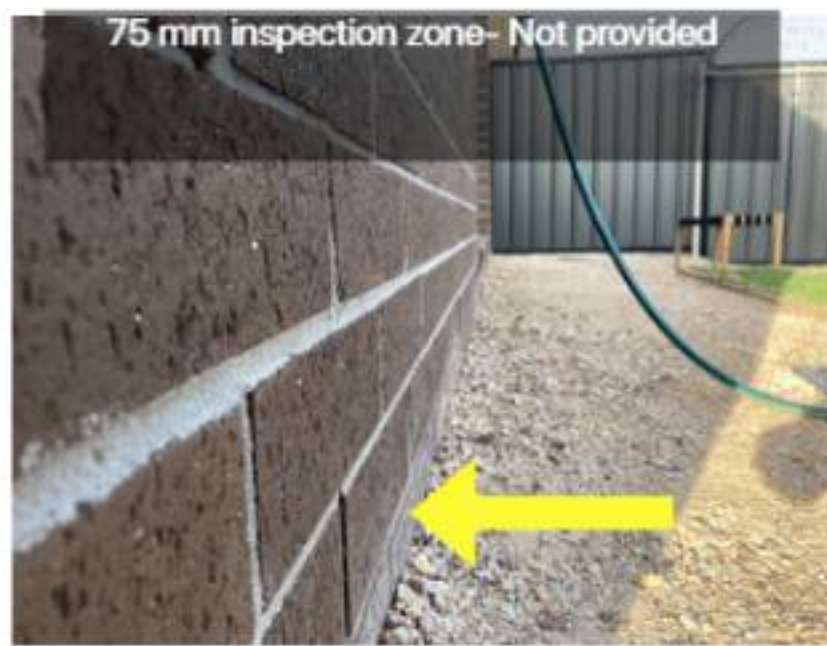
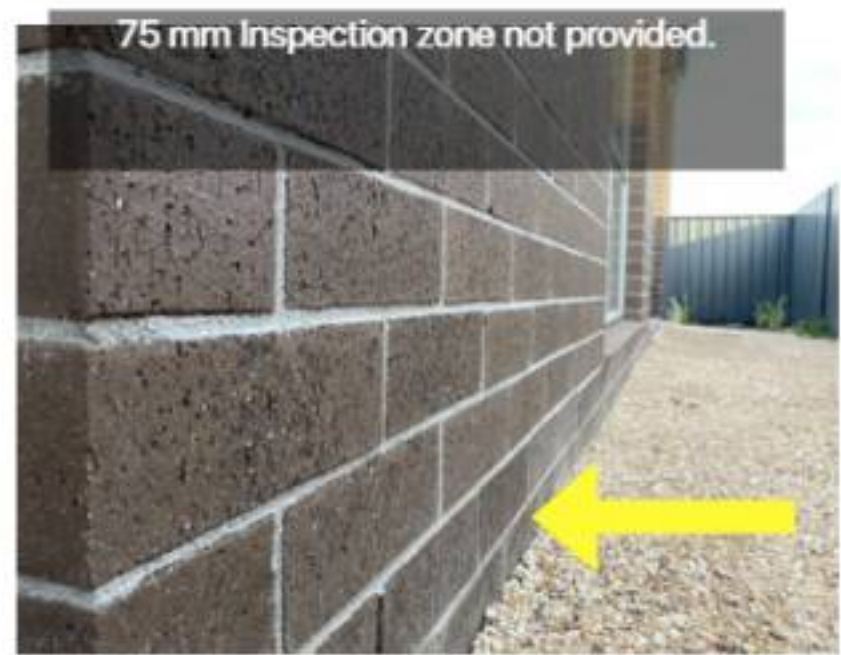
Finding: Slab Edge –inspection zone Not provided

An inspection zone of at least 75mm in relation to the exposed slab edge, between the bottom brick and the perimeter pavement, is required. This inspection zone should be maintained in order to force termites into the open where they can be detected more readily during regular inspections. Where the slab edge cannot be properly inspected, it is highly recommended that termite or timber pest inspections be carried out every 12 months to aid protection of the property against infestation.

Reference: National construction code Volume 2 - section 3.1.3.3

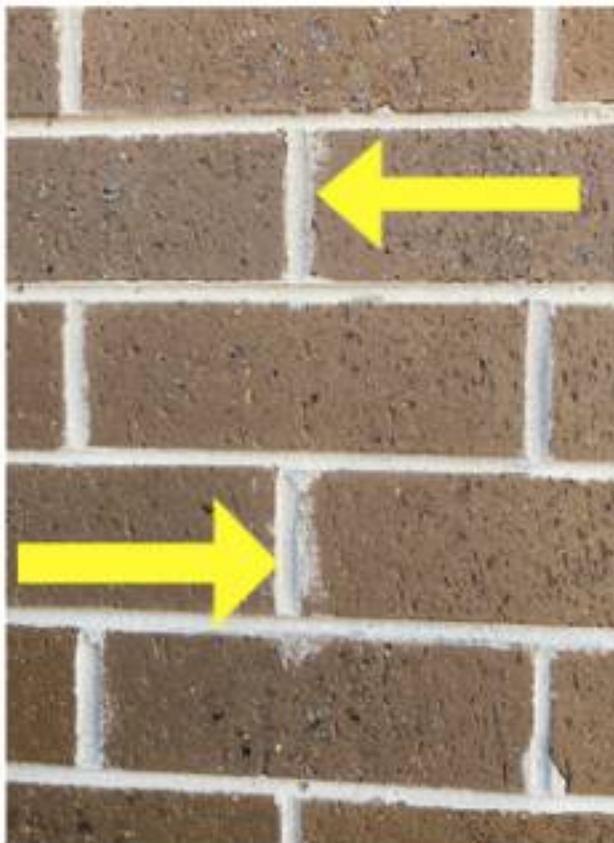
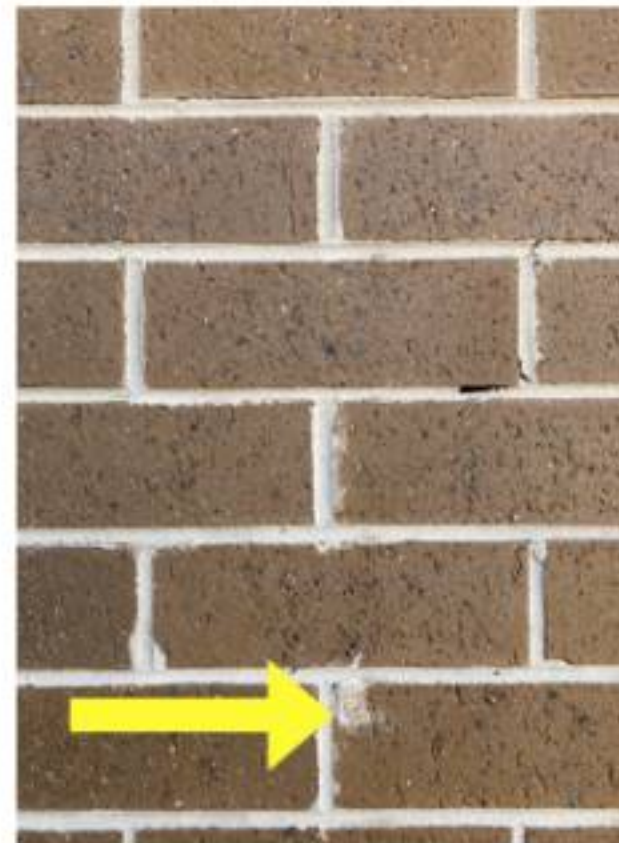
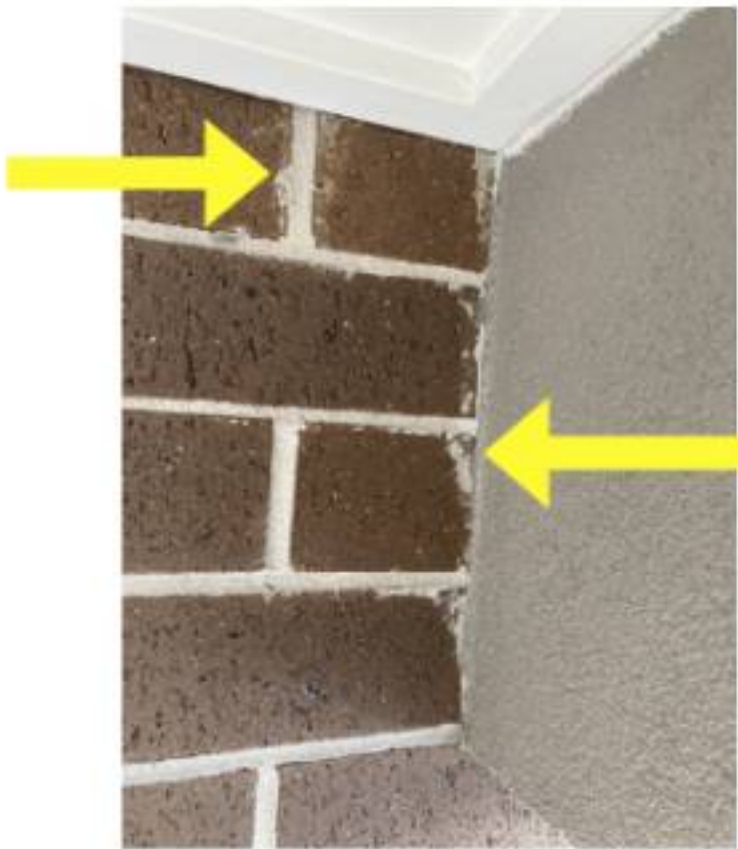
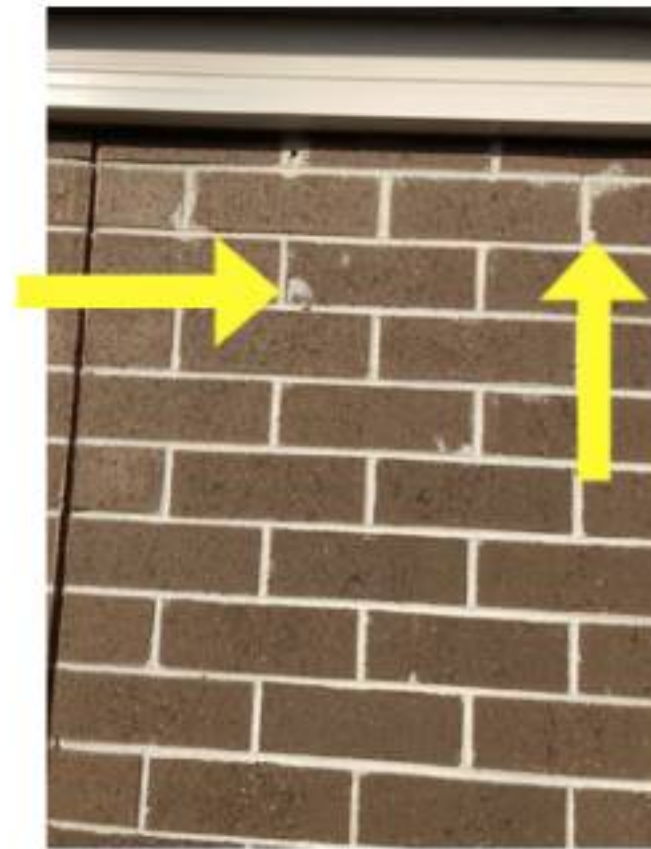
### Substandard Workmanship 3.01

Location: All External Areas

Finding: Brickwork - Efflorescence

Efflorescence appears to be affecting the brickwork, concrete or tiles in this area. Efflorescence typically occurs when excess salts within the concrete are leached to the surface due to water transfer. A cleaning contractor or brick cleaner may be appointed to rectify.

As per VBA standard and tolerance guide 3.07 , masonry faces are defective if they are not cleaned and free of excess mortar.

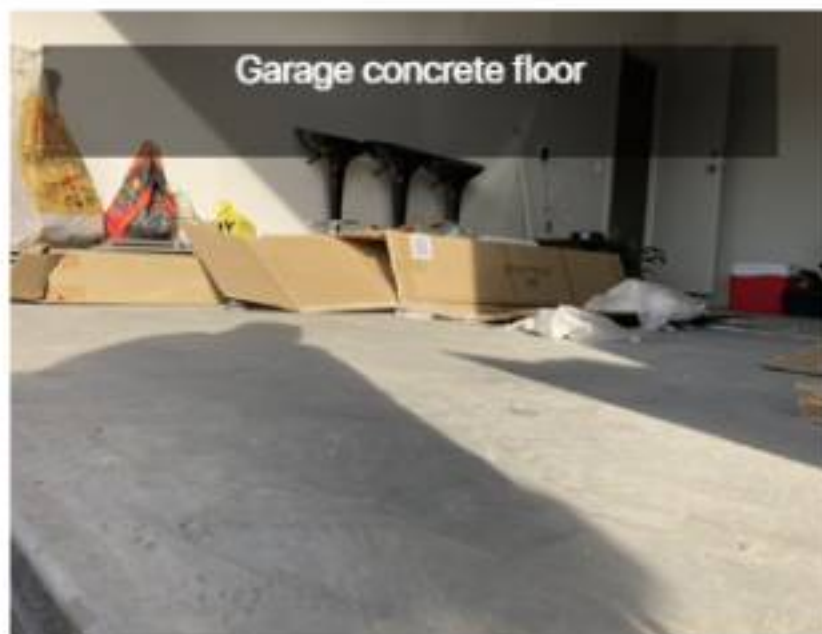
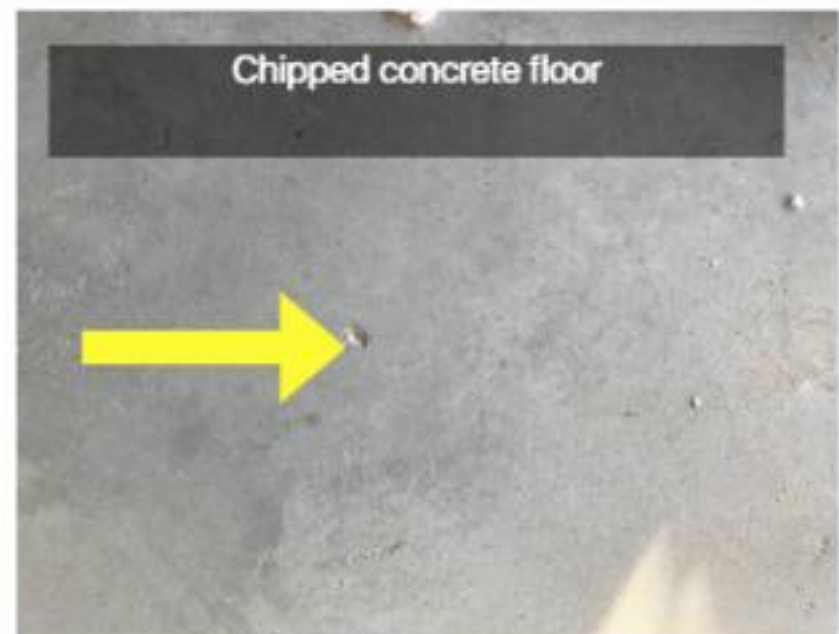
### Substandard Workmanship 3.02

Location: Garage

Finding: Surface - Chipped

Concrete floor is defective if it is chipped at handover.

As per VBA standards and tolerance guide 2.11, the finish to concrete slab is defective if it is not suitable for the documented applied finishes such as polished concrete.

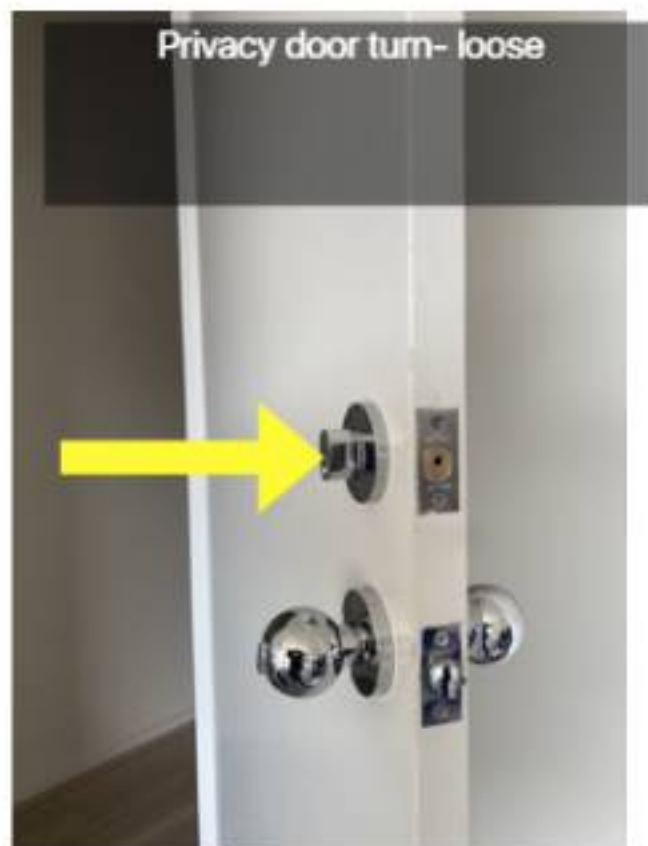
### Substandard Workmanship 3.03

Location: Garage

Finding: Door furniture- defective

During the documented maintenance period after completion, handles, locks and latches are defective if they do not operate as intended by the manufacturer.

Reference: VBA guide to Standards and Tolerances 2015 - 8.03

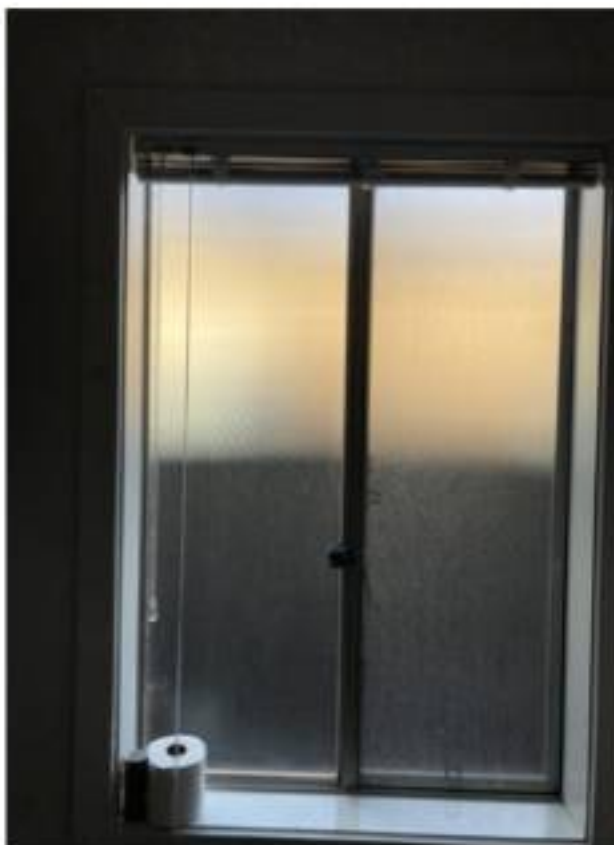
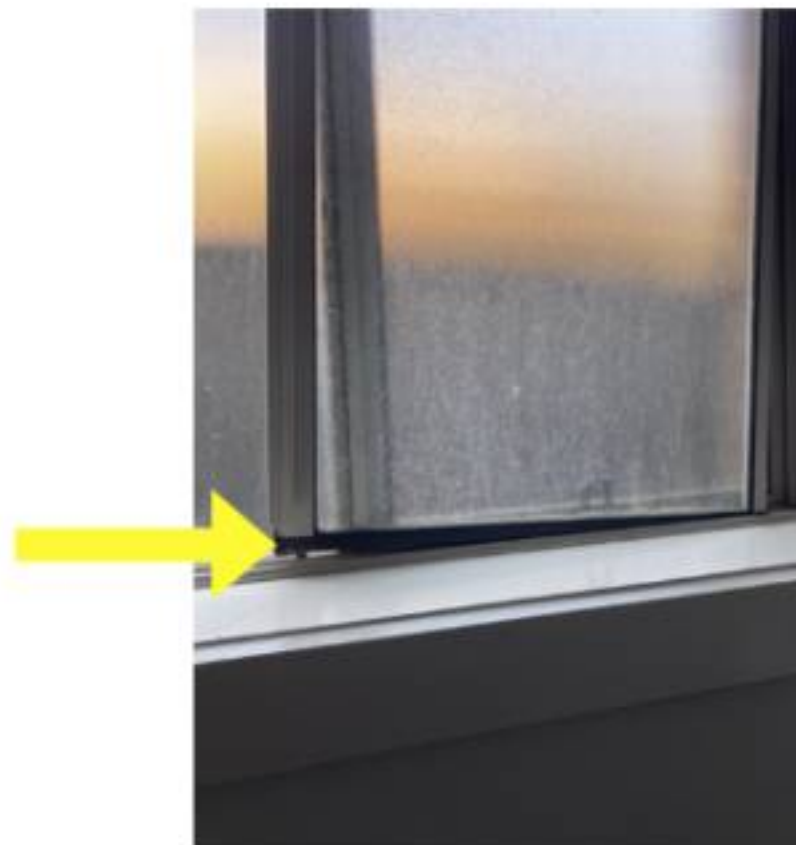
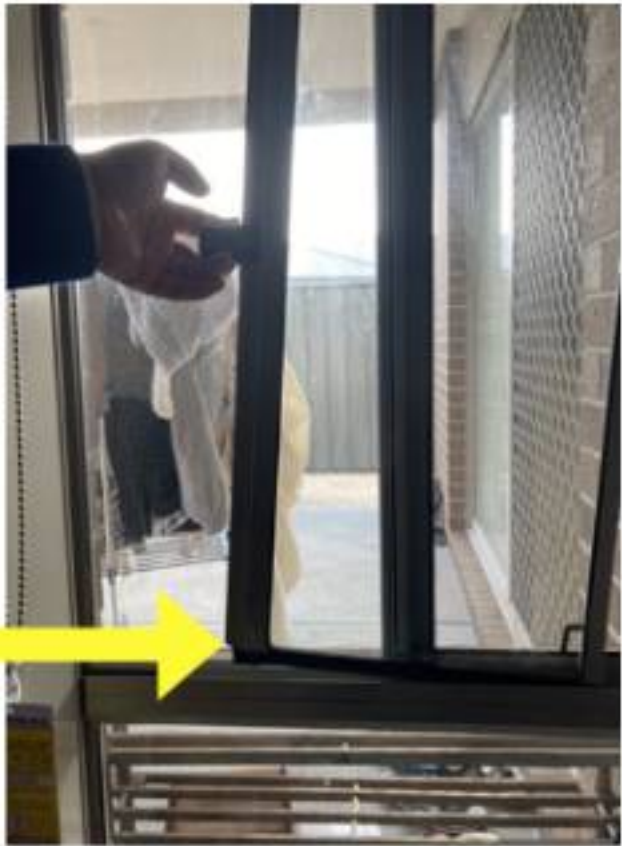
### Substandard Workmanship 3.04

Location: All Internal Areas

Finding: Faults and damage to Fittings- window

The fitting in this area is loose and requires adjustment to tighten. If left unmanaged, the fitting may further deteriorate.

As per VBA standards and tolerance guide 18.02, during the documented maintenance period after handover, fittings are if they do not operate as intended by the manufacturer.

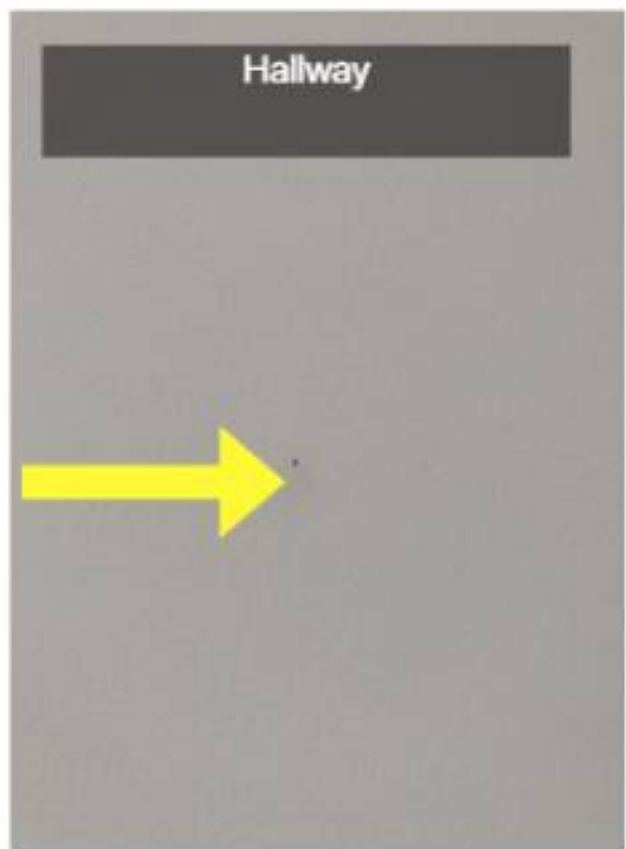
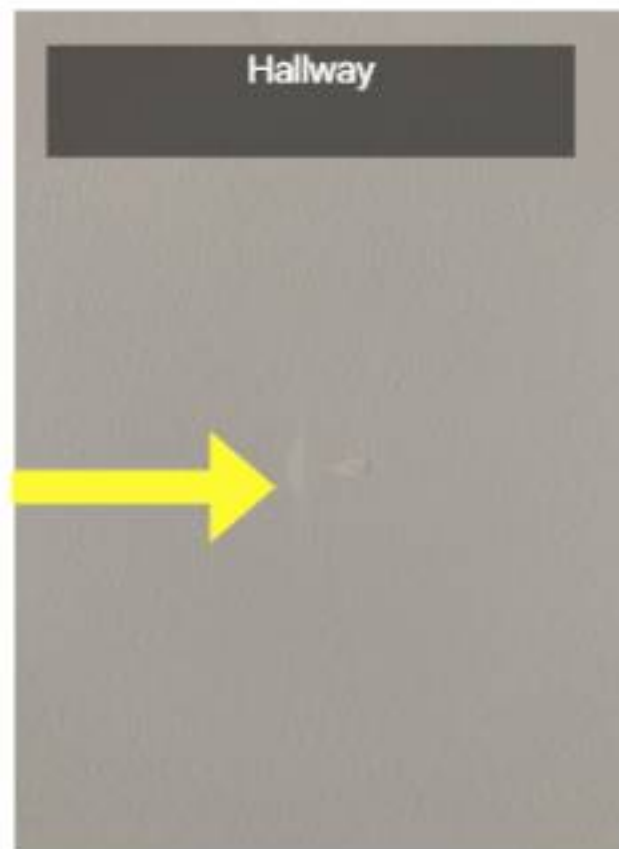
### Substandard Workmanship 3.05

Location: All Internal Areas

Finding: Walls - surface chipped

Chipped wall surface has been observed at the time of inspection. Internal walls are defective if it is chipped at handover.

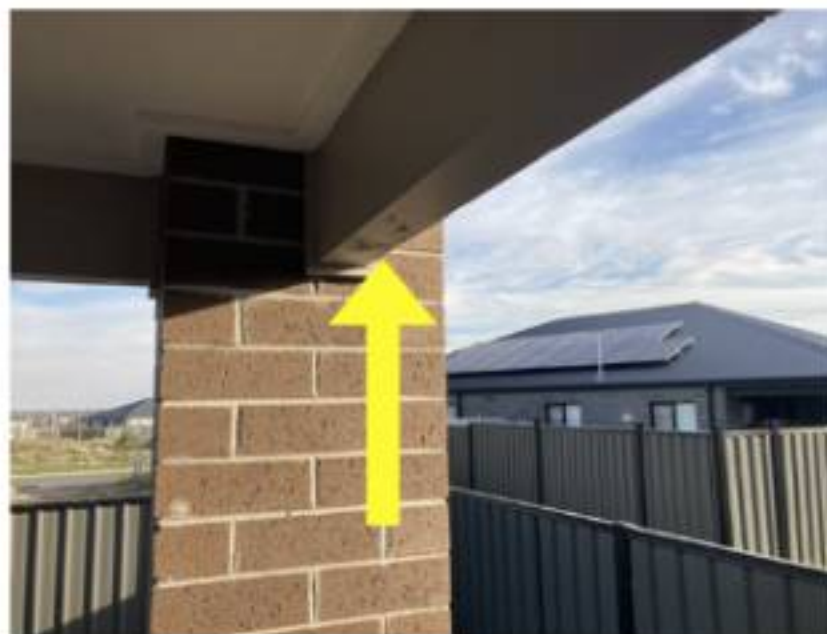
## Substandard Workmanship 3.06

Location: Alfresco

Finding: Paint finish - Incomplete( Alfresco Beam)

The paint finish in this area was identified as being incomplete at the time of inspection. Incomplete areas of paint finish expose the area to moisture, potentially accelerating the deterioration of underlying building materials. Incomplete paint finishes should be sanded back, filled, levelled and painted.

Unless documented otherwise, coatings are defective if they fail by lifting, blistering, flaking, fading etc., within the minimum period shown in Table 12.05 of Victorian Guide to Standards and Tolerances 2015.

Minimum 36 months of durability of coated paint finishes is required as per Victorian guide to standards and Tolerances 2015.

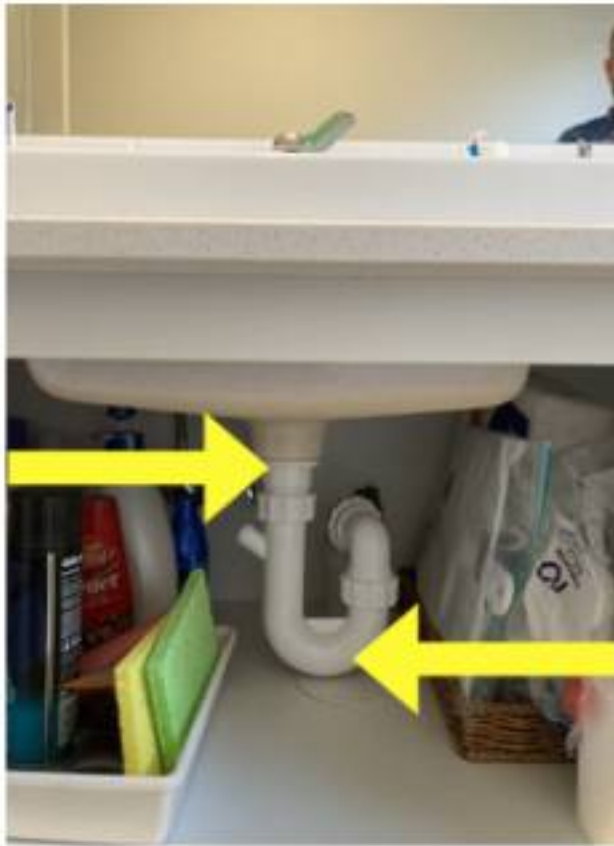
## Substandard Workmanship 3.07

Location: Bathroom

Finding: Water leak- Wash Hand Basin

Water leaks were found to be present to exterior plumbing work. It is highly advised that a licensed plumber be appointed to rectify any water leaks that may be present.

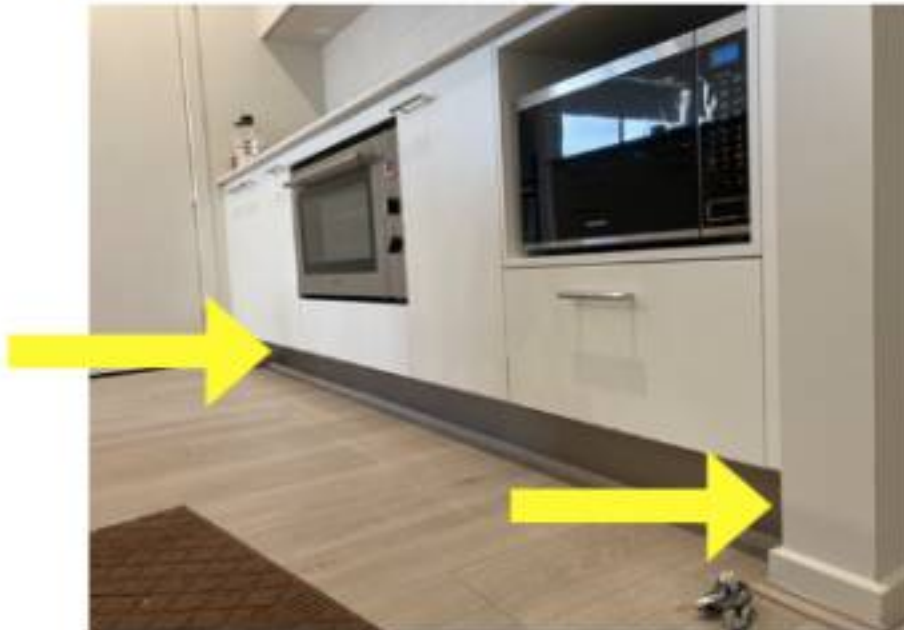
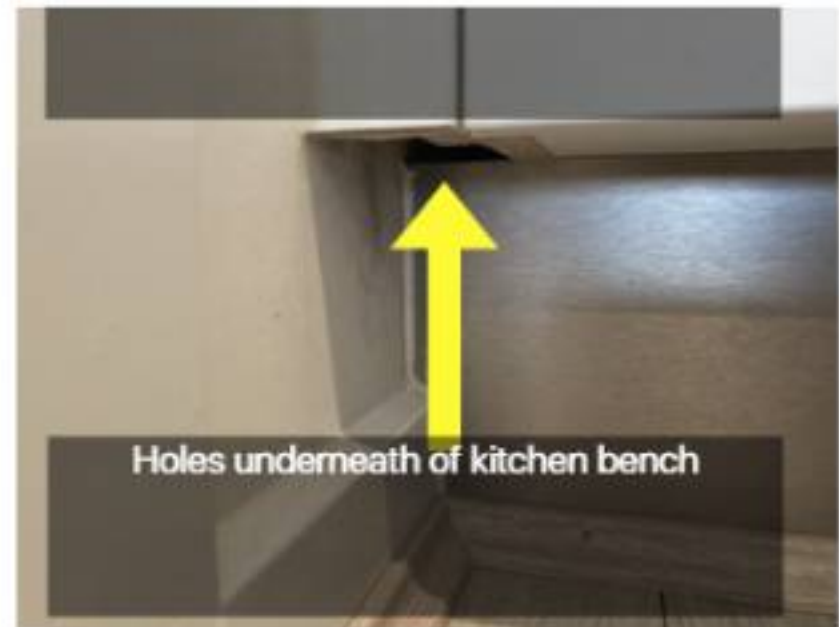
### Substandard Workmanship 3.08

Location: Kitchen

Finding: Installation - substandard or incomplete

The installation of this building element appears to have been completed to a substandard level of workmanship or is incomplete. Generally substandard repairs or installation are related to poor workmanship, the use of inappropriate materials, or a failure to complete installation to a suitable standard.

Unfinished and substandard building works are likely to degrade more quickly and may create potential for secondary defects to associated building elements.

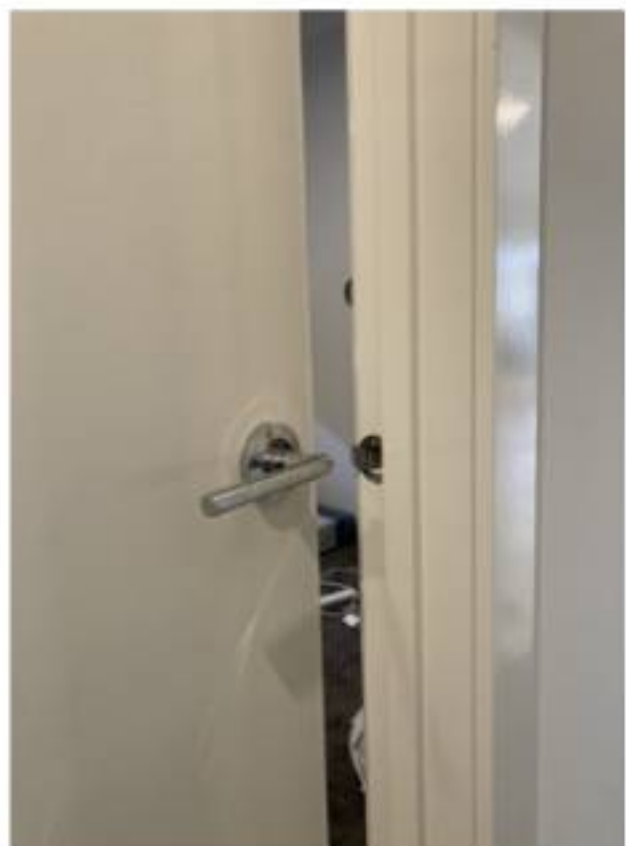
### Substandard Workmanship 3.09

Location: All Internal Areas

Finding: Door - Striker plate missing or poorly installed

The striker plate to this door is misaligned and has consequently resulted in the doors operation being compromised. Readjustment of the striker plate is recommended.

As per Victorian guide to Standards and Tolerances guide 2015 - 8.01, doors are defective if they are not installed in accordance with the manufacturer's installation instructions.

It is advised to check and rectify all internal doors including main door.

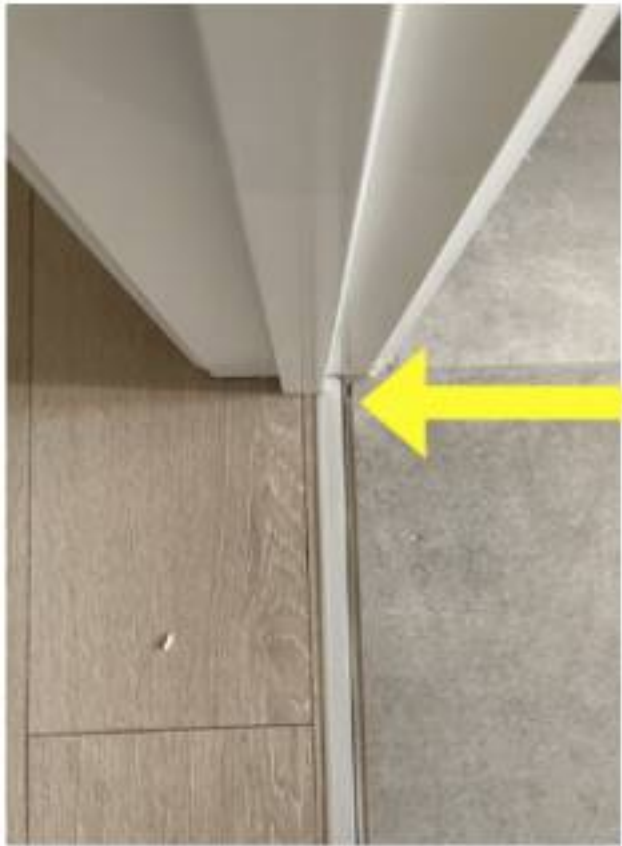
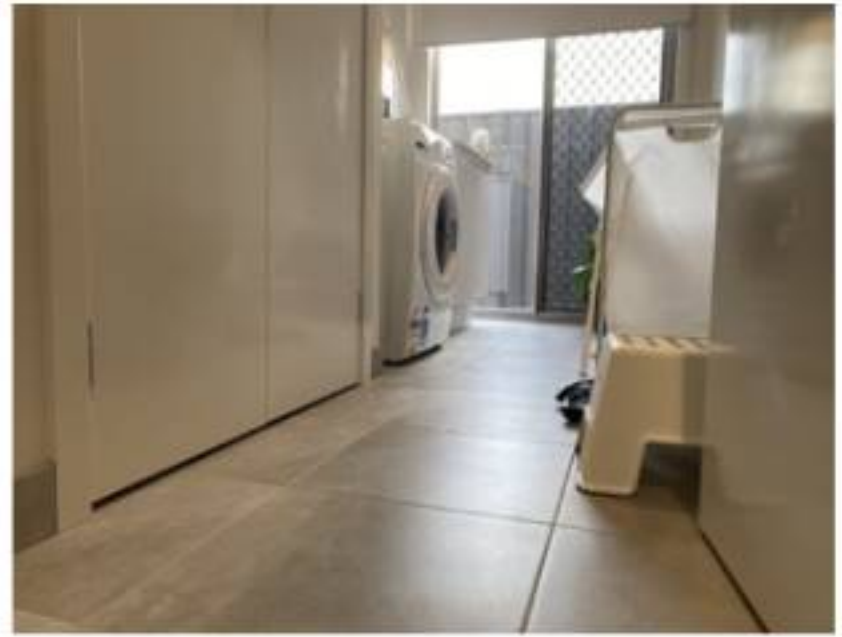
### Substandard Workmanship 3.10

Location: Laundry

Finding: Missing grout on floor tiles

Grouting is defective if it is not carried out in accordance with the requirements of Clause 5.7 of AS 3958.1.

Joints are defective if they are not, as far as is practicable, of consistent width and can be seen from a normal viewing position.

Finished grout is defective if it is not uniform in colour, smooth, without voids, pinholes or low spots.

Grout is defective if it becomes loose within 24 months of handover.

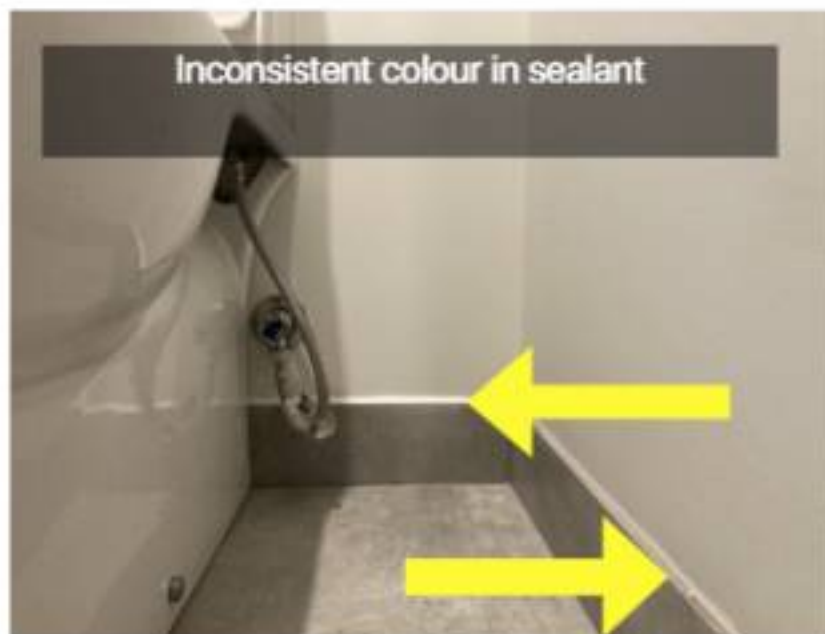
### Substandard Workmanship 3.11

Location: Separate Toilet

Finding: Flexible sealants to junctions- Inconsistent colour

Flexible or waterproof sealants to junctions are defective if they are not installed when required by the Building Code of Australia and AS 3958.1, or in accordance with the manufacturer's installation requirements.

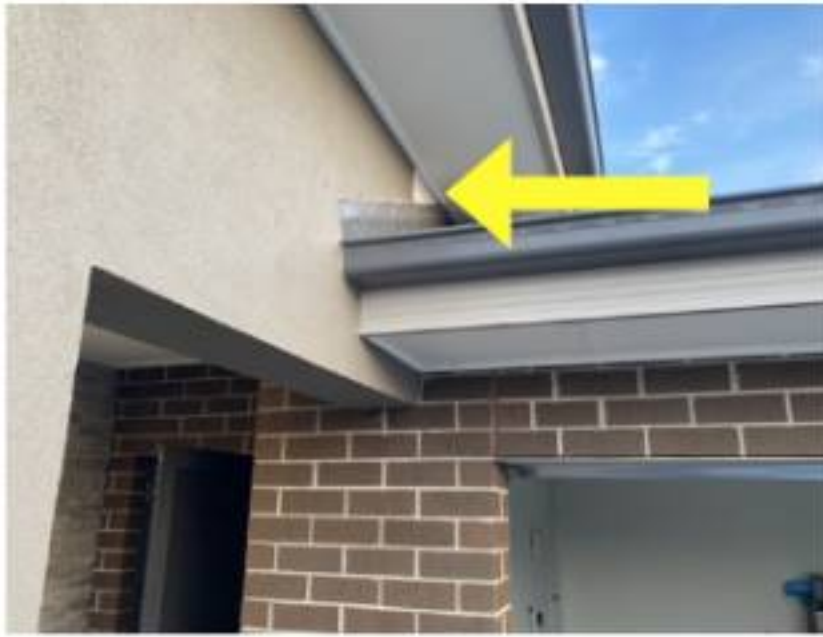
### Substandard Workmanship 3.12

Location: Roof exterior

Finding: Rendered surface- Inconsistent colour

Repairs to surfaces that have been rendered are defective if they do not match the colour and texture of the remaining wall or adjacent area as close as practicable

Reference: VBA guide to Standards and Tolerances 2015- 9.05

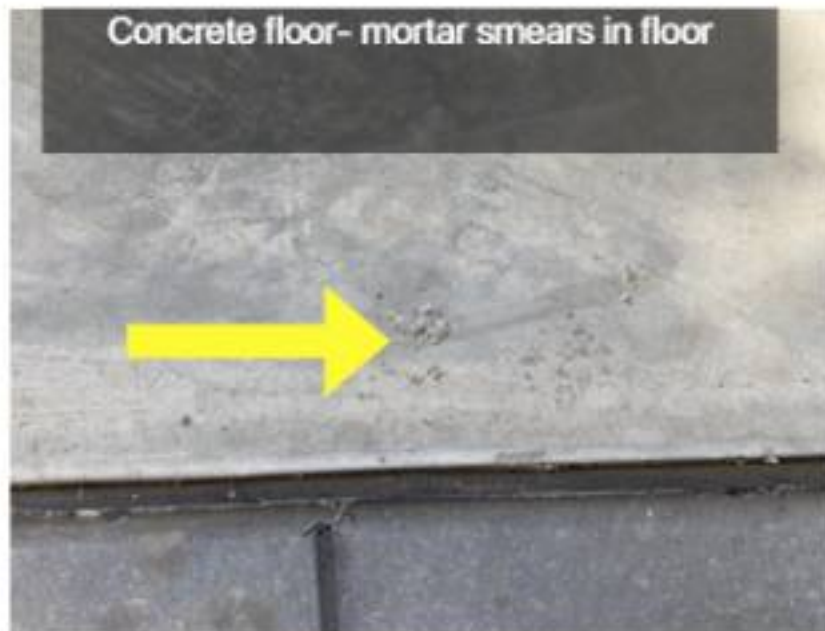
### Substandard Workmanship 3.13

Location: Garage

Finding: Cleaning, Mortar smears and stains

Stains, mortar smears and damage caused by cleaning are defective if they are visible from normal viewing position.

Please refer to VBA standards and tolerance guide 3.11.
