# Defects Liability Period Inspection Report

Inspection Date: 28 Apr 2021

Property Address: 8 Flaubert Rd Craigieburn 3064

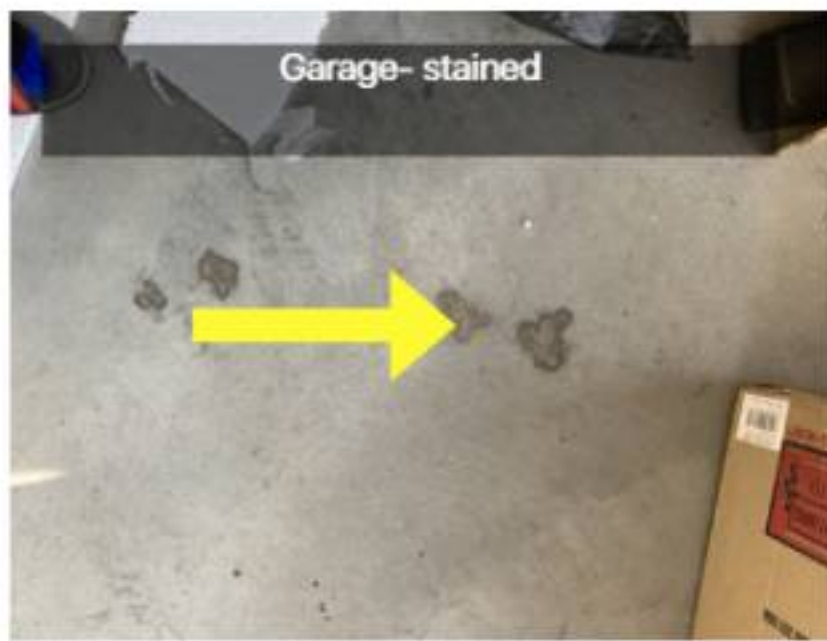
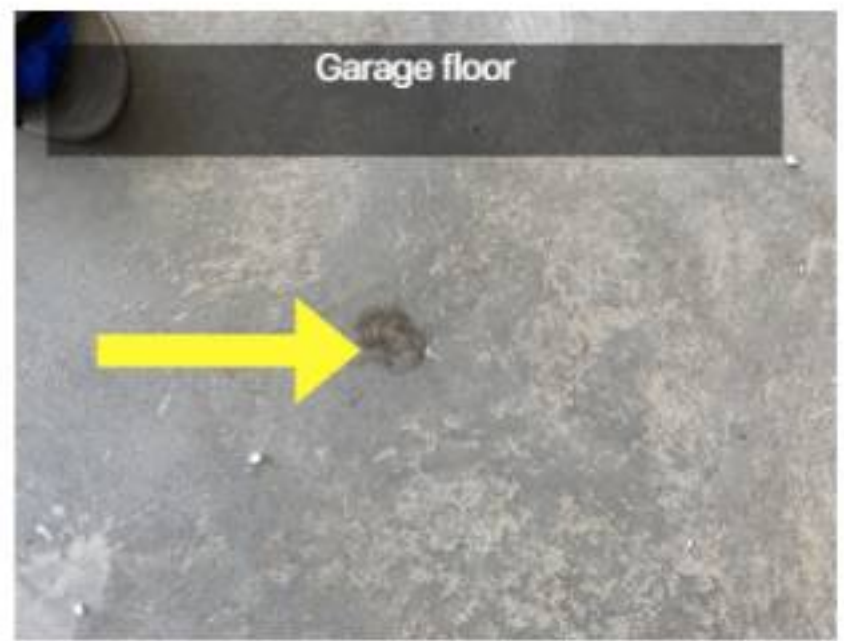
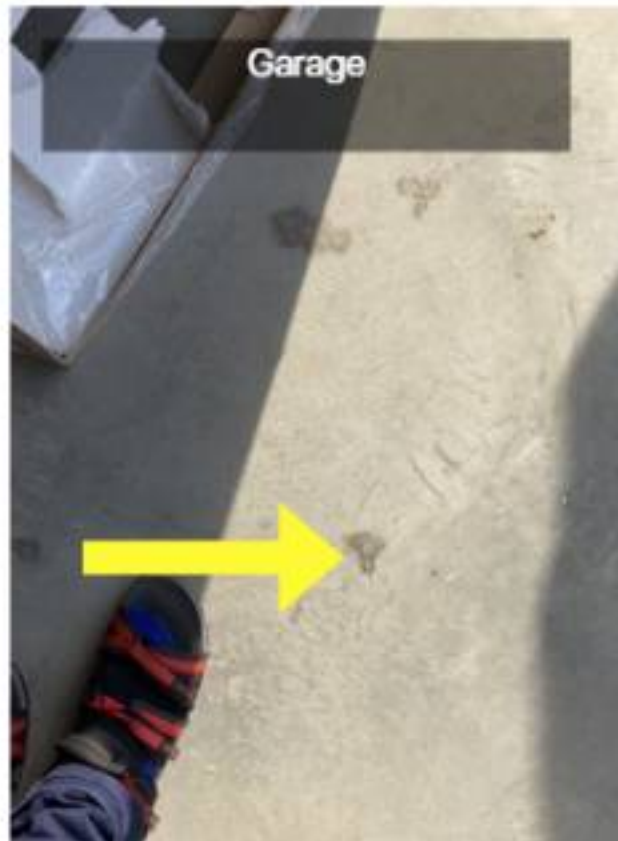
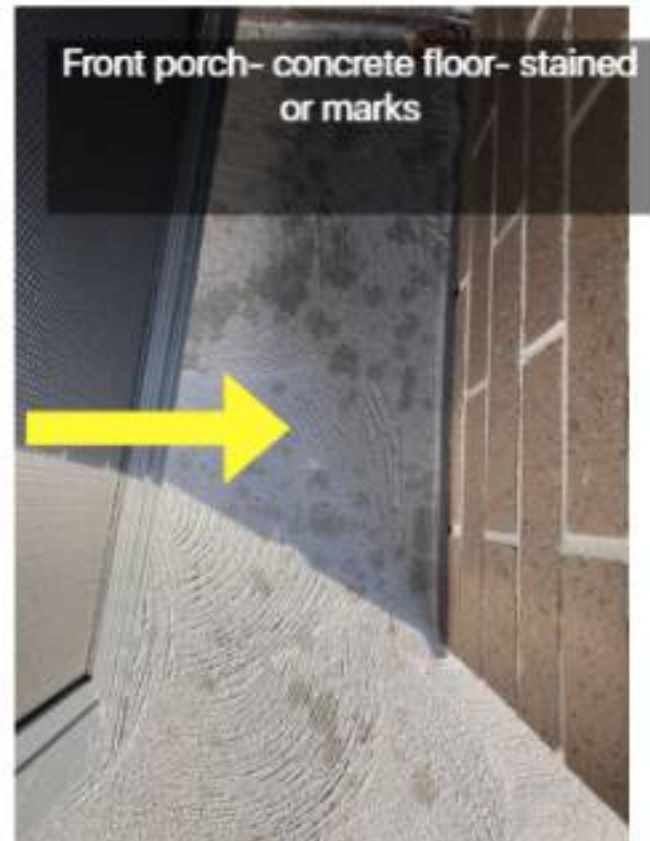
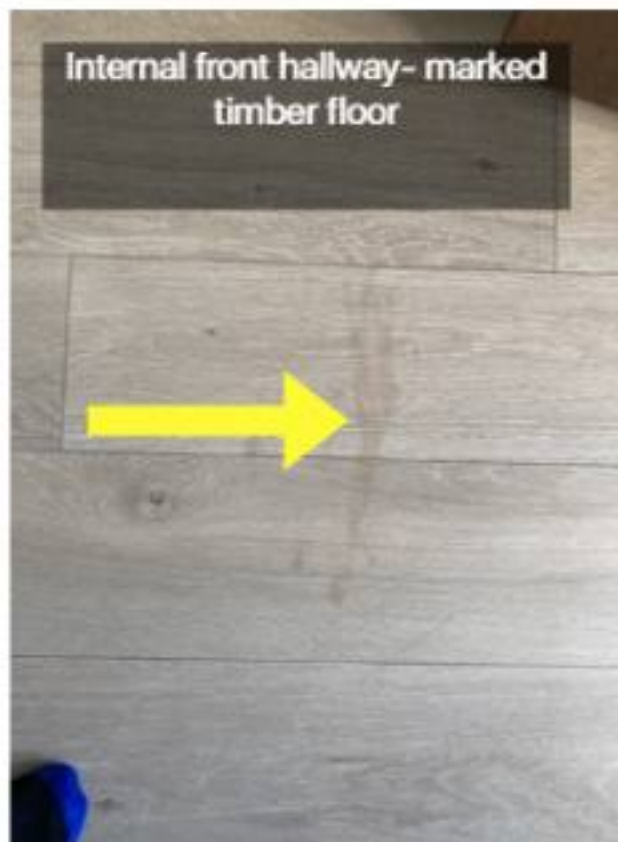
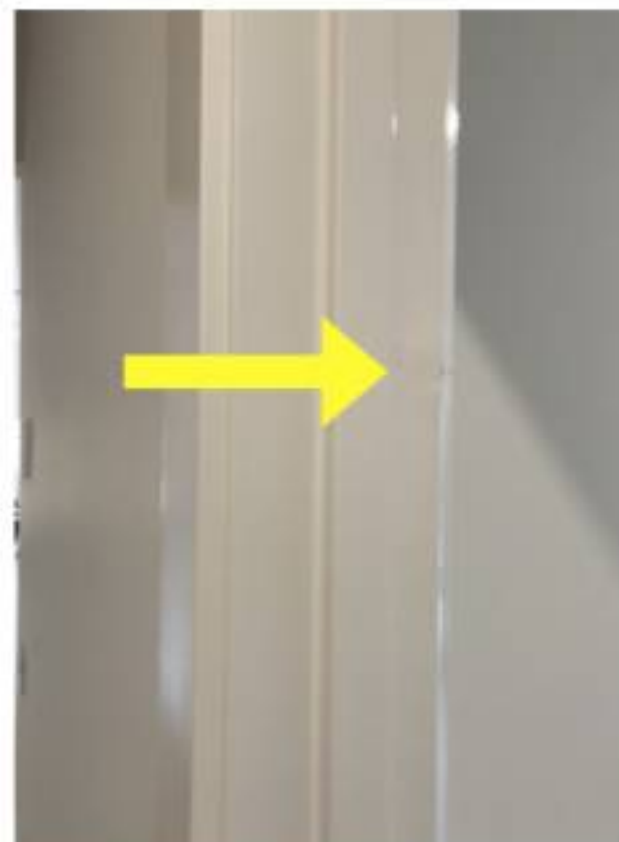
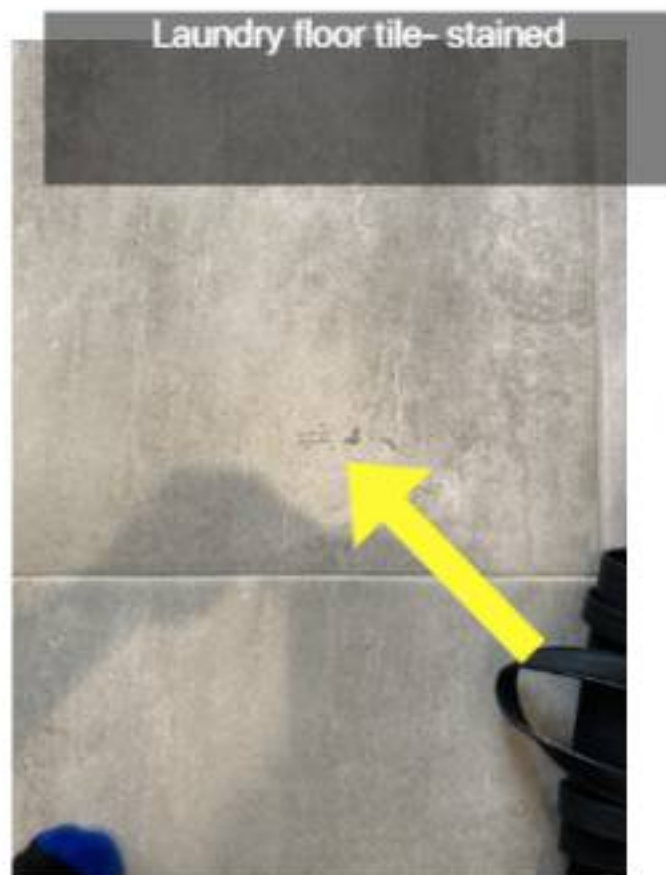
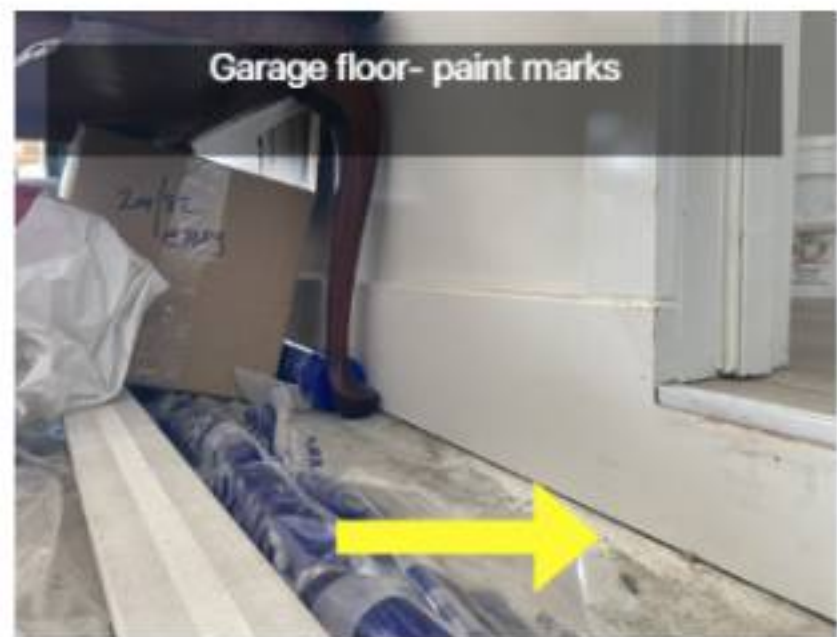
### Substandard Workmanship 3.14

Location: All areas

Finding: Surface - Marked

Marked or stained floor has been noted during the inspection.

Owners are entitled to expect that the building site and works are clean and tidy on completion. Building sites are defective if they are not clear of building debris.

Building works are defective where windows are not clean, floors are not swept, mopped or vacuumed as appropriate, tiles, sinks, basins, troughs, baths, etc. are not cleaned, and shelving, drawers and cupboards ready for use.

Reference: VBA guide to Standards and Tolerances 2015- 18.08

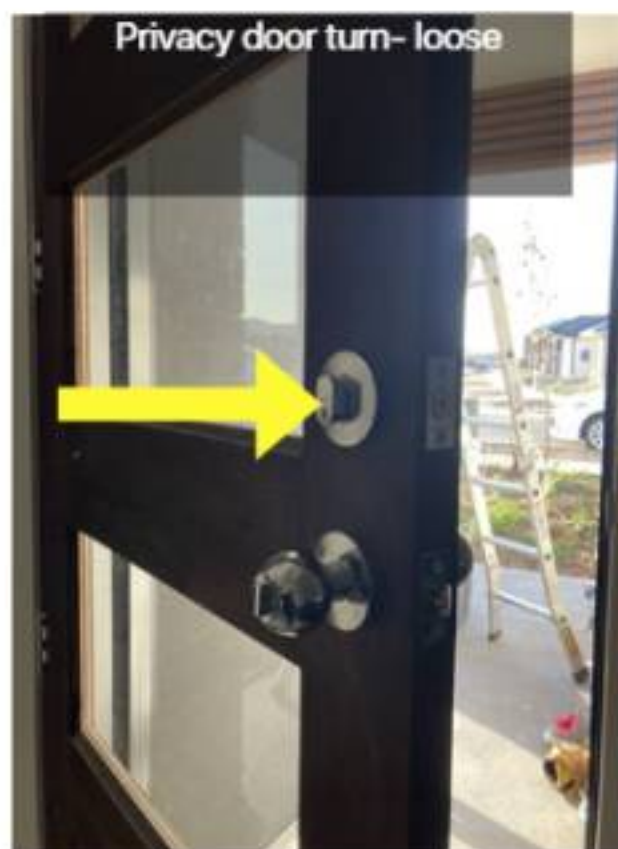
### Substandard Workmanship 3.15

Location: Front Main Door

Finding: Door furniture- defective

During the documented maintenance period after completion, handles, locks and latches are defective if they do not operate as intended by the manufacturer.

Reference: VBA guide to Standards and Tolerances 2015 - 8.03

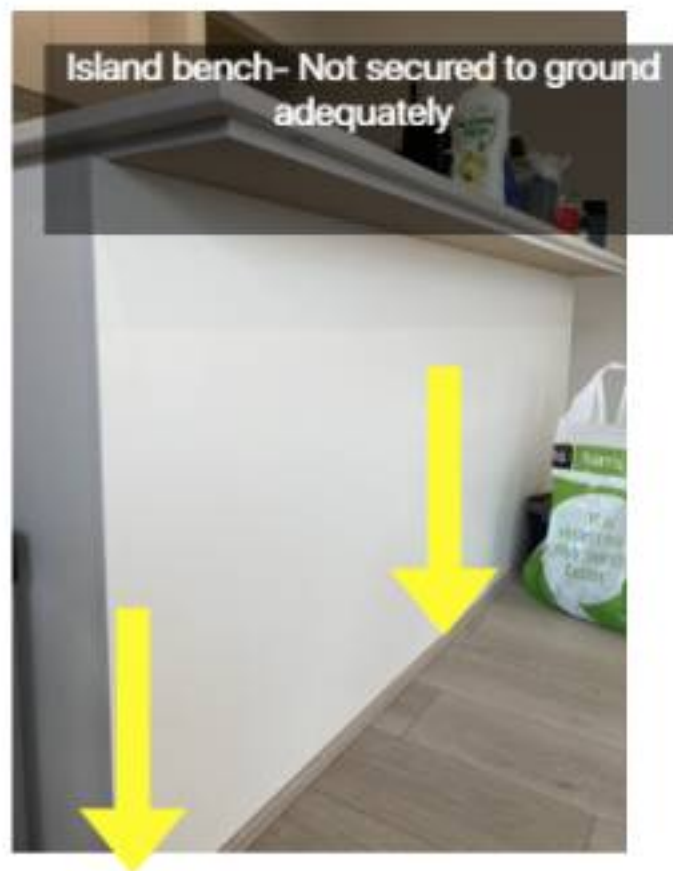
### Substandard Workmanship 3.16

Location: Kitchen

Finding: Fitting or fixture - Loose

The fitting in this area is loose and requires adjustment to tighten. If left unmanaged, the fitting may further deteriorate.
