**IBC PROPERTY  
INSPECTIONS**

# Practical Completion Inspection Report

Inspection Date: 31 May 2022

Property Address: 173 Forest Red Gum Drive Mickleham 3064

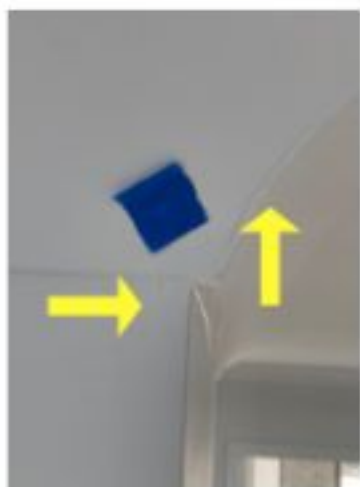
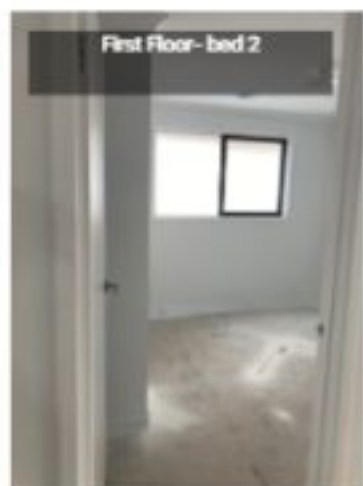
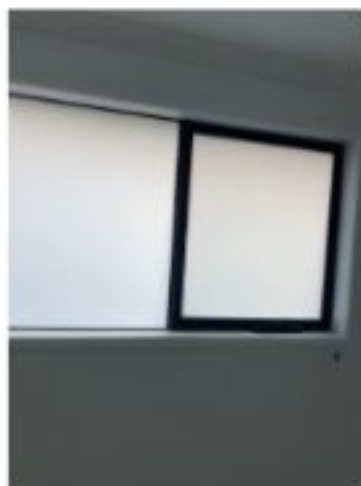
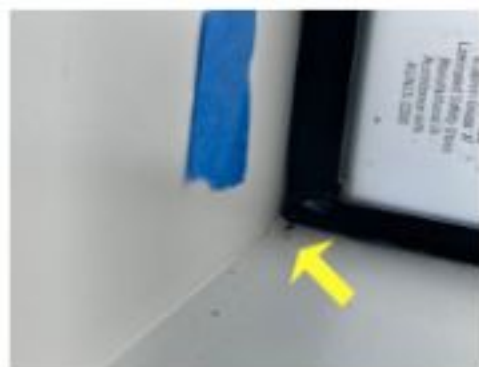
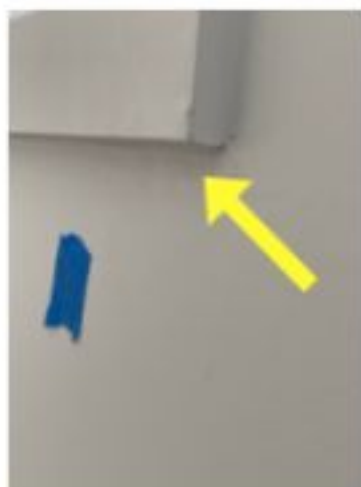
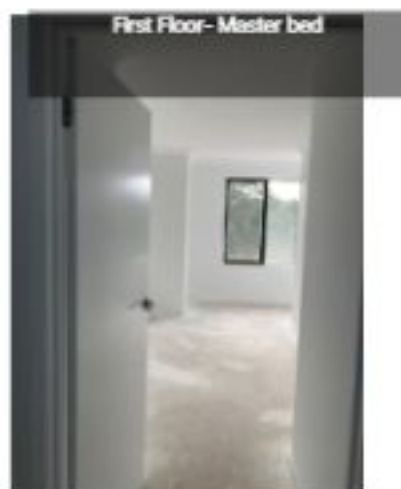
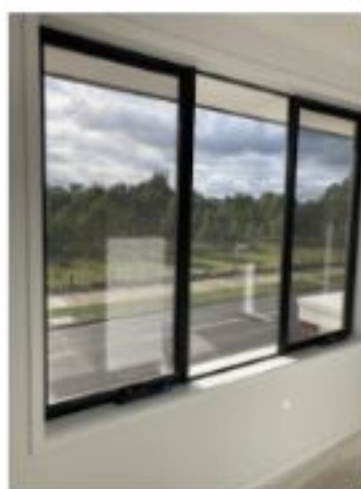
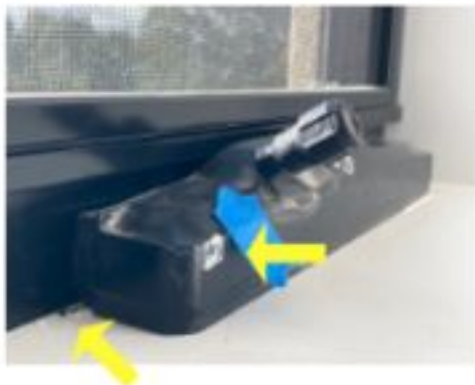
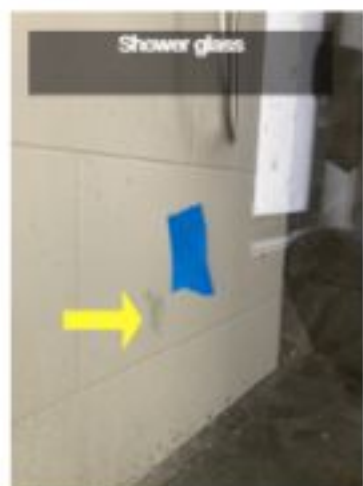
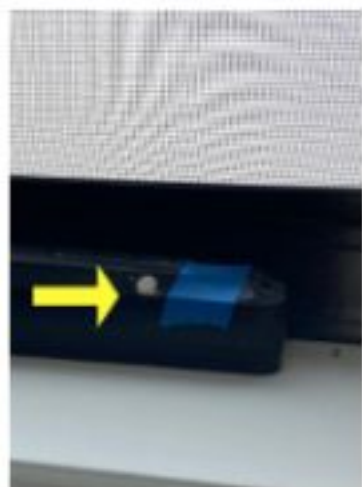
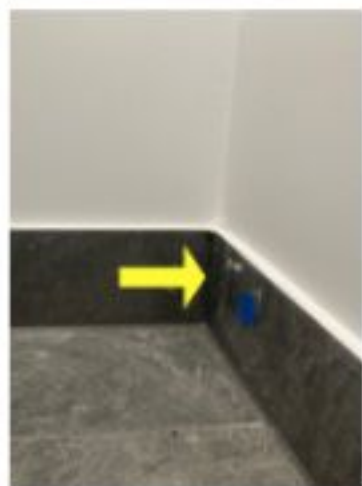
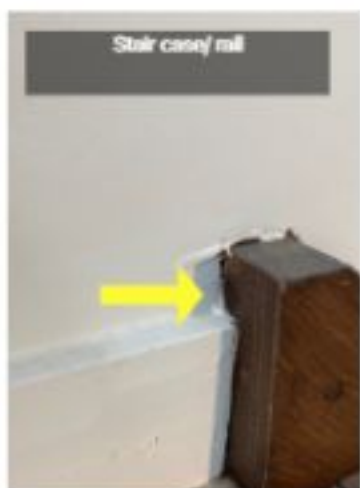
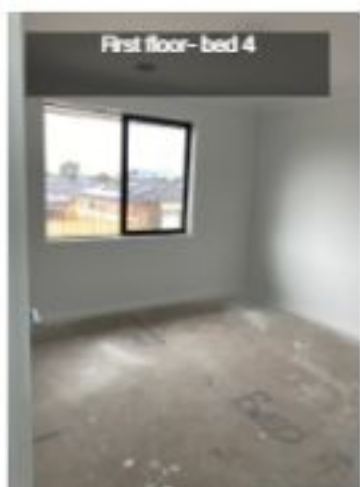
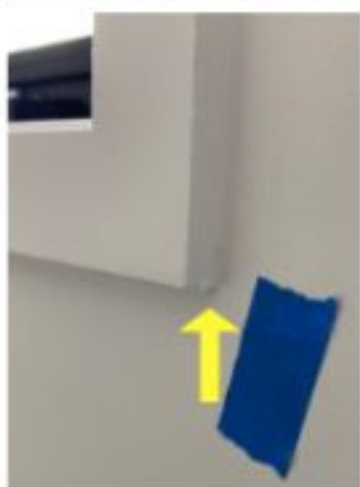
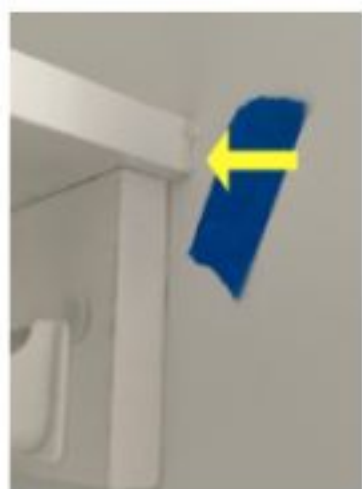
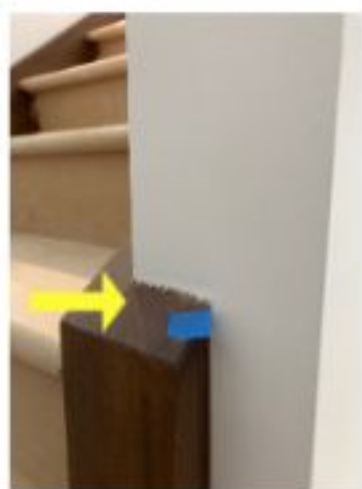
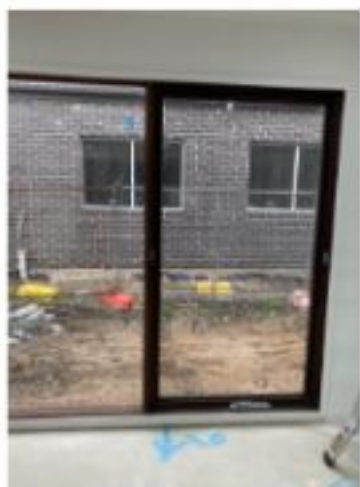
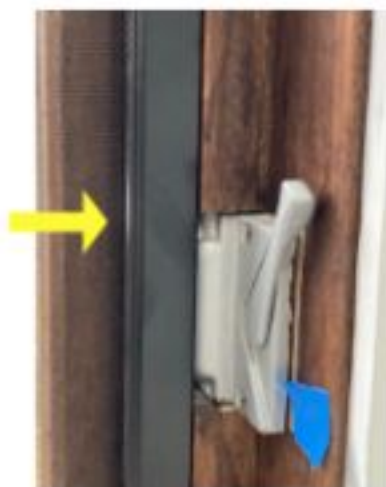
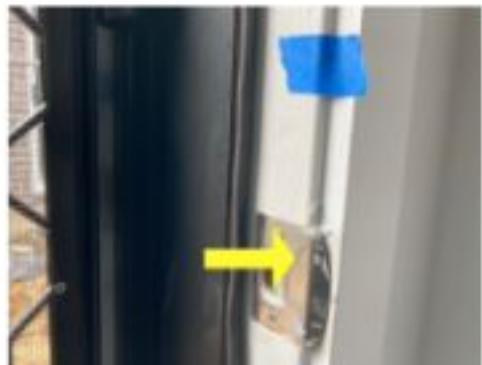
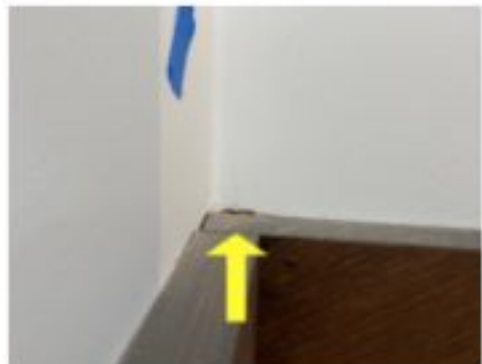
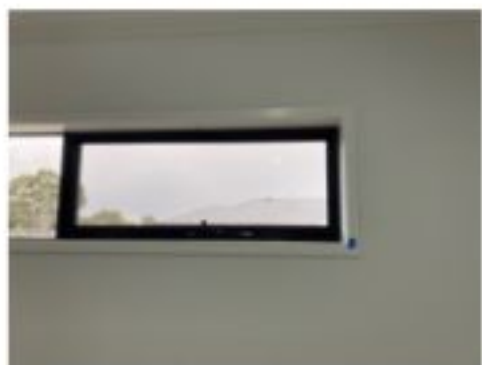
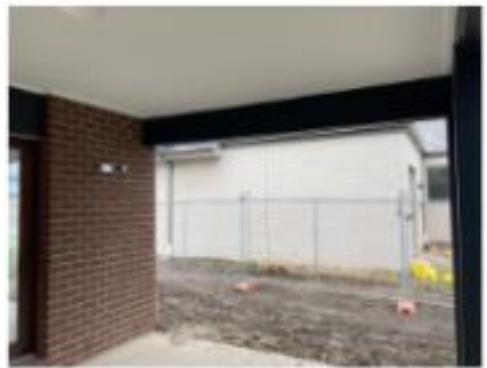
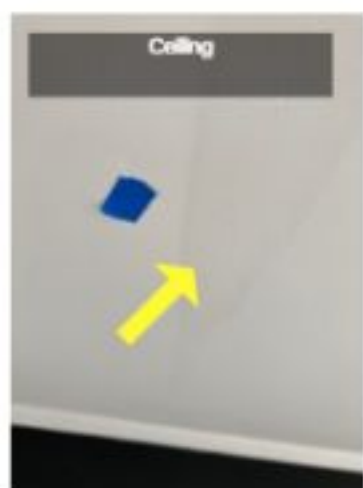
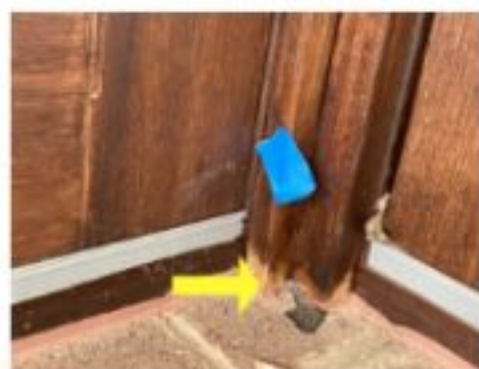
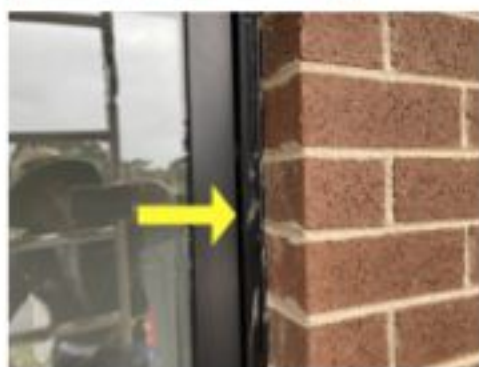
## Non Compliant 1.04

Location: All Internal Areas

Finding: Paint - poor surface finish

1. Paint works in internal areas were noted as defective due to marks and irregularities as shown on photographic evidence. Marked with Blue tape.

2. Substandard painting works in the store room underneath the staircase.

Victorian Building Authority's Guide to standards and Tolerances 2015-12.02

The builder to rectify. Re- inspection is advised

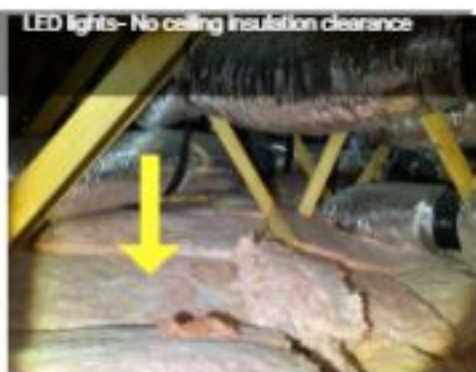
## Non Compliant 1.05

Location: Roof Space

Finding: Inadequate ceiling clearance around LED lights

50 MM clearance of ceiling insulation has not been kept. Most of the LED lights have been covered with insulation without any clearance being kept. This is a fire hazard

1. AS/ NZS 3000- 2007- Electrical Installations

3. Action: The builder to rectify. Re- inspection is advised

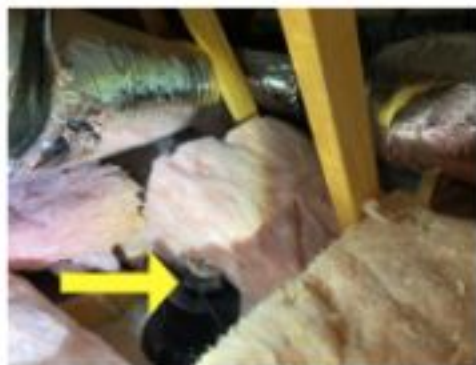
## Non Compliant 1.06

Location: Roof Space

Finding: Bathroom exhaust- discharged in to roof space

It has been observed that kitchen and bathroom exhaust has been discharged directly in to roof space. The roof space appeared unventilated.

2. Applicable law/ BCA reference: Building code of Australia(BCA) part 3.8.7.3

Exhaust from a bathroom, sanitary compartment, or laundry must be discharged directly or via a shaft or duct to outdoor air. The builder to rectify. Re- inspection is recommended

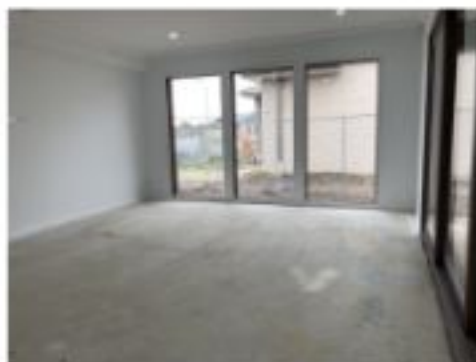
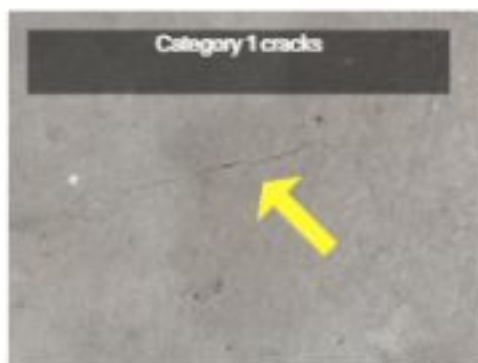
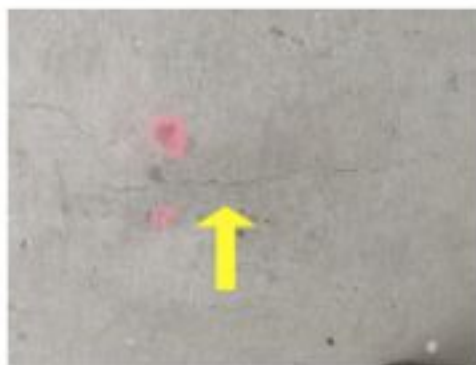
## Non Compliant 1.07

Location: Ground Floor- Living/ Dining

Finding: Cracks In concrete slab- Category 1

Cracks In concrete slabs

VBA guide to standards and tolerances 2015-2.10

Category 1 and 2 cracks to slabs are to be monitored for a period of 12 months. At the end of the monitoring period, cracks are defective if they are greater than category 2 and attributed to the actions of the builder.

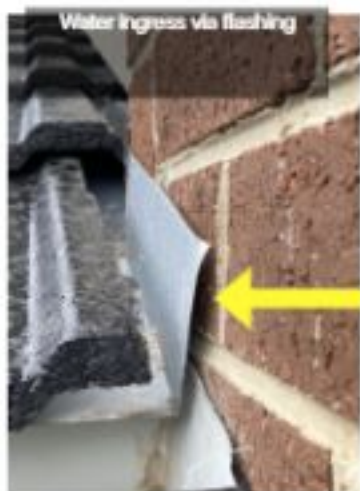
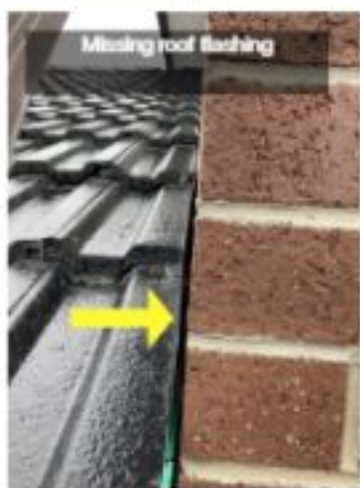
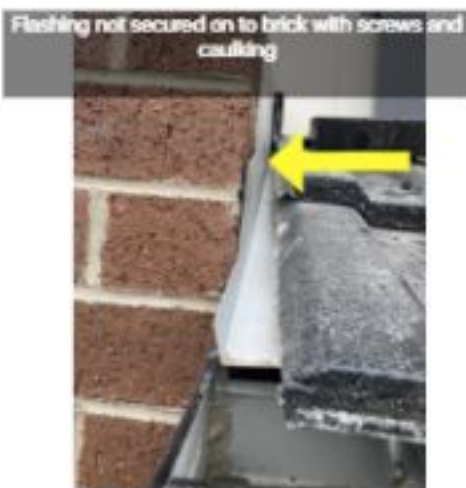
## Non Compliant 1.09

Location: Roof

Finding: Missing roof flashing- All areas of lower roof

Missing roof flashings noted on lower roof with water ingress across entire property.

Roofing, including flashings and accessories, is defective if it leaks under normal weather conditions and is due to the builder's workmanship, causes unhealthy or dangerous conditions, loss of amenity for occupants, undue dampness or deterioration of building elements.

The builder to rectify. Re- inspection is advised

Upper roof was not checked due to working height restrictions. The builder must investigate upper roof as well to detect flashing issues and rectify.

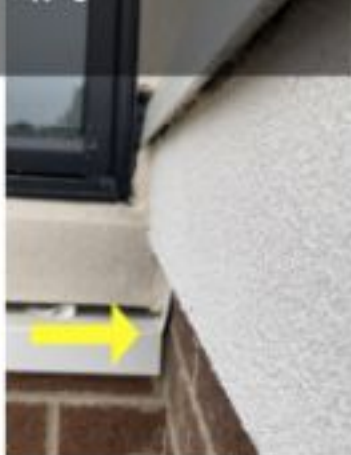
Capping not secured on to bricks

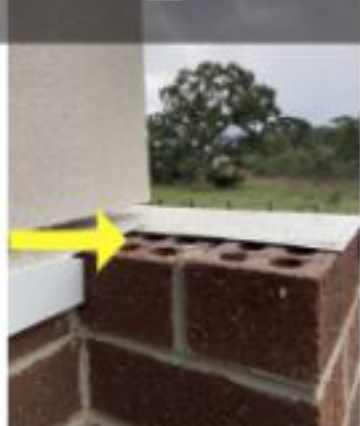
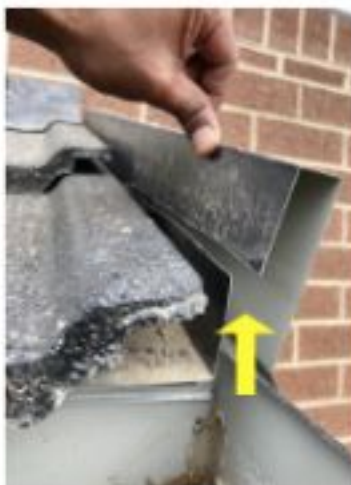
Missing flashing with water entry in to brick wall

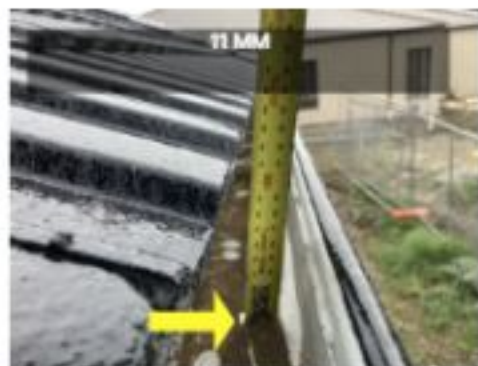
### Non Compliant 1.10

Location: Lower Roof

Finding: Water retention on gutters

Water retention on gutters of 11 mm noted. This will lead to decay of gutters.

Gutters are defective if they retain a depth of more than 10 mm of water

The builder to rectify. Re- inspection is recommended . The builder must check upper roof gutters and rectify

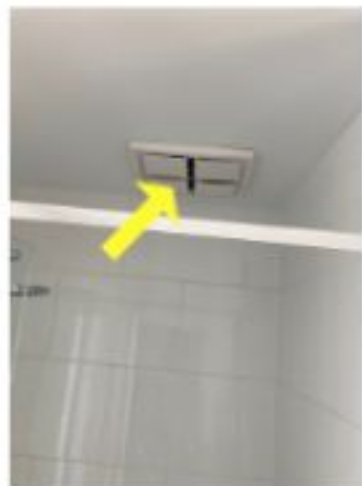
### Substandard Workmanship 2.01

Location: First Floor Ensuite

Finding: Noisy fan

Noisy fan noted. On subsequent inspection of roof space, fan was partly covered with ceiling insulation batts with potential obstruction to movement of blades.

VBA | GUIDE TO STANDARDS AND TOLERANCES 2015- 18.02 Faults and damage to appliances and fittings

The builder to further investigate all exhaust fans and rectify.

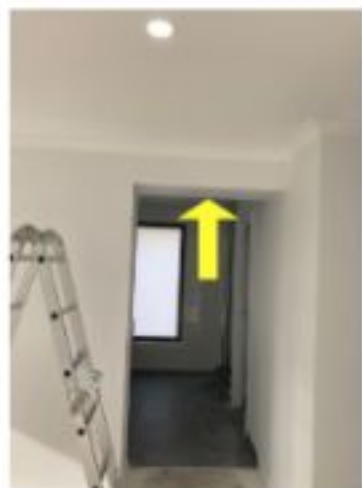
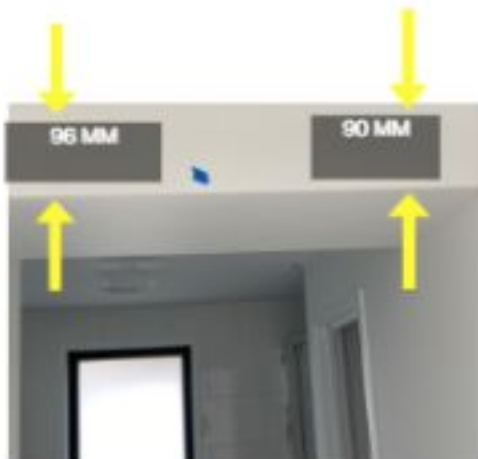
## Substandard Workmanship 2.02

Location: First Floor- Master Bedroom

Finding: Bulkhead - Not plumb

Bulkhead is not plumb. Deviation is 6 MM.

3. Action: The builder to rectify:

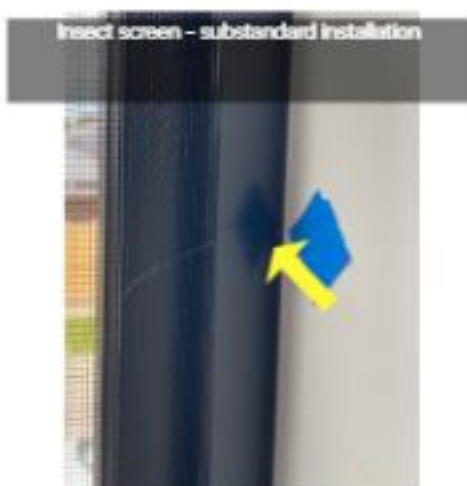
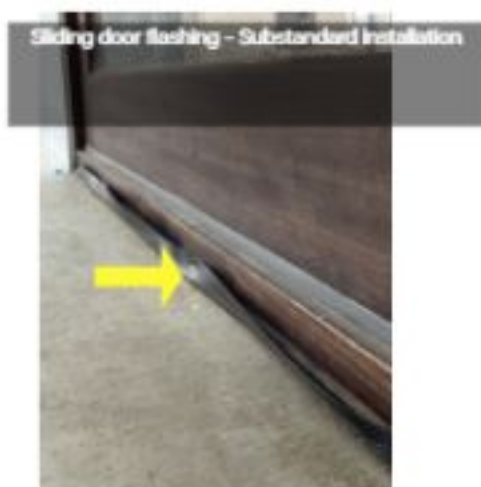
### Substandard Workmanship 2.05

Location: All areas

Finding: General photographic evidence for substandard workmanship

1. General defects of substandard workmanship

3. Action: The builder to rectify.

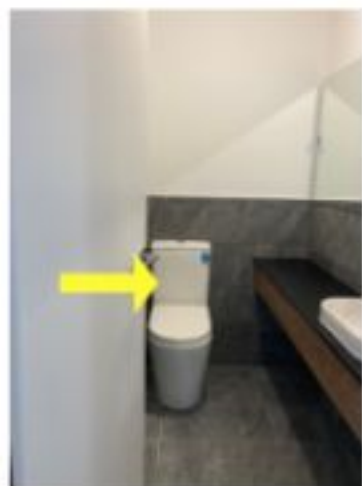
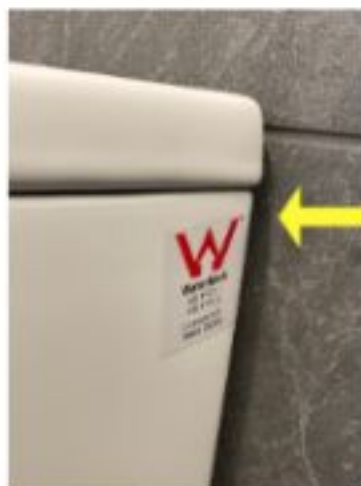
Finding: WC commode cistern- loosely fitted

WC- cistern loosely fitted

3. Action: The builder to rectify.

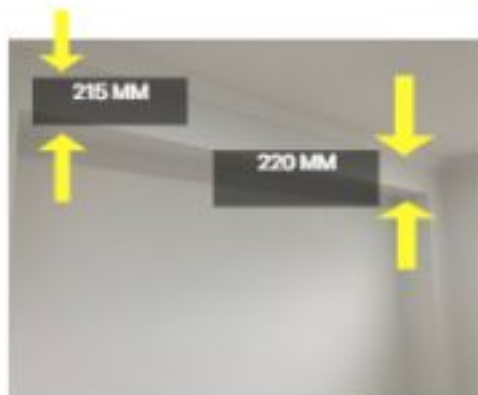
### Substandard Workmanship 2.09

Location: Ground Floor- Theatre

3. Action: The builder to rectify:

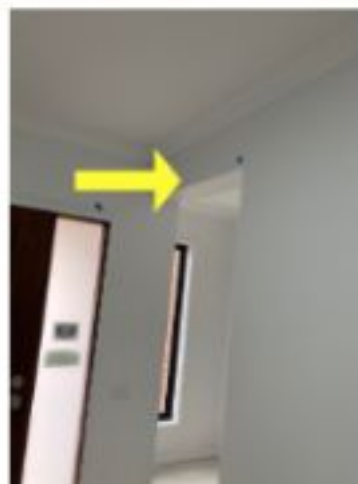
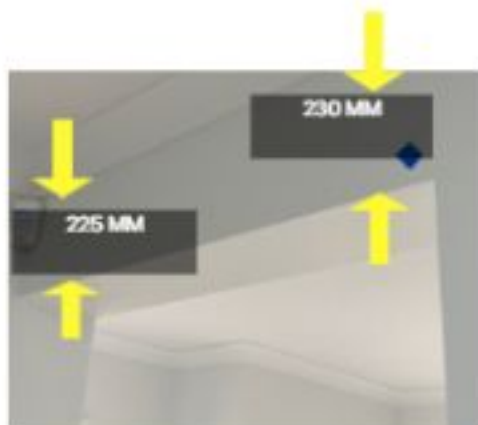
## Substandard Workmanship 2.10

Location: Ground Floor- Study  
Finding: Bulkhead is not plumb

3. Action: The builder to rectify.

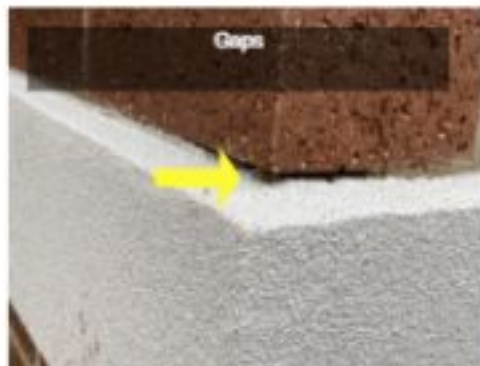
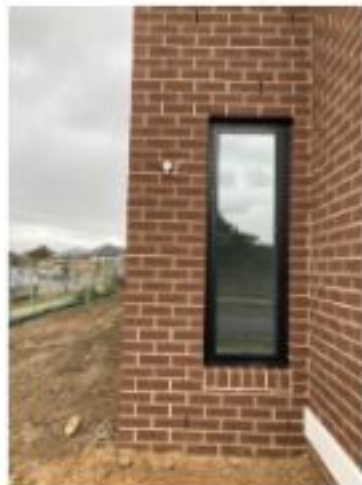
## Substandard Workmanship 2.11

Location: All External Areas  
Finding: Defects on external brickwork

3. Action: The builder to rectify.

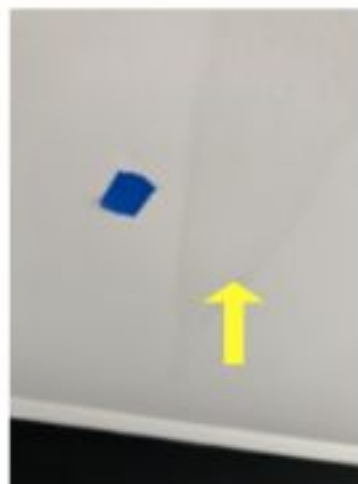
## Substandard Workmanship 2.12

Location: Garage

Finding: Water stain mark on ceiling

1. Water stain noted on ceiling. Garage roof's defects noted with lack of flashing with water entry.

3. Action: The builder to rectify all roof flashing defects. The builder should further investigate water stain on ceiling and rectify the source of leak.

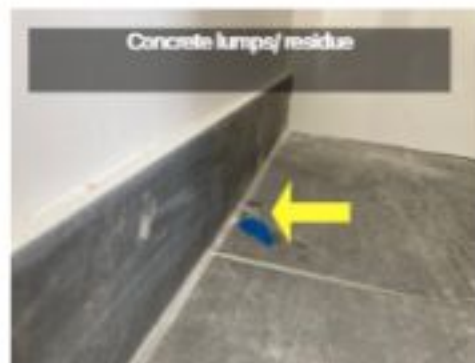
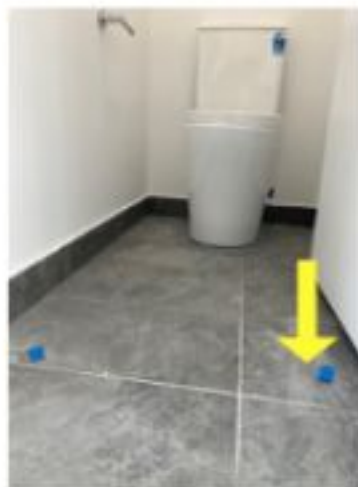
## Incomplete 3.01

All internal areas were noted as uncleaned. The builder should clean the site at practical completion stage.

Building works are defective where windows are not clean, floors are not swept, mopped or vacuumed as appropriate, tiles, sinks, basins, troughs, baths, etc. are not cleaned, and shelving, drawers and cupboards ready for use.

3. Action: The builder to rectify

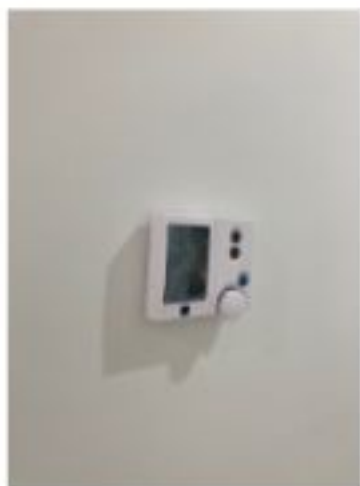
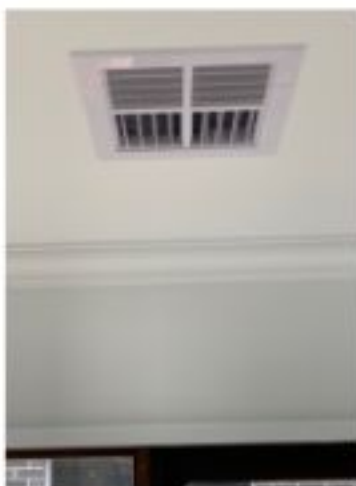
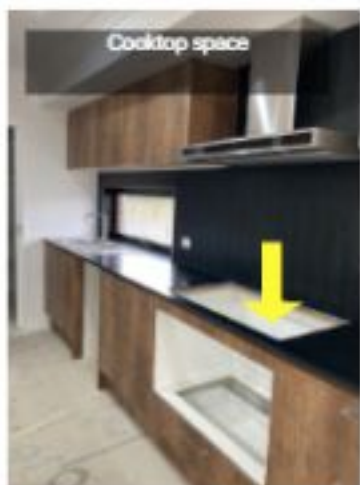
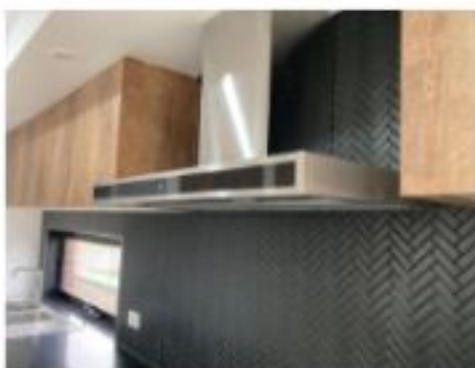
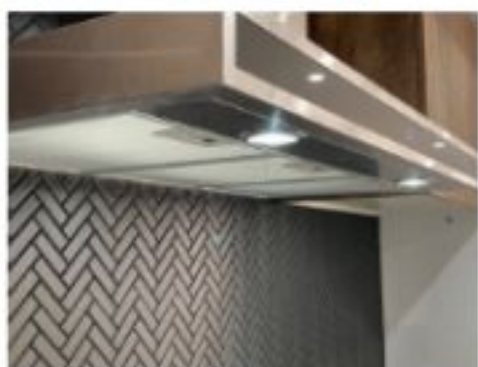
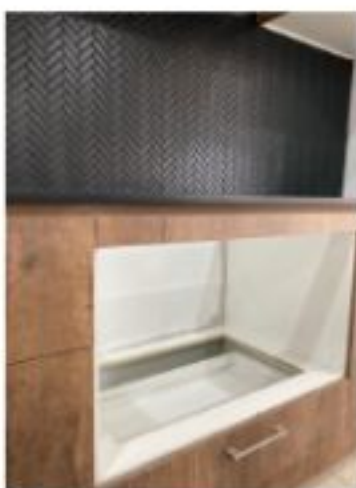
Following incomplete works noted during inspection. The builder should complete all work prior to final handover as per contract's inclusion list.

1. Heating/ cooling - Not commissioned at the time of inspection
2. Hot water not commissioned at the time of inspection
3. Oven, dishwasher, cooktop, hot water unit not installed at the time of inspection

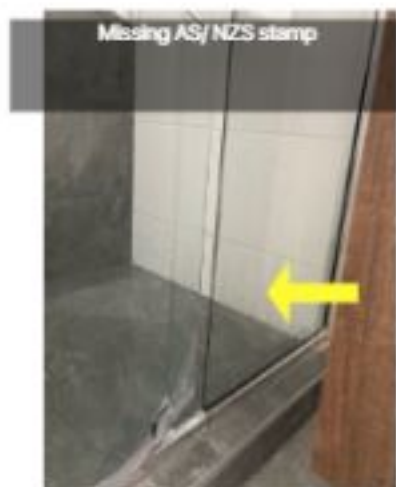
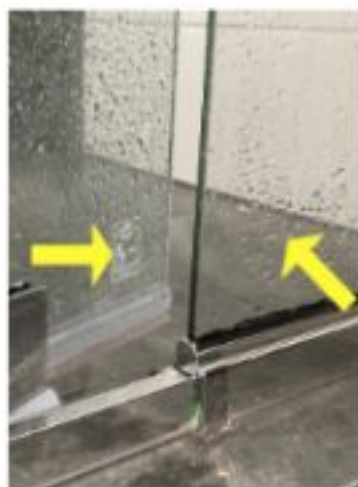
### Incomplete 3.03

I have noted that shower screens ( each panels) have not been stamped with the name, registered trademark and the code of manufacturer.

2. Applicable Building code/ AS standard reference:  
AS 2308- Safety glazing materials in buildings)

3. Action: The builder to replace panels with stamped ones.

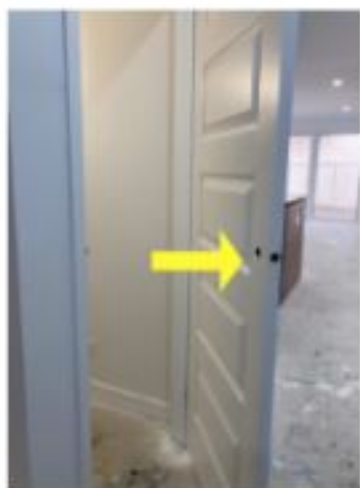
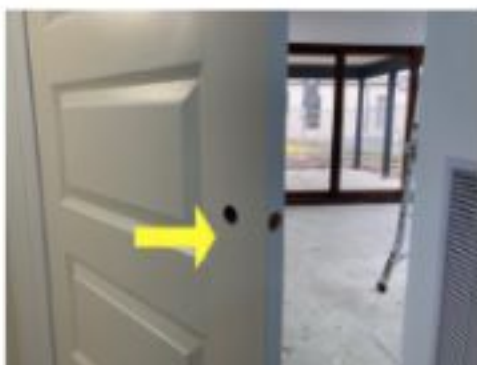
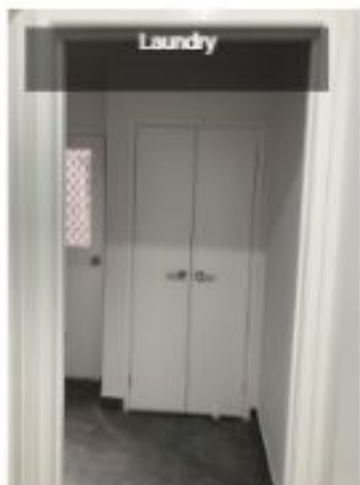
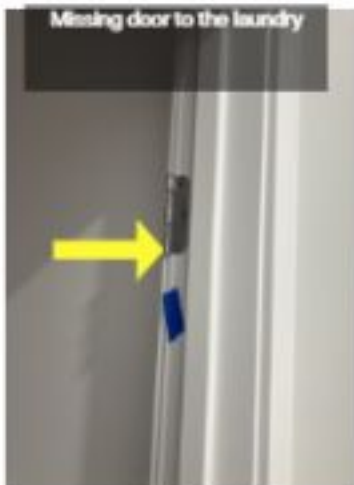
## Incomplete 3.04

Location: Ground Floor- Store Room/ Laundry

Finding: Missing door locks/ missing doors

1. Missing door locks- store room
2. Missing door to the laundry
3. Missing back door to the garage

Action: The builder to install door locks
