# Sample Building Report For Customer Pre Inquiry

Inspection Date: 25 Sep 2025

Property Address: Sample Street Sample

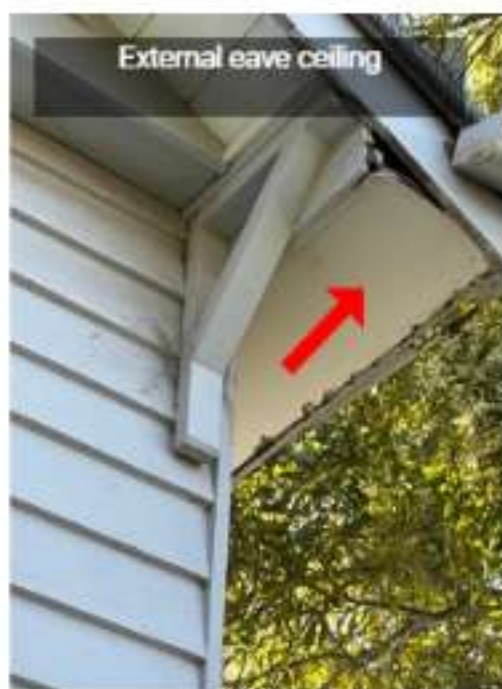
**Finding:** Major safety hazards

Asbestos is suspected on the property under floor tiles/ wall lining due to Age of the property.

Client to engage a licensed tradesman to assess & make further advice before buying the property

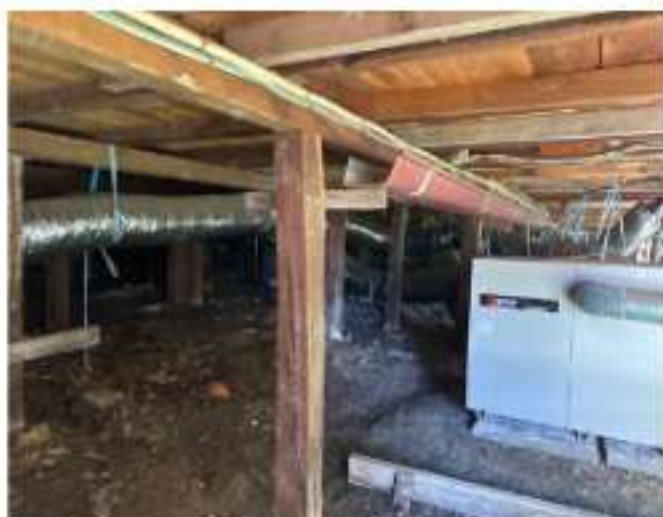
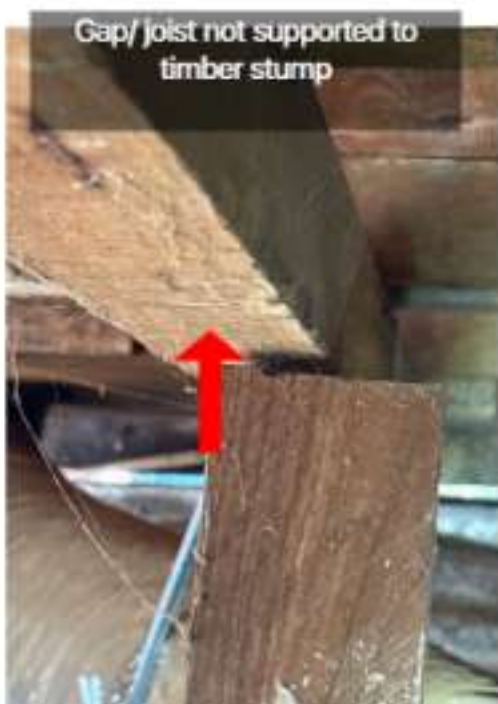
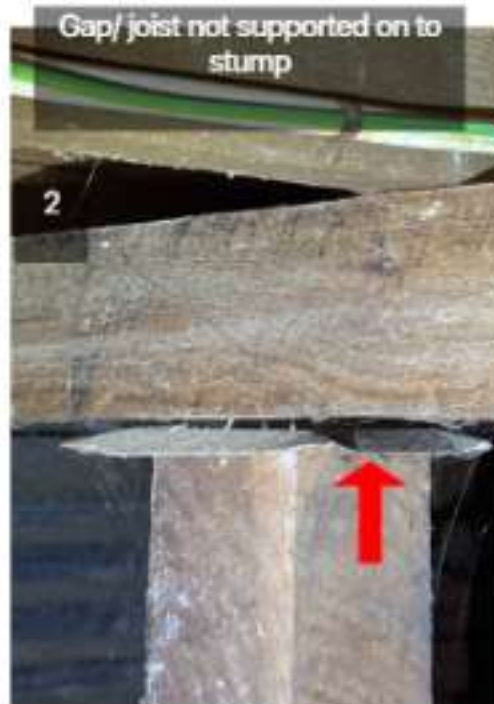
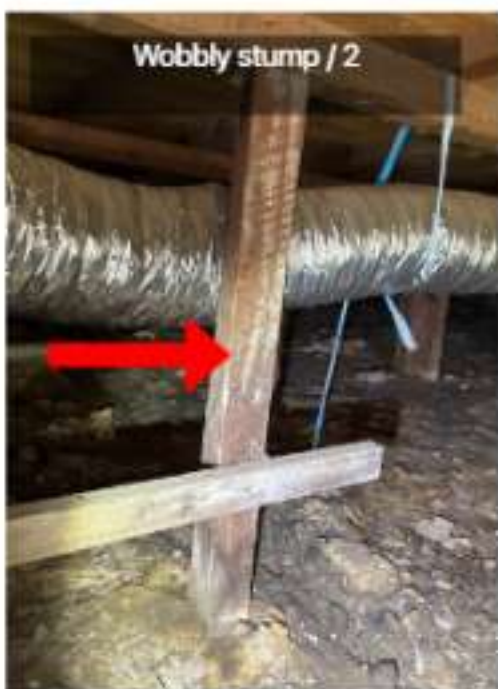
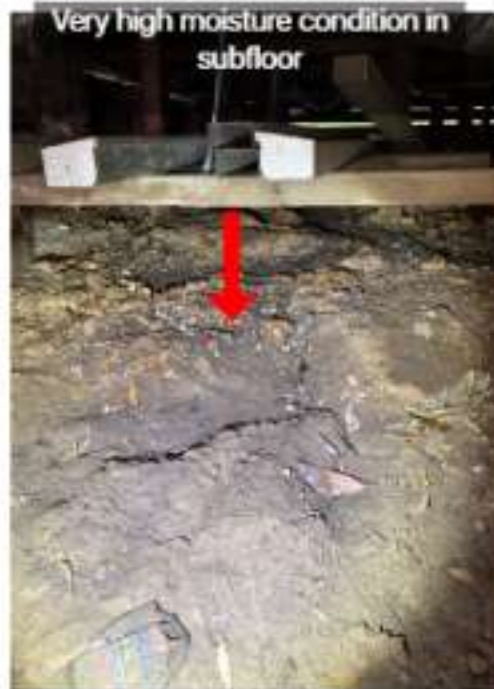
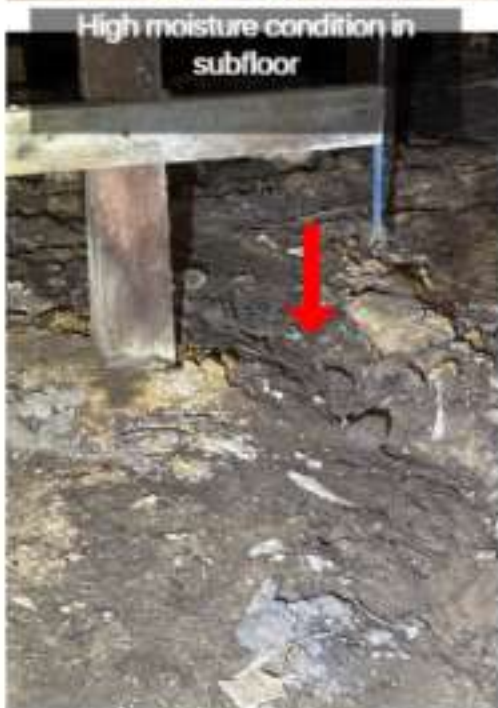
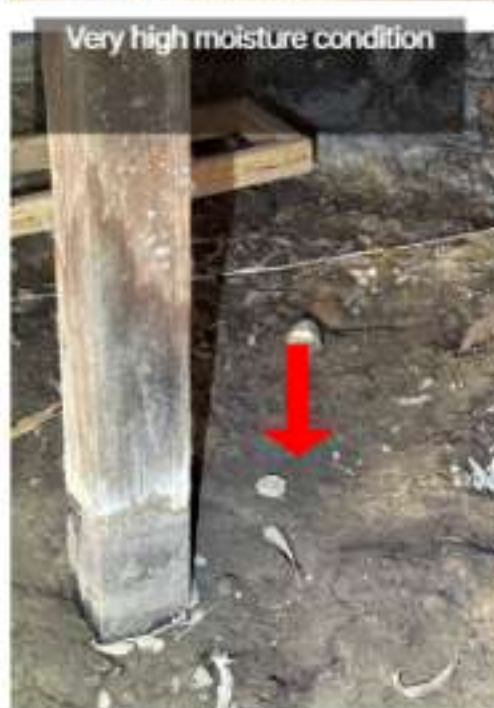
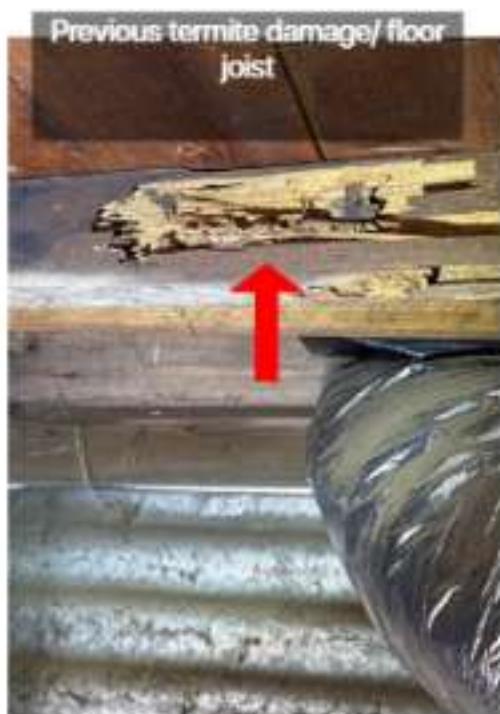
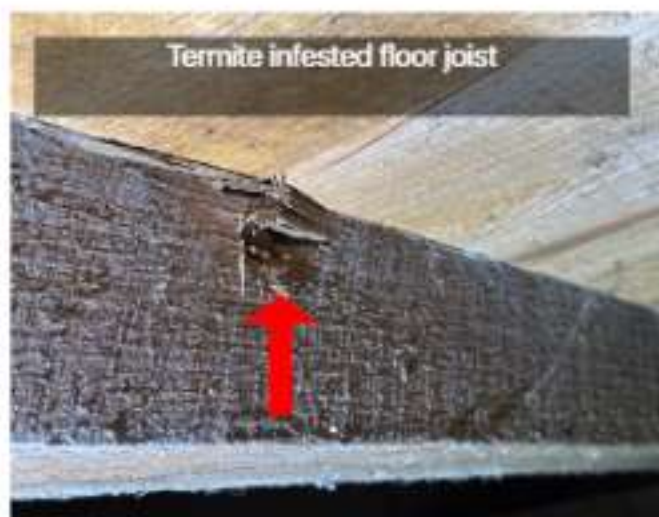
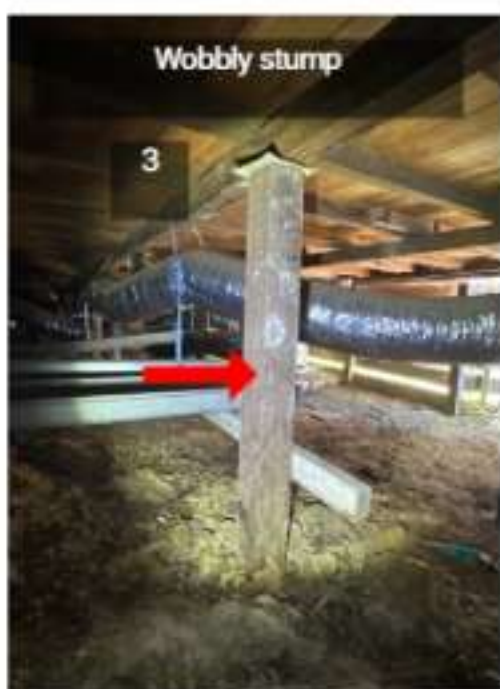
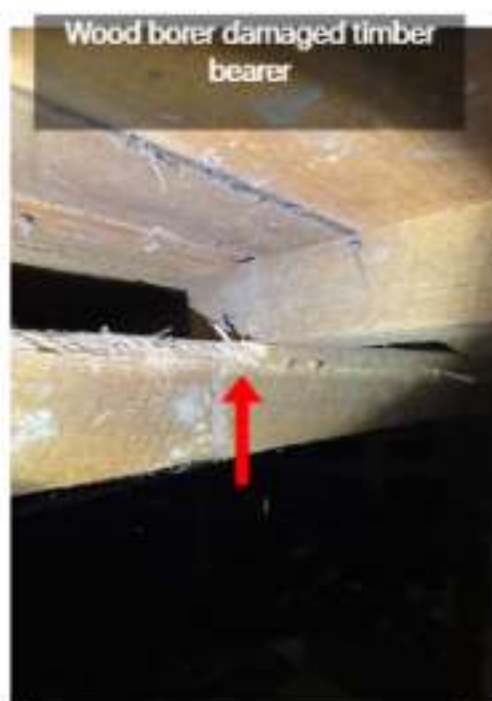
**Finding:** Major structural defects on subfloor structure ( refer to photographic evidence)  
1. Wood rotten timber posts & significantly wobbly stumps at various locations ( approximately 6 stumps)

Timber stumps have sunk due high ground movement as a result of external surface water ingress & suspected underground pipe leak.

2. Very high moisture condition in subfloor

As a result of external surface water ingress & suspected underground pipe leak. This condition is conducive to further deterioration of subfloor structure. Timber posts have sunk & became detached or unstable due to significant ground movement

4. Significant wood borer damage( due to live powder post beetle activity)

5. Significant gaps between timber bearer & stump due to sunken timber posts  
Significantly squeaky internal floor noted.

Client to engage a licensed builder to inspect entire subfloor structure & make further advice before buying the property

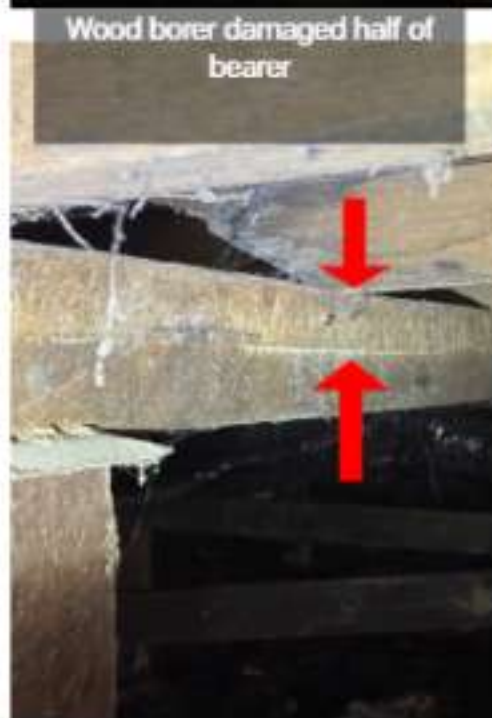
Half of timber bearer damaged by wood borer attack

This is a significant structural defect. Replacement of affected timber is required

Recommend client to engage a licensed timber pest technician to re-inspect property & make further advice.

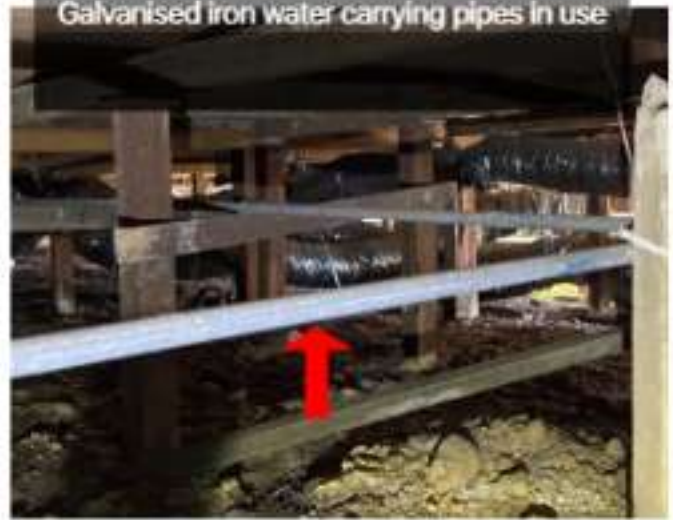
Gap under timber bearer/ timber stump sunk

Galvanised iron water carrying pipes in use

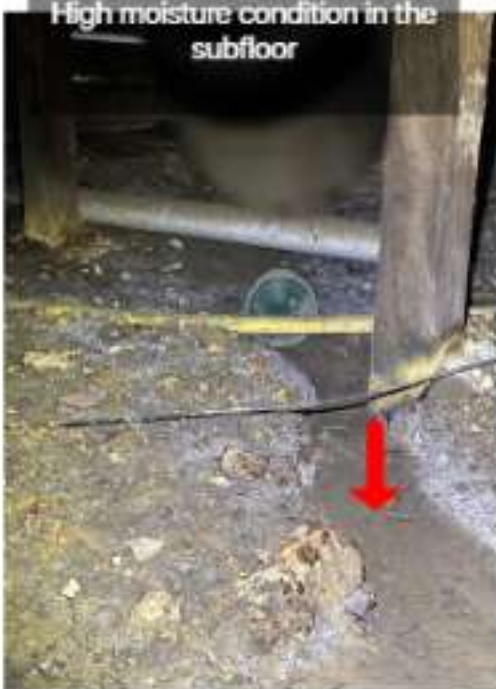
High moisture condition in the subfloor

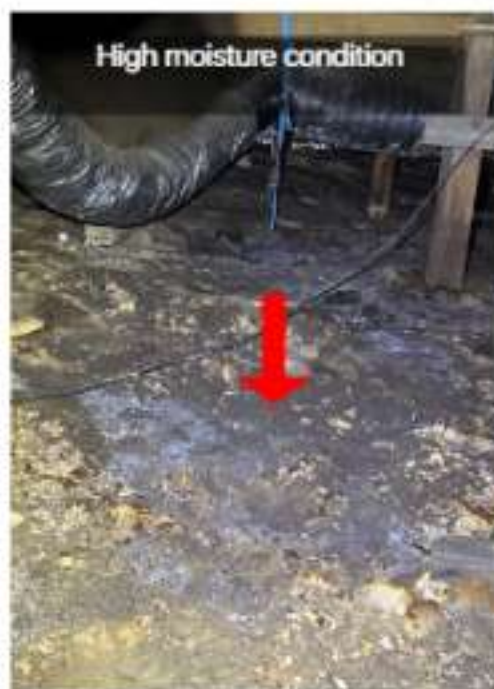
High moisture condition

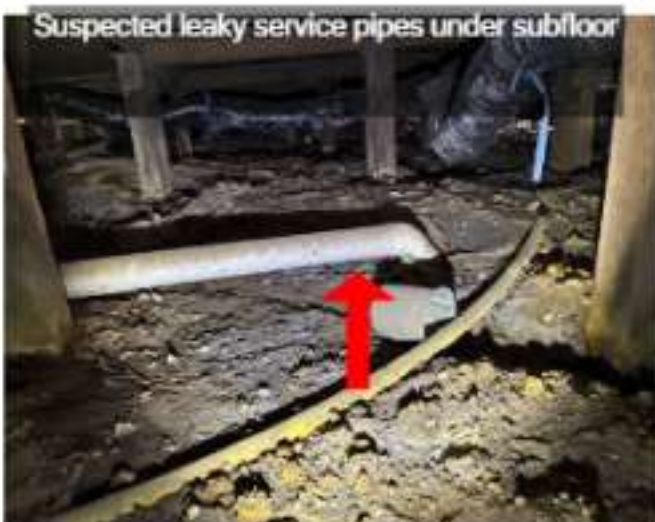
Suspected leaky service pipes under subfloor

Recommend client to engage a licensed plumber to carry out CCTV pipe inspection & make further advice.

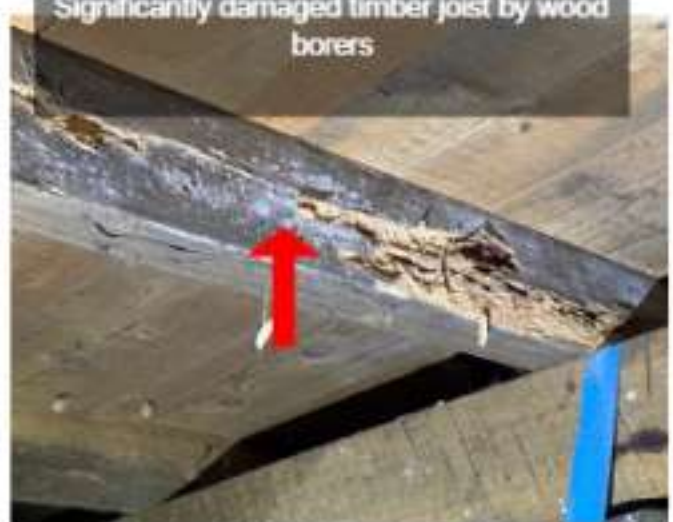
Significantly damaged timber joist by wood borers

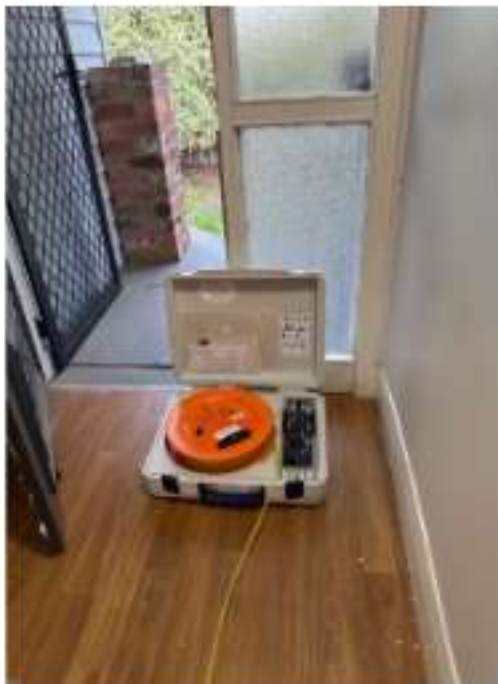
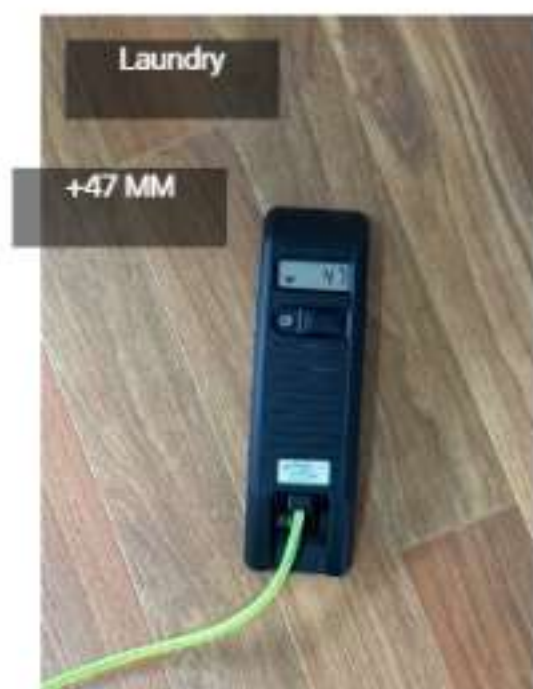
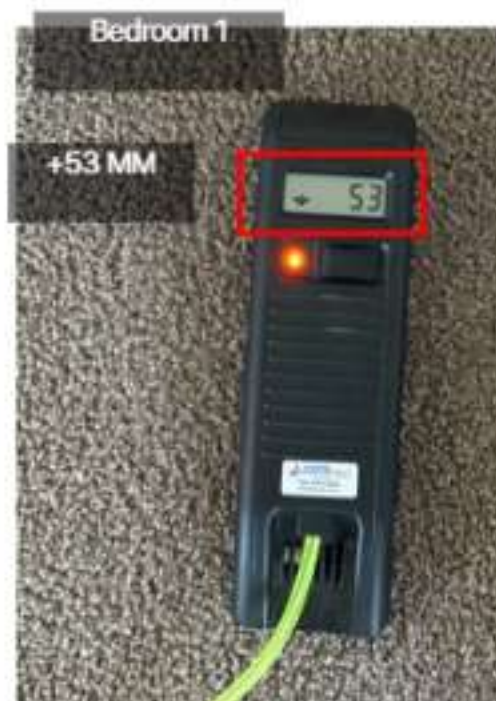
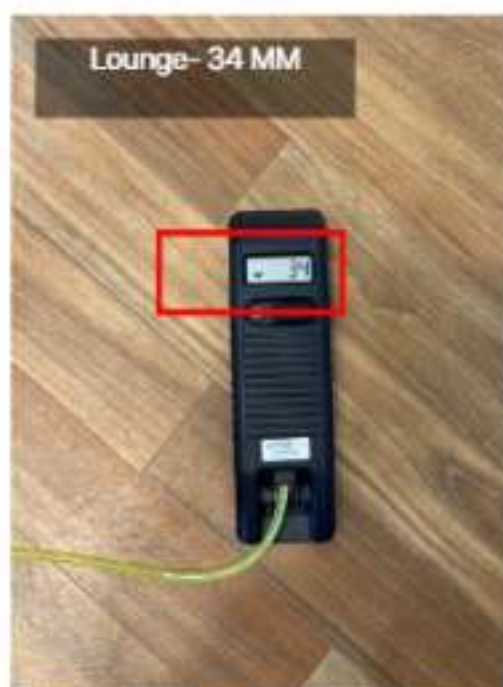
**Finding:** Floor is out of level ( 53 MM deviation)- Major structural defect  
Significant deviation of 53 MM noted due to major structural defects associated with subfloor structure ( refer to item 2.01)

Victorian Building Authority's Guide to standards and tolerance- 2015- Section 2.08-The overall deviation of floor level to the entire building footprint shall not exceed 20 MM

Recommend client to consult a licensed builder for further advice & method of rectification

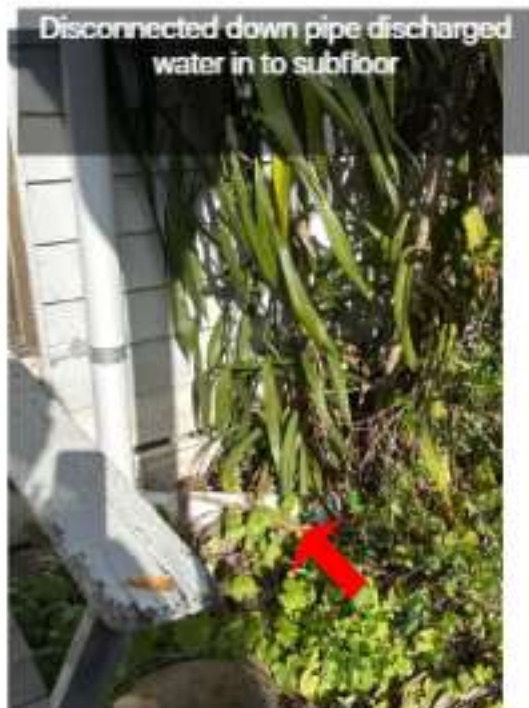
**Finding:** Poor site drainage / Trees around building foundation:

Impact from tree roots & water ingress in to foundation increases foundation movement.  
( Victorian Building Authority)

### Open ended down pipes discharged water in to subfloor foundation

Recommend Client to engage a licensed tradesman to install concrete pavement to stop surface water ingress in to foundation.

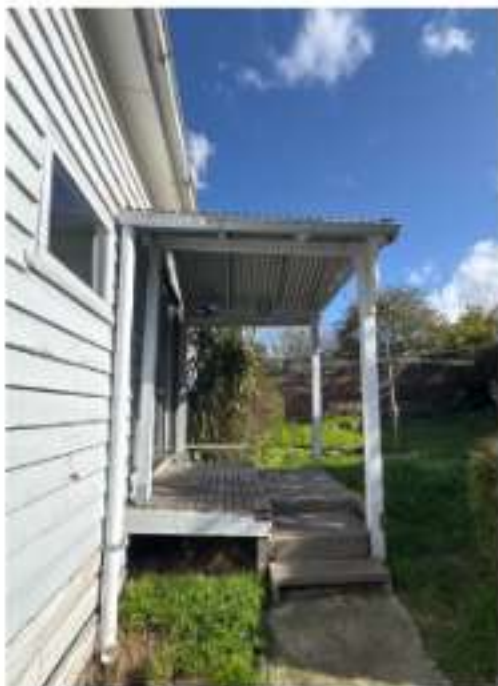
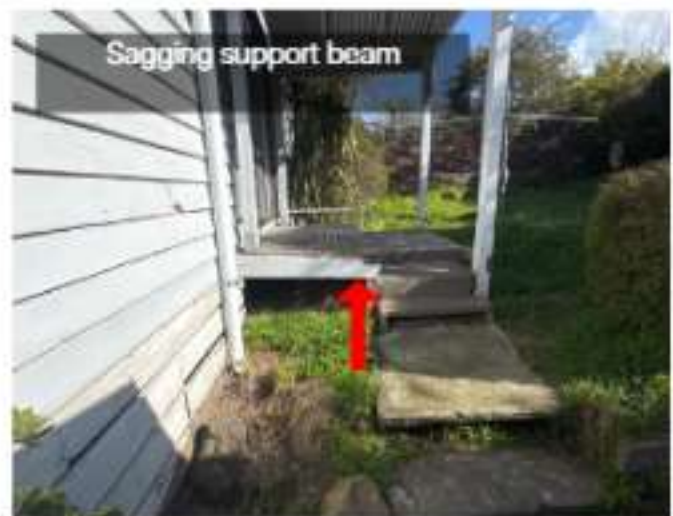
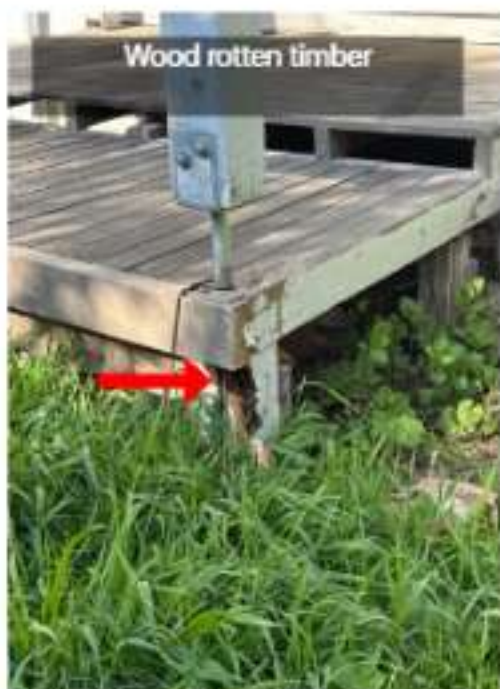
Whole structure is not stable & shaky due to wood rotten timber posts.

Recommend client to engage a licensed tradesman to assess & make further advice.

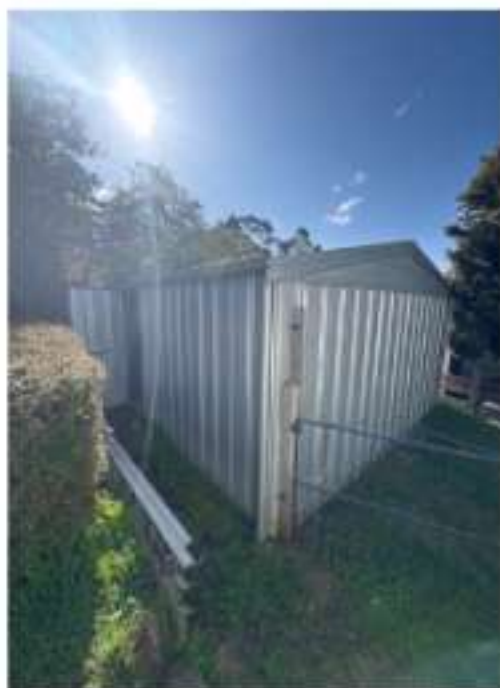
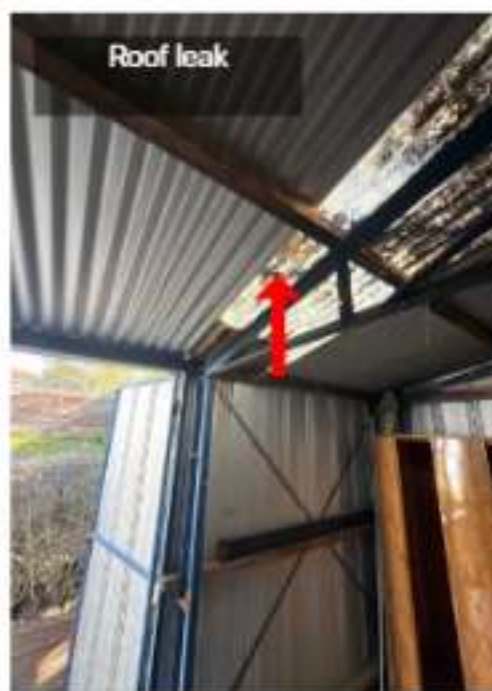
The shed steel structure was in reasonably good condition .

Roof was leaky due to broken roof sheets.

Roof steel structure in good condition

Recommend client to engage a licensed tradesman to repair roof leak.

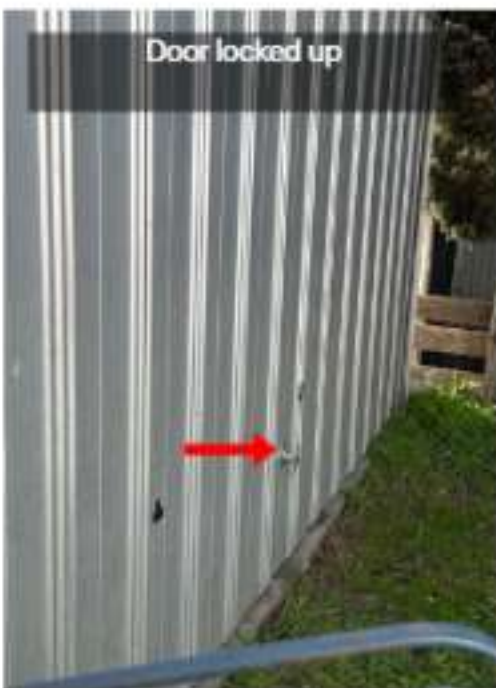
Door locked up

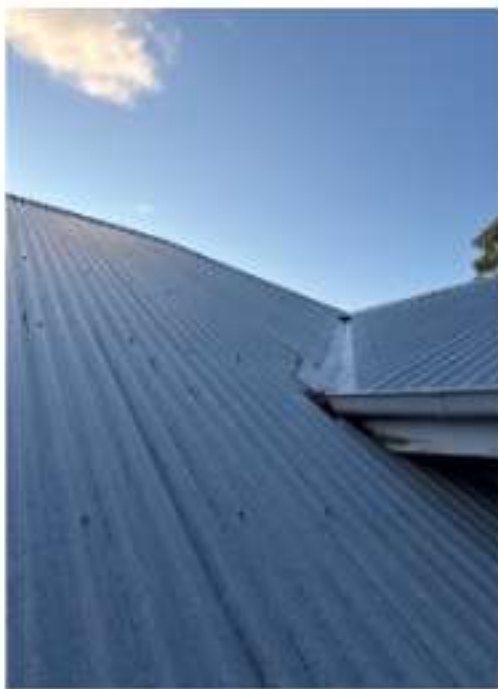
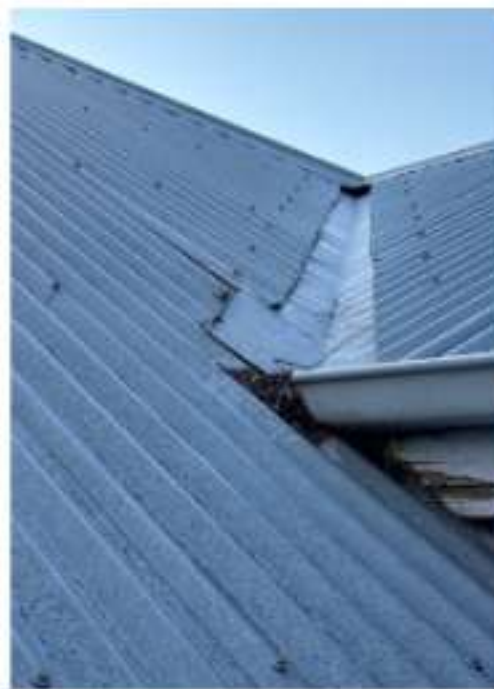
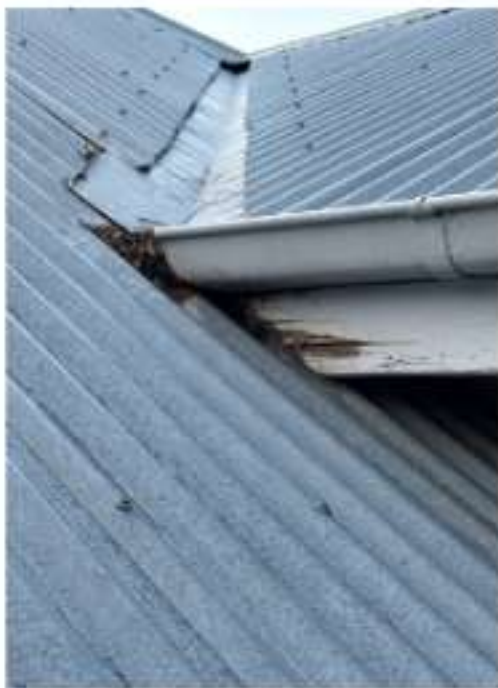
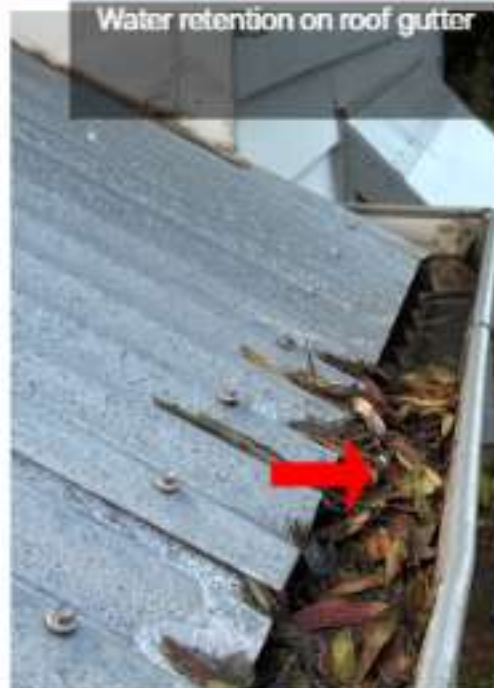
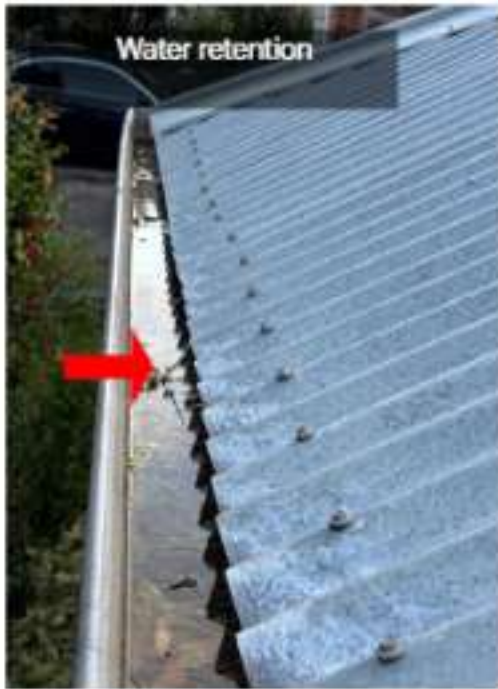
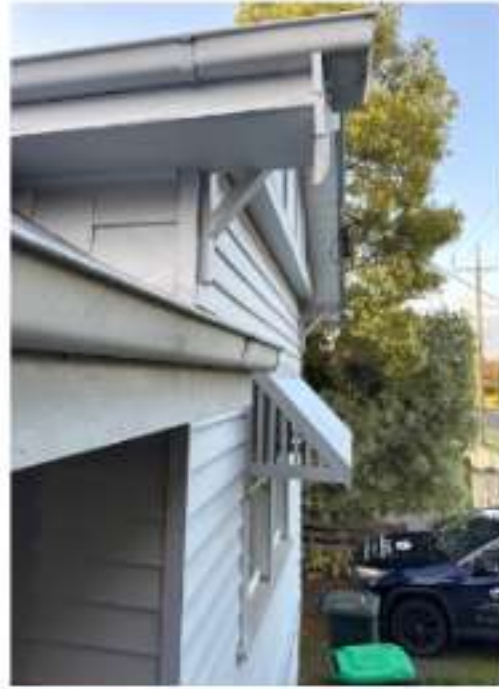
1. Corroded roof gutters noted due to water retention.
2. Blocked roof gutters noted with potential water ingress in to ceiling if left unattended.
3. Open ended down pipes discharged water in to subfloor

Recommend client to engage a licensed roof plumber to assess & make further advice.

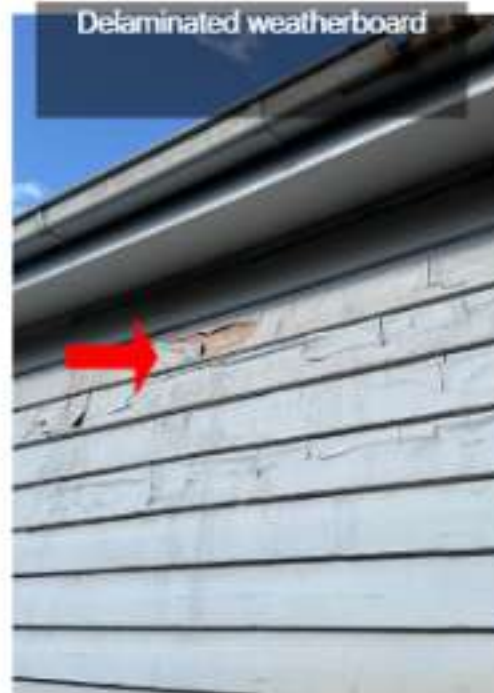
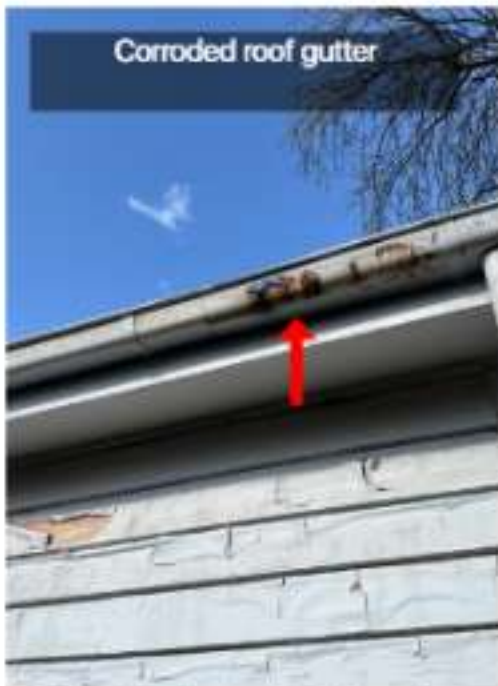
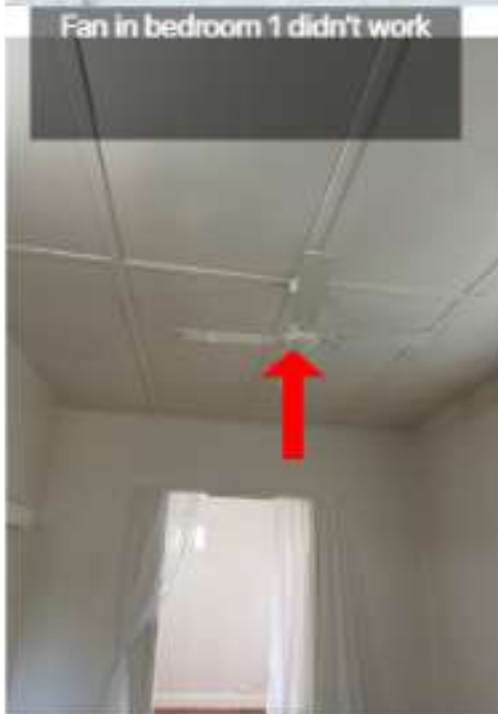
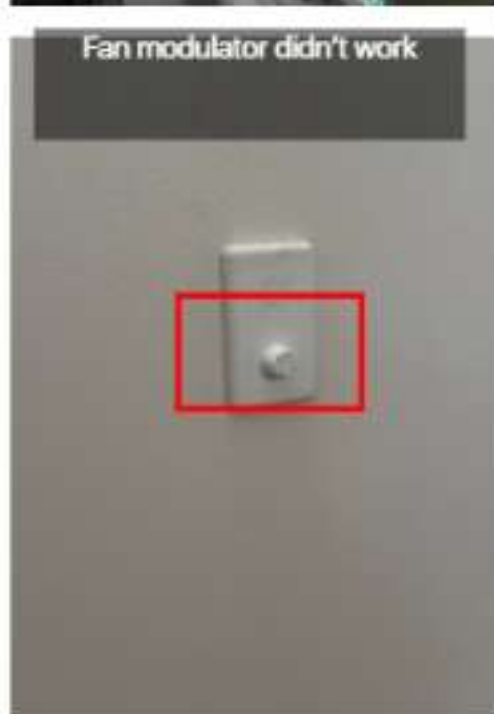
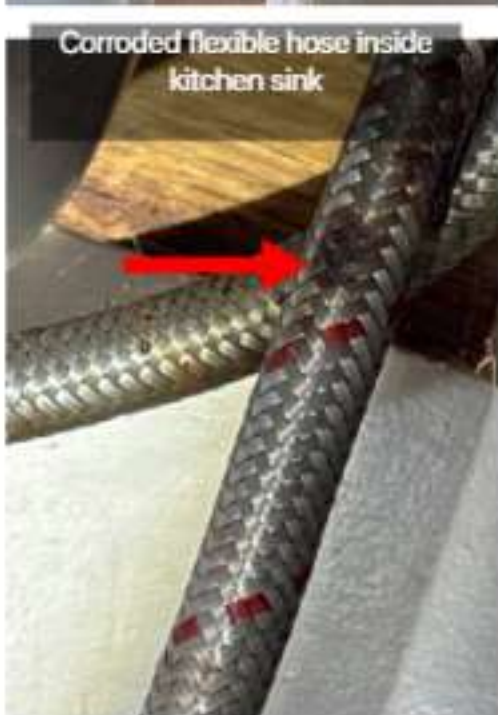
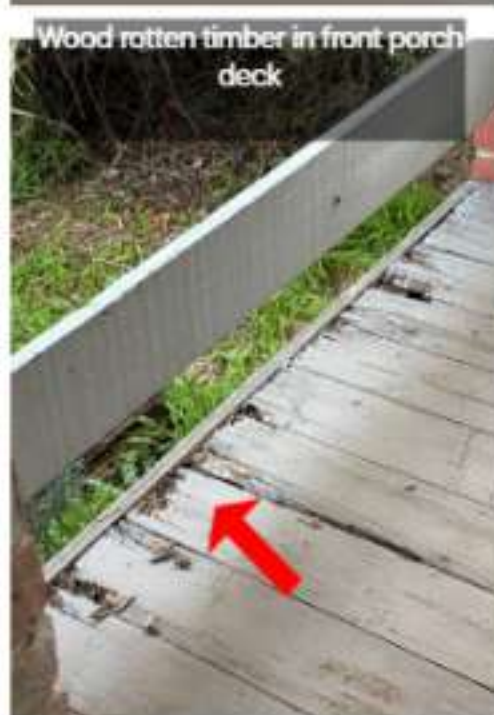
**Finding:** Minor defect list:

Recommend client to engage relevant licensed tradesman to assess all defects listed & make further advice.

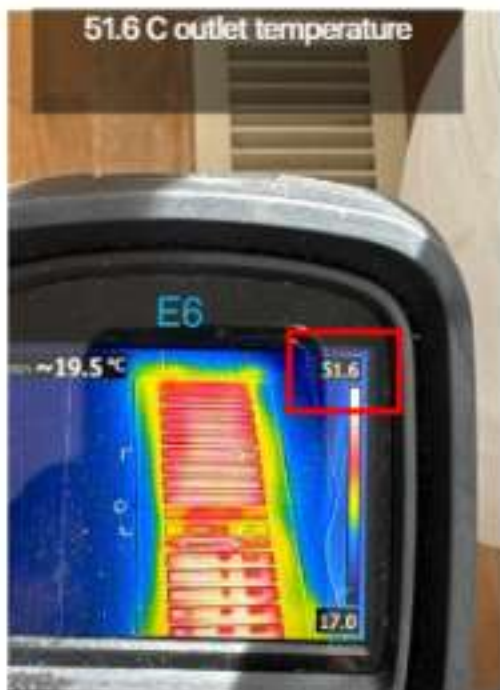
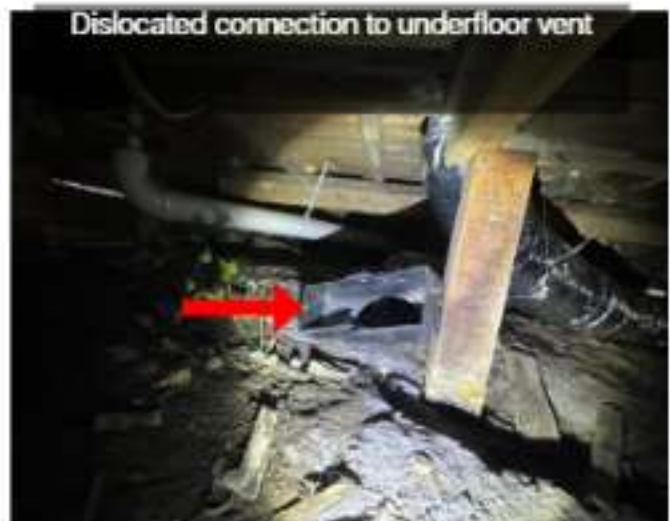
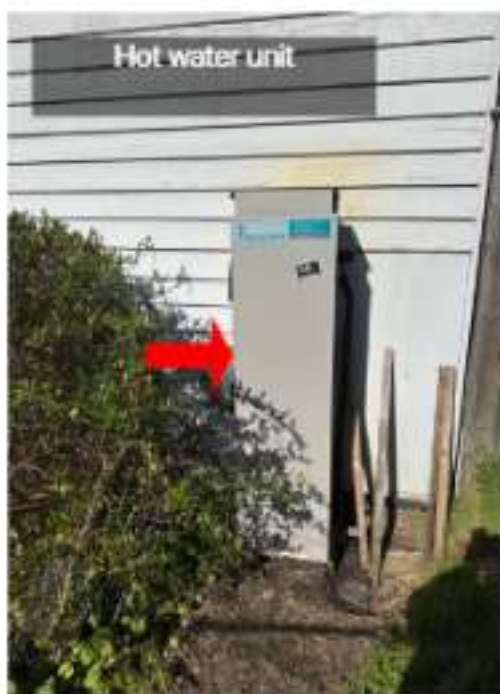
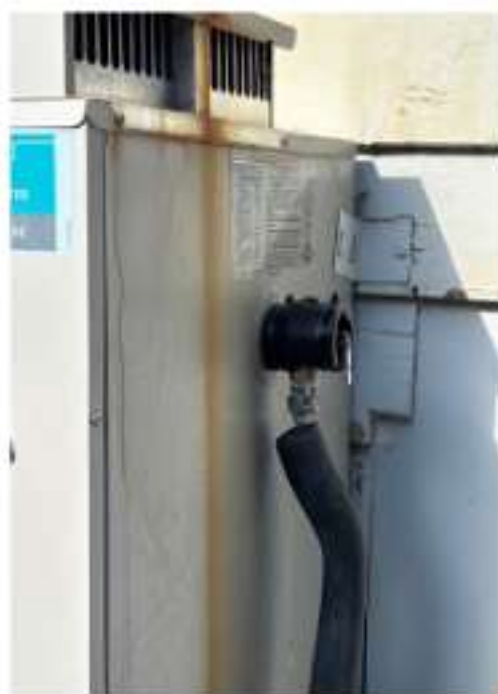
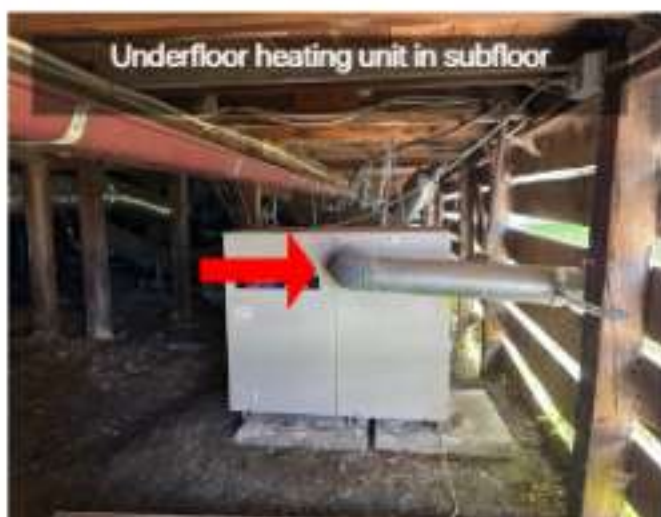
Hot water unit was in reasonably good condition.

A few vents were not attached to the flexible duct from the underfloor unit.

Underfloor heating unit in good condition.

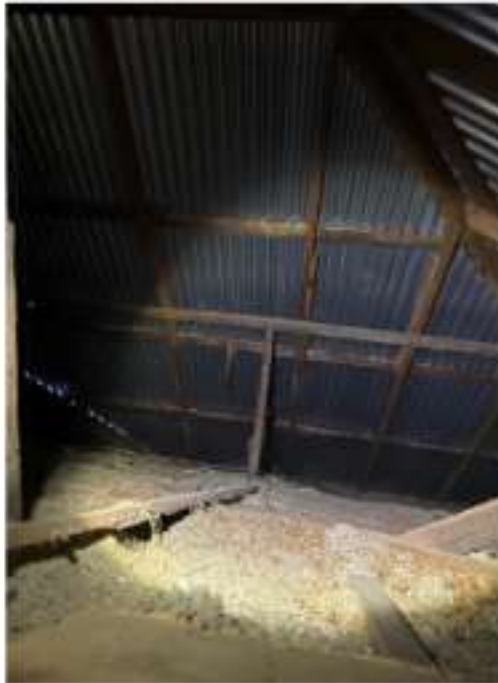
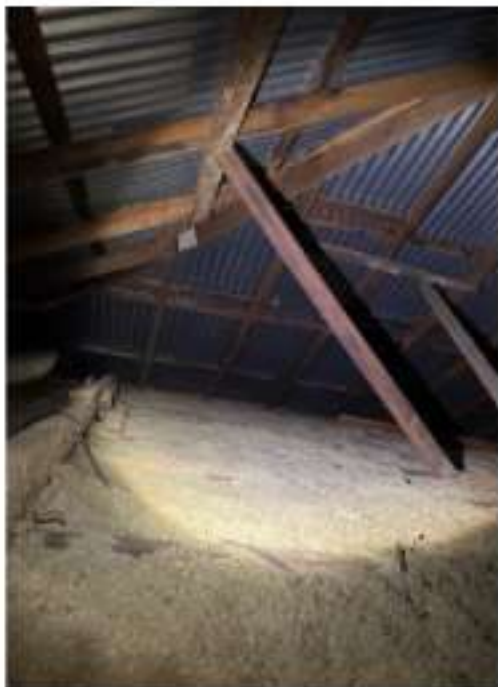
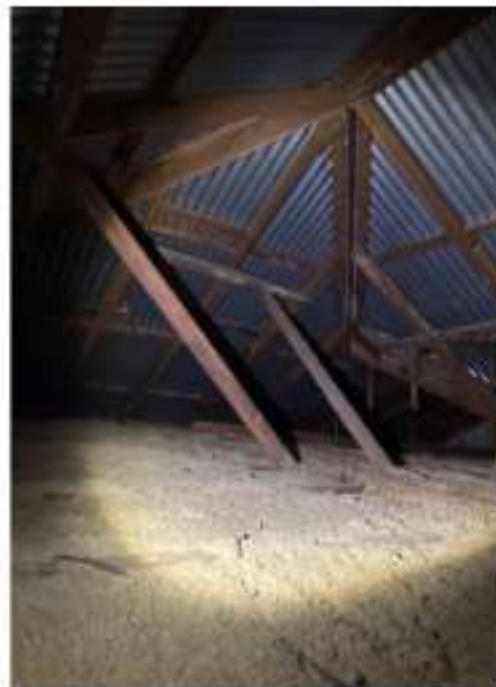
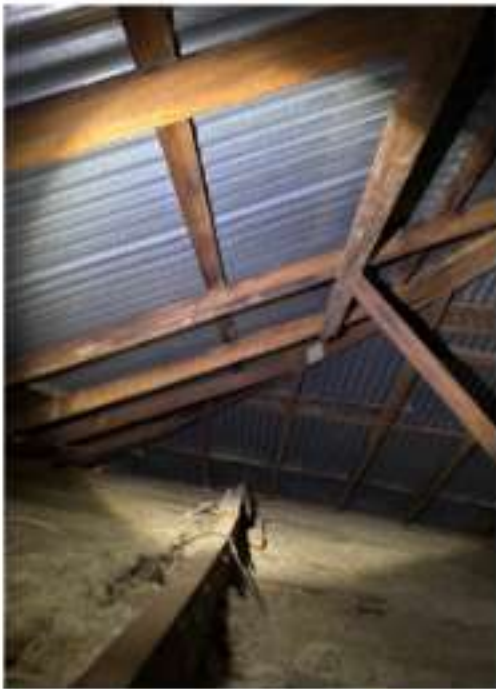
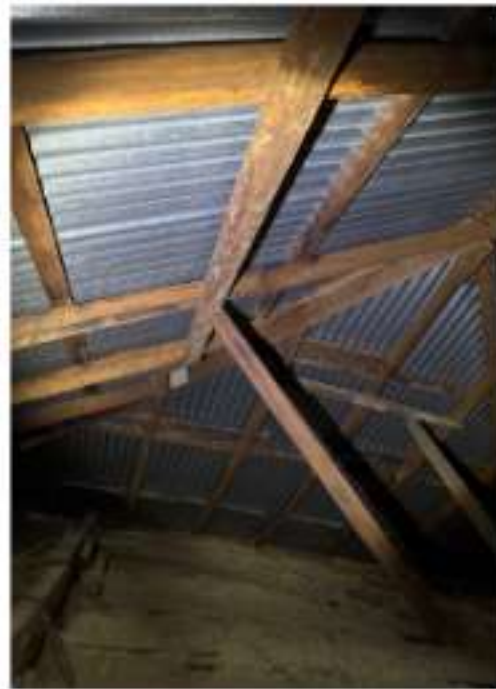
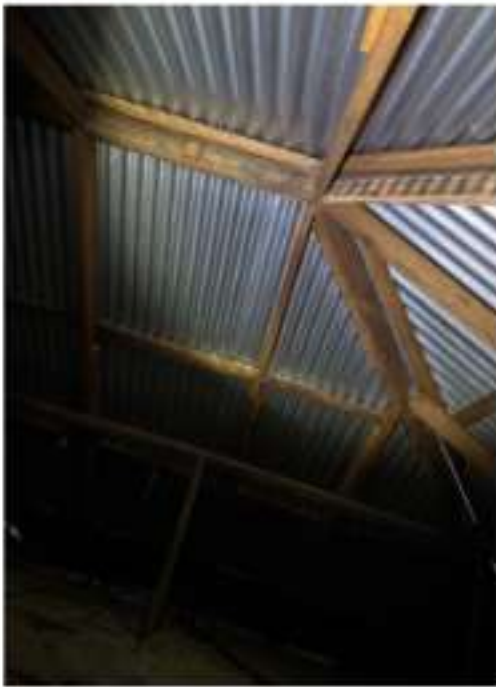
1. Kitchen & bathroom exhaust discharged in to unventilated roof void . Recommend client to engage a licensed tradesman to discharge exhaust out of building.

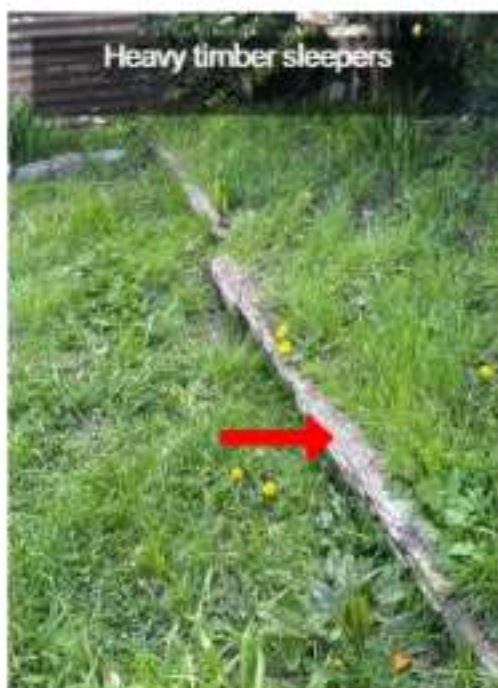
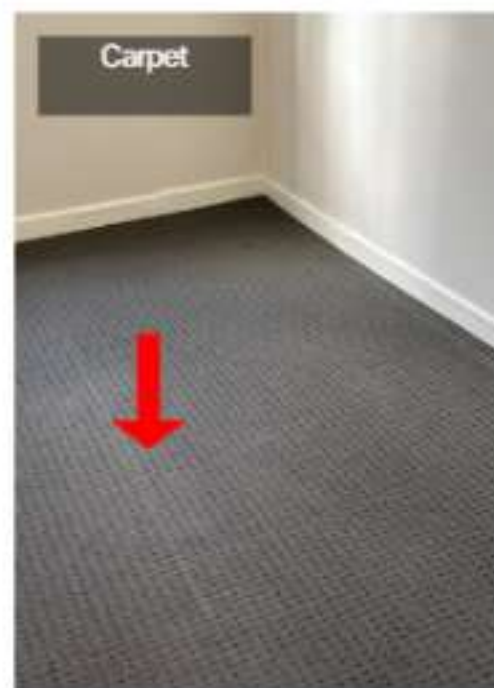
Without full access behind these obstructions, timber pest activity or damage & structural defects may be concealed.

Recommend further invasive inspection.
