# Defects Liability Period Inspection Report

Inspection Date: 28 Apr 2021

Property Address: 8 Flaubert Rd Craigieburn 3064

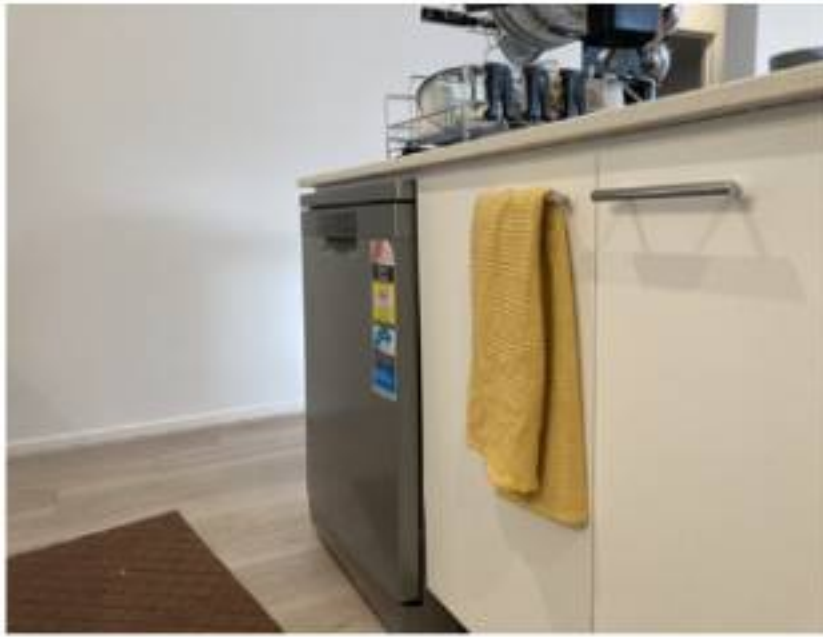
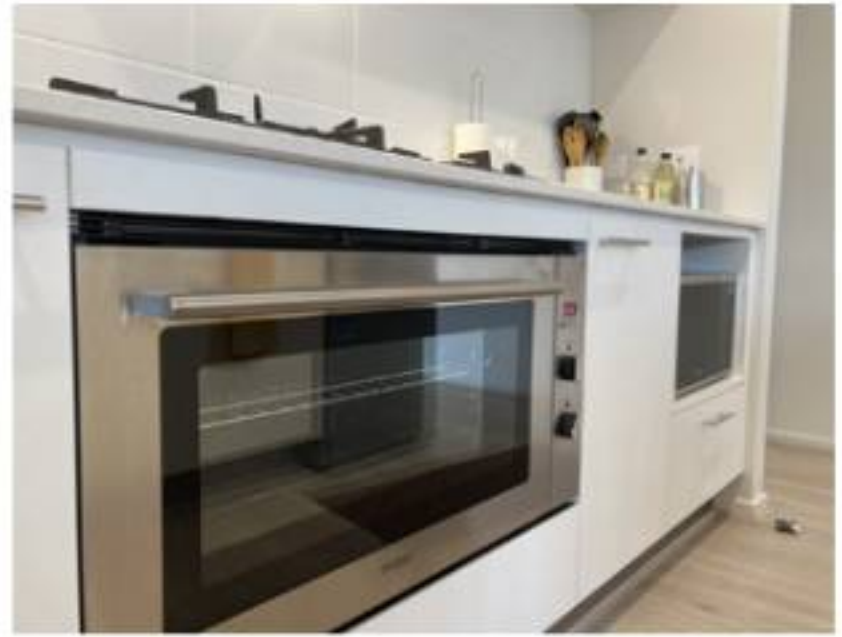
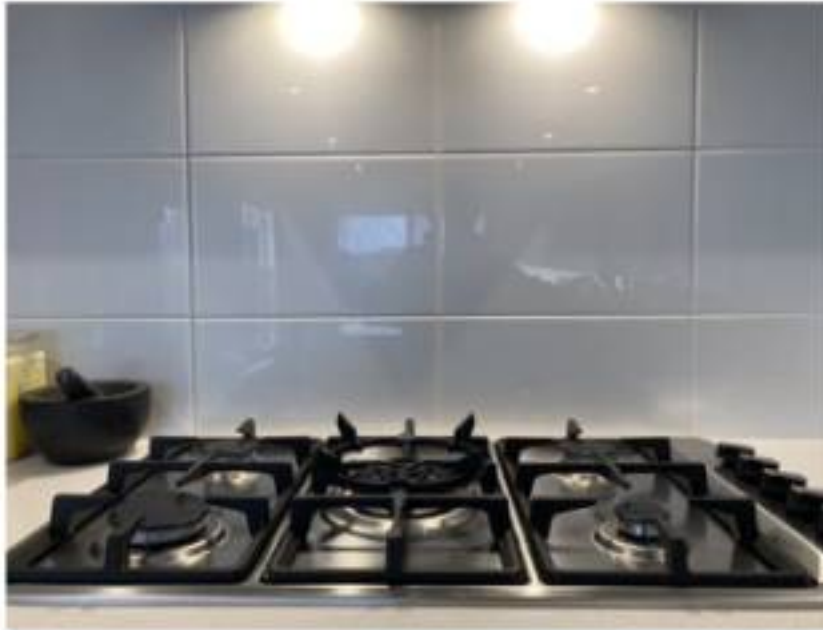
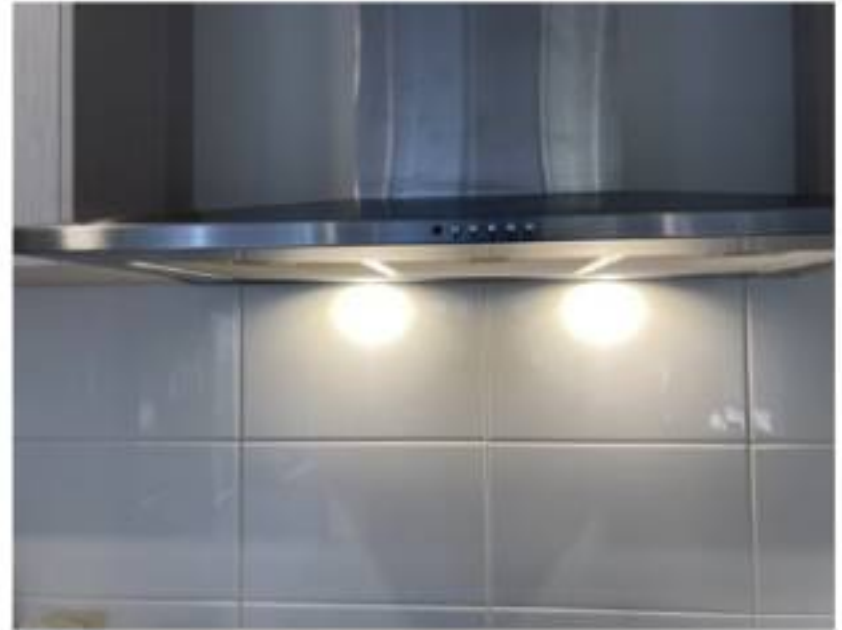
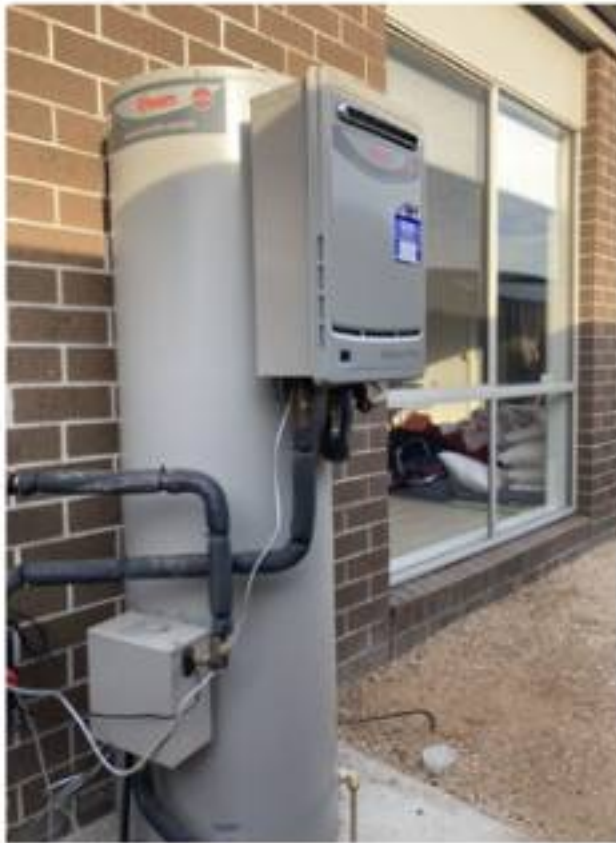
Finding: Appliances and fittings

The owner is responsible for organising warranty service for faults in appliances and fittings supplied as part of the building contract where the builder has provided the warranty documents to the owner. Service outside the warranty period is the responsibility of the owner.

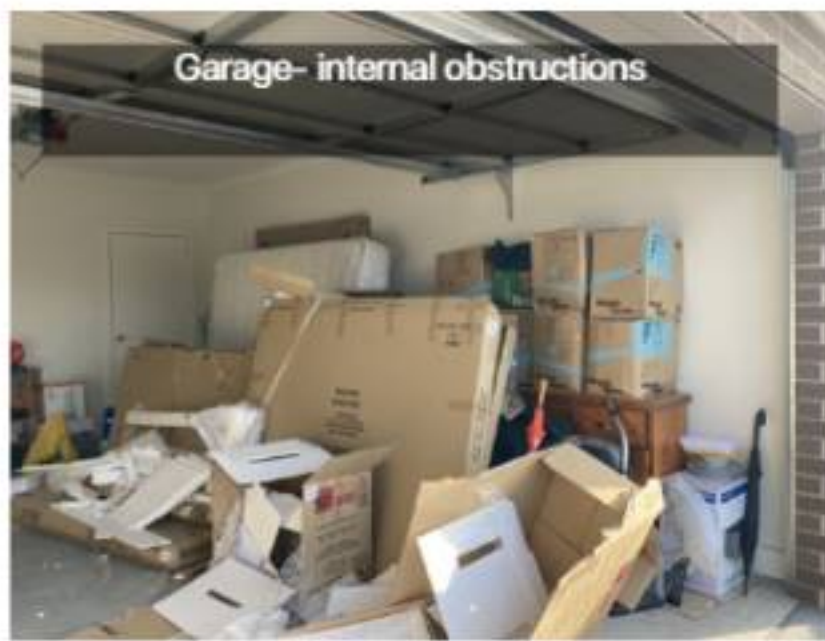
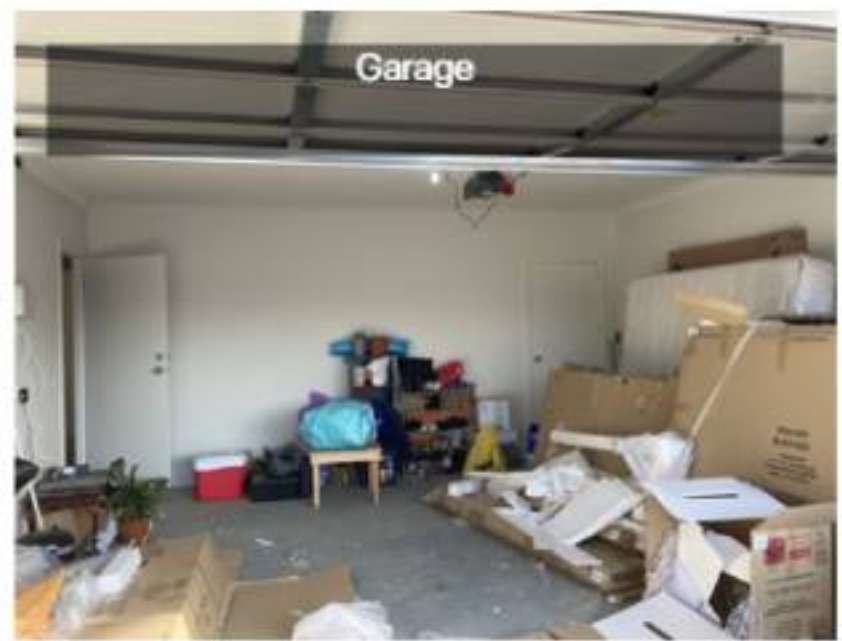
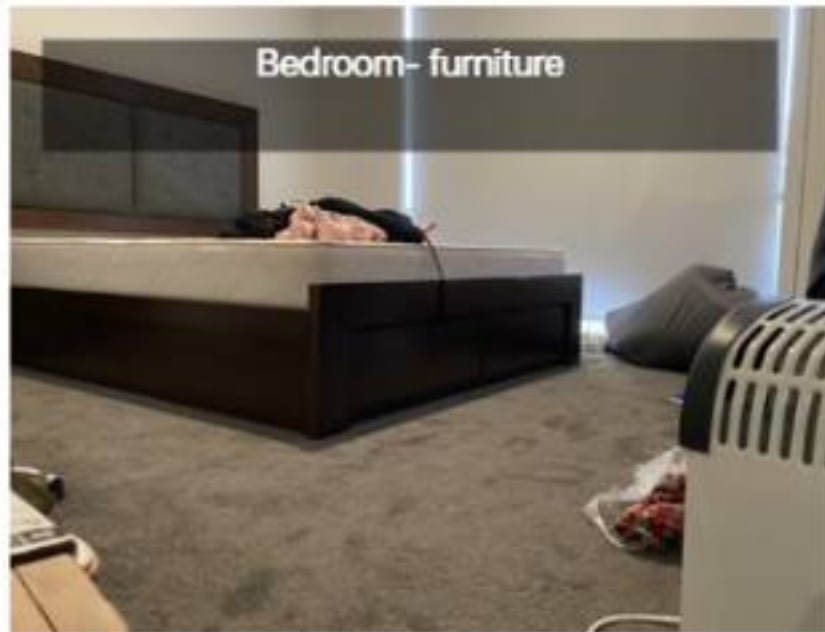
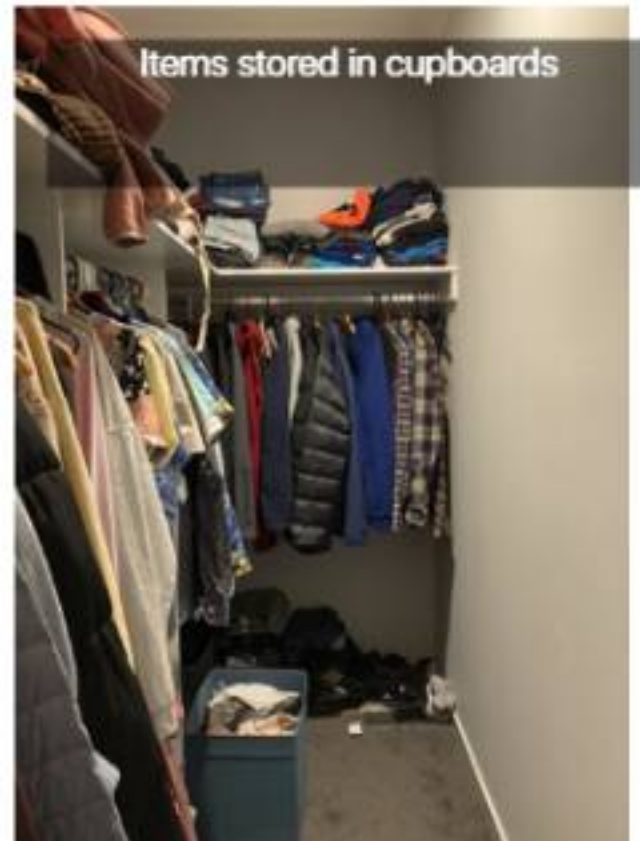
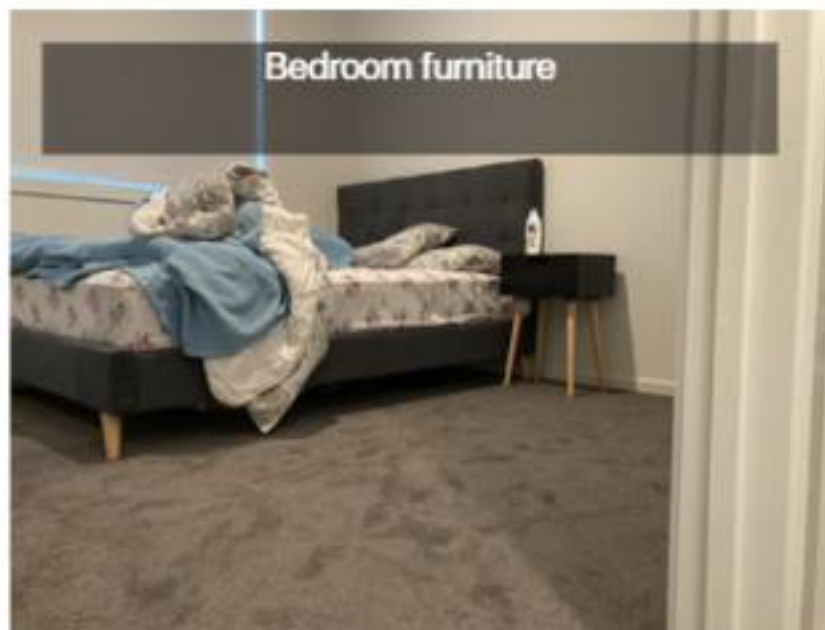
Location: All areas

Finding: Obstructions

Photographic evidence is submitted to show obstructions to this inspection.
