**IBC PROPERTY  
INSPECTIONS**

# Practical Completion Inspection Report

Inspection Date: 31 May 2022

Property Address: 173 Forest Red Gum Drive Mickleham 3064

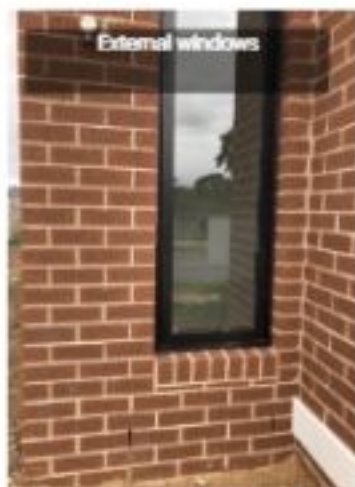
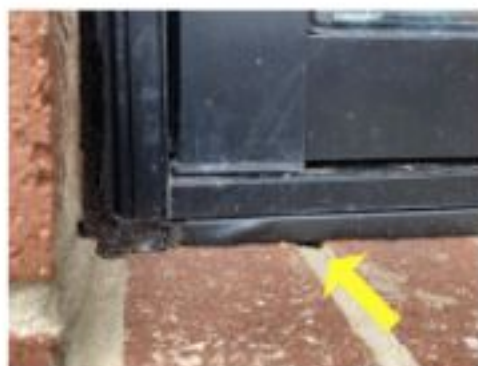
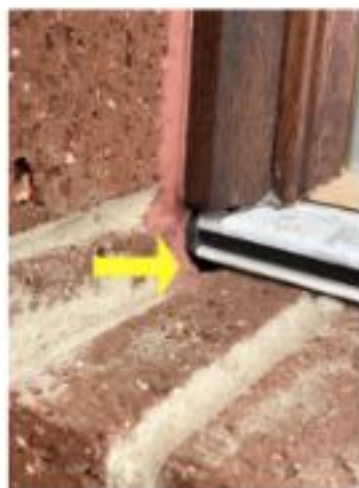
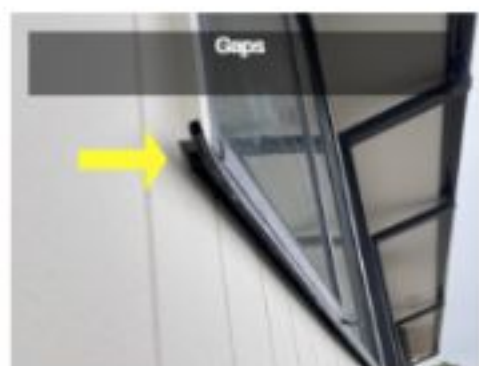
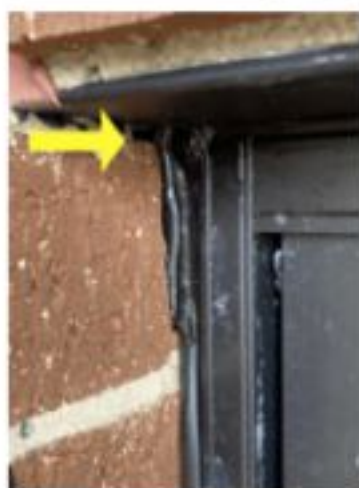
Finding: External windows- Missing Sealing

Gaps noted on weather strips of windows allowing water/unhealthy air in to the home.

The builder to rectify. Re- inspection is advised

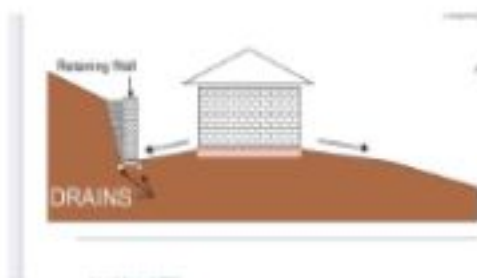
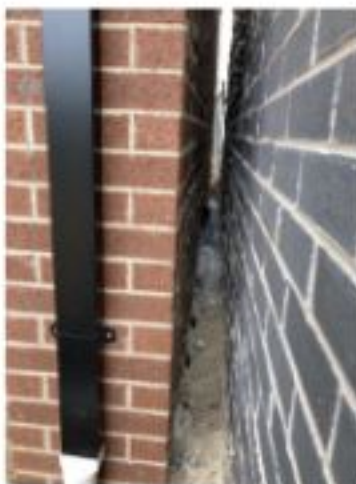
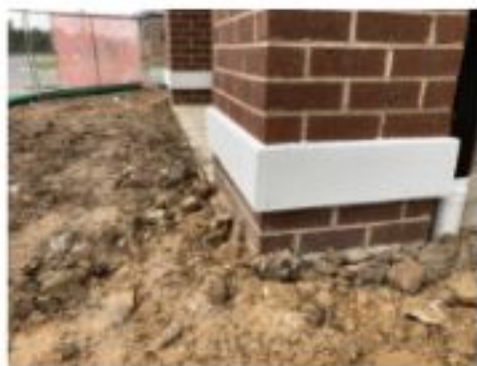
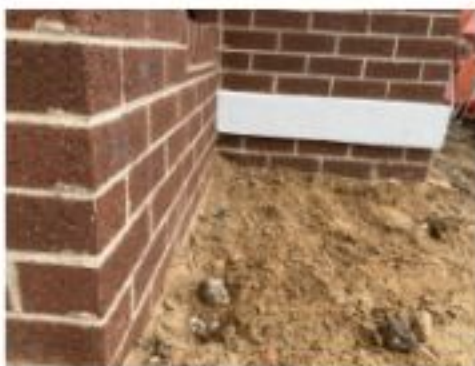
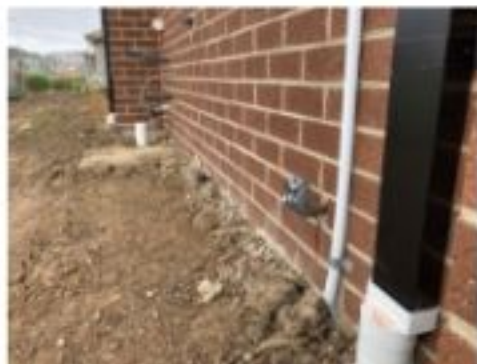
Location: All External Areas

Finding: Site drainage- Inadequate

I noted inadequate site drainage around the property. Water ingress in to building's foundation due to inadequate site drainage will lead to movement of building.

Site drainage is required to be maintained from the start of construction by the builder.

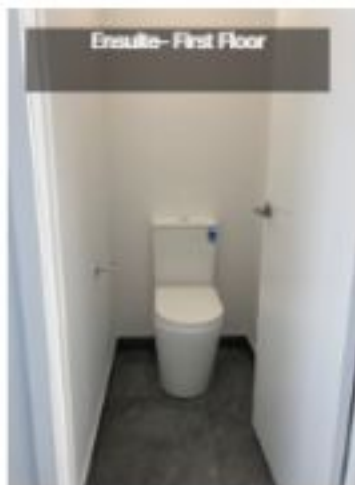
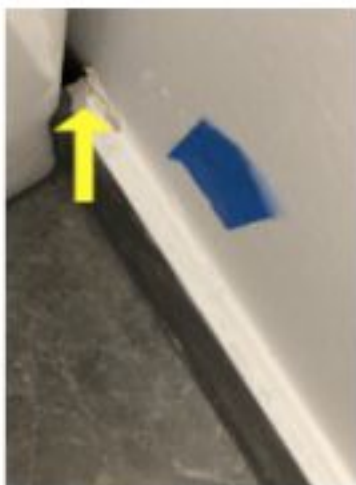
Location: All Internal Areas

Finding: Missing Grouting & Joints

I have noted missing Grouting and Inconsistent Waterproof sealant application.

The builder to rectify

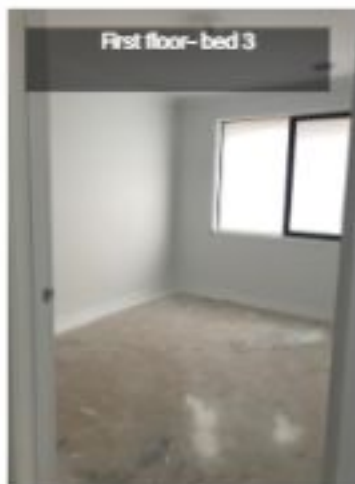
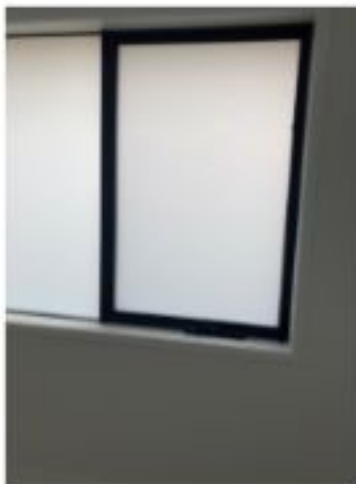
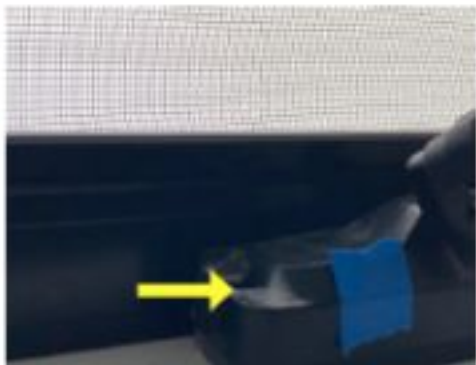
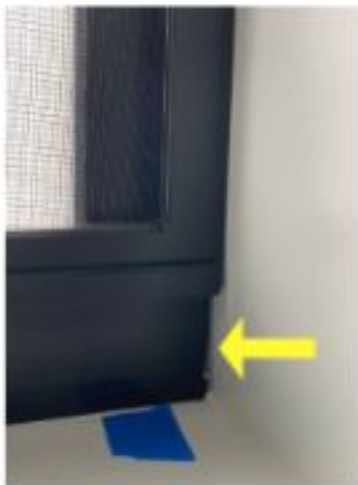
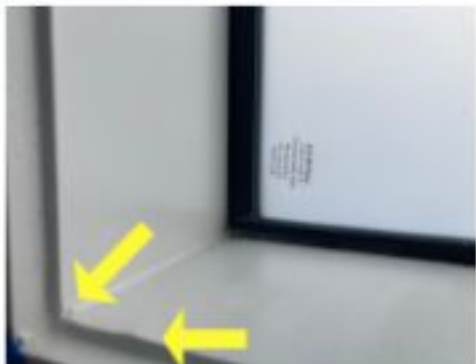
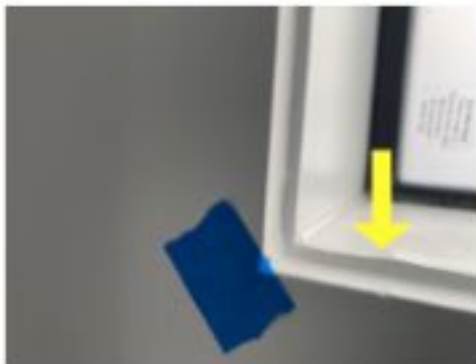
Location: All Internal Areas

1. Paint works in internal areas were noted as defective due to marks and irregularities as shown on photographic evidence. Marked with Blue tape.

The builder to rectify. Re- inspection is advised

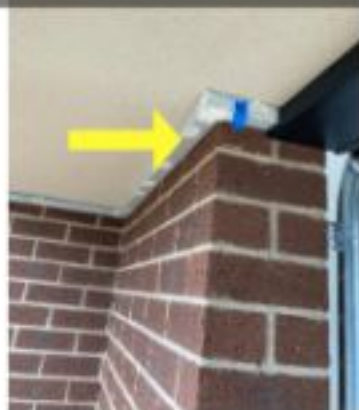
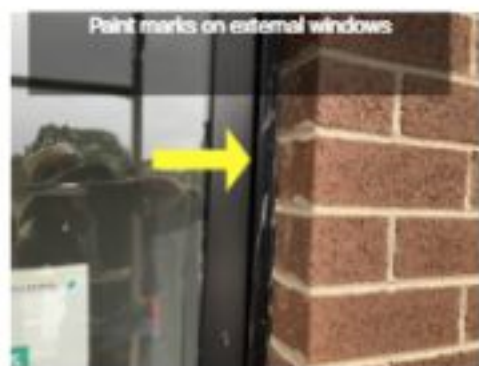
External eave quad- garage

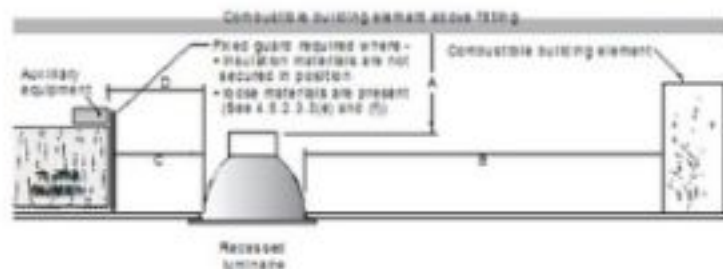
## Non Compliant 1.05

Finding: Inadequate ceiling clearance around LED lights

50 MM clearance of ceiling insulation has not been kept. Most of the LED lights have been covered with insulation without any clearance being kept. This is a fire hazard

3. Action: The builder to rectify. Re- inspection is advised

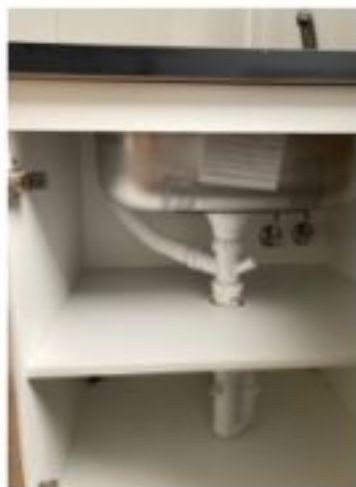
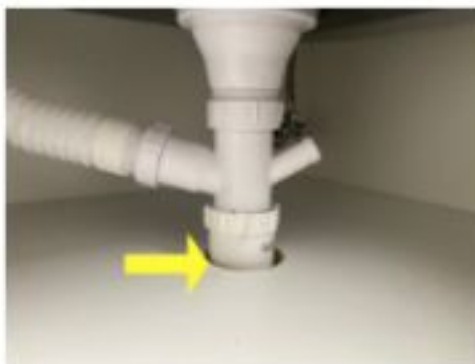
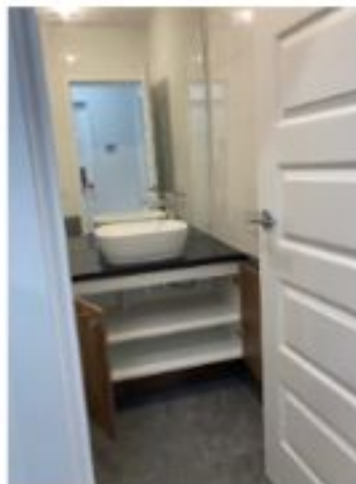
I have noted that pipes are not fitted through a neat minimal size hole.

3. Action: Builder to rectify

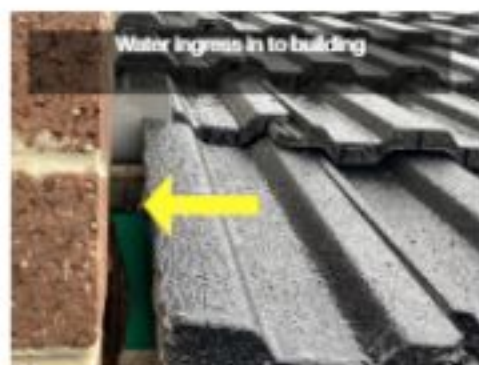
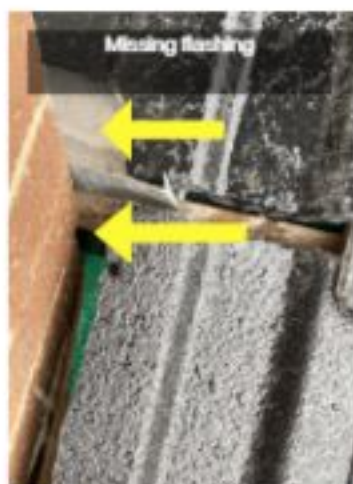
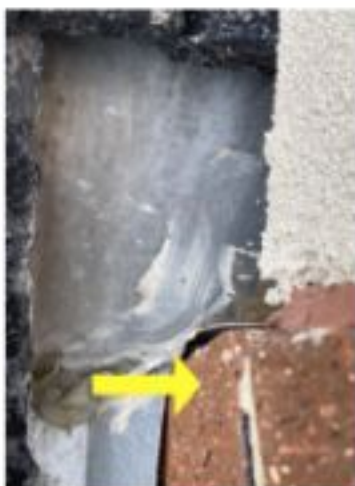
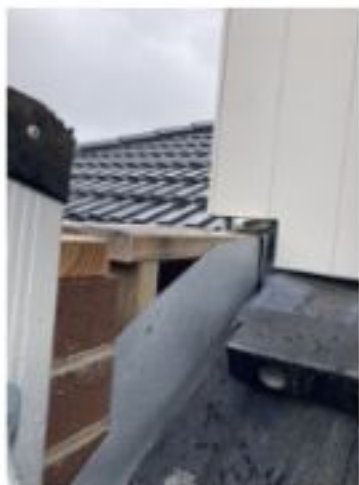
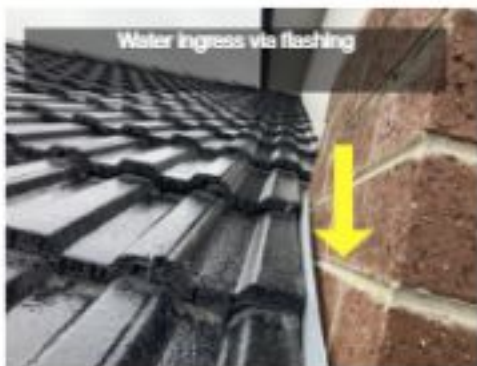
## Non Compliant 1.09

Finding: Missing roof flashing- All areas of lower roof

Missing roof flashings noted on lower roof with water ingress across entire property.

Roofing, including flashings and accessories, is defective if it leaks under normal weather conditions and is due to the builder's workmanship, causes unhealthy or dangerous conditions, loss of amenity for occupants, undue dampness or deterioration of building elements.

The builder to rectify. Re- inspection is advised

Upper roof was not checked due to working height restrictions. The builder must investigate upper roof as well to detect flashing issues and rectify.

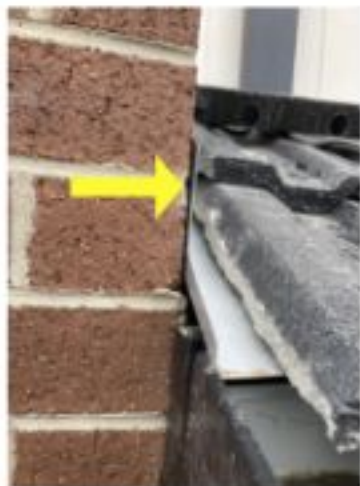
Capping not secured on to bricks

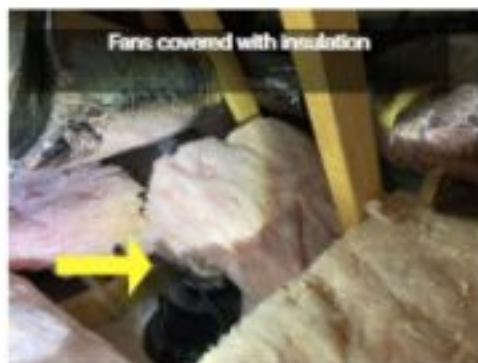
Noisy fan noted. On subsequent inspection of roof space, fan was partly covered with ceiling insulation batts with potential obstruction to movement of blades.

The builder to further investigate all exhaust fans and rectify.

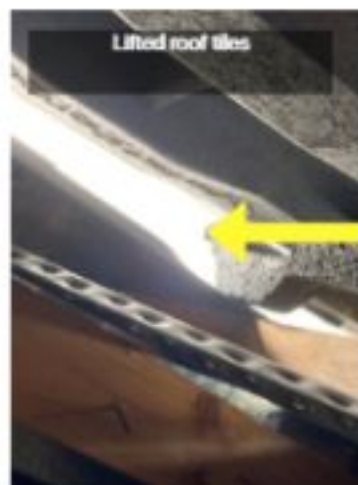
Significant gap around flashing of evaporative cooling unit. Lifted tiles observed with water ingress and potential wild life entry.

3. Action: The builder to rectify.

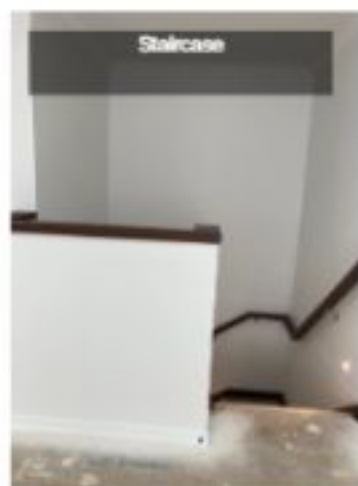
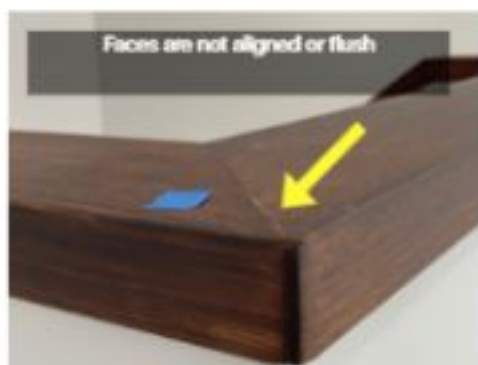
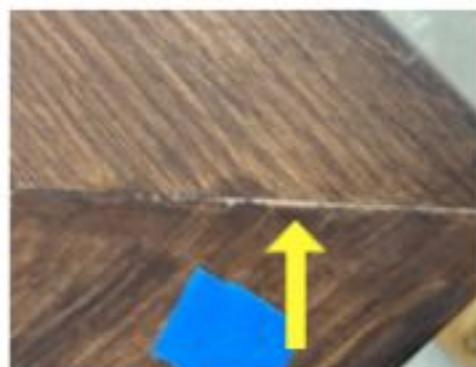
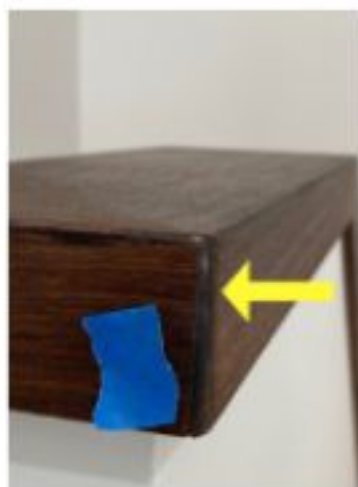
## Substandard Workmanship 2.04

Finding: Internal mouldings- defective finish

3. Action: The builder to rectify.

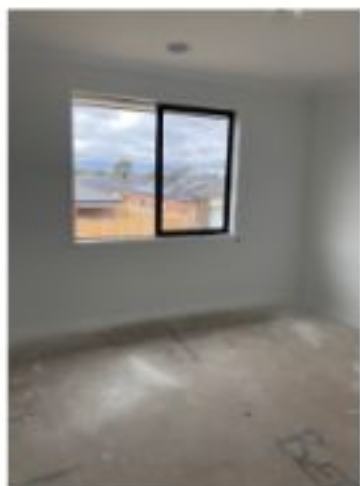
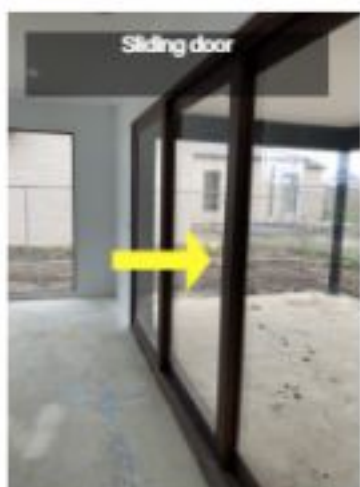
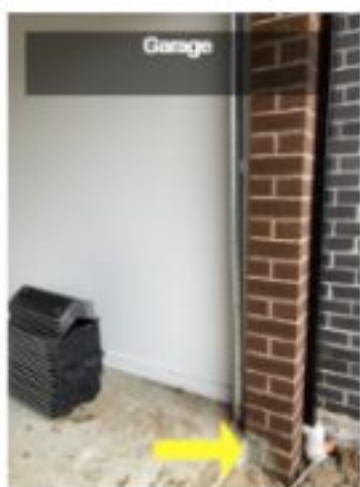
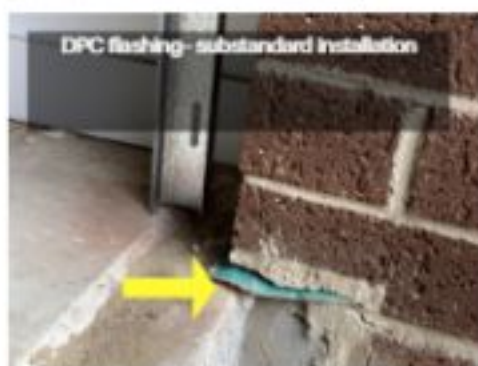
### Substandard Workmanship 2.05

1. General defects of substandard workmanship

3. Action: The builder to rectify.

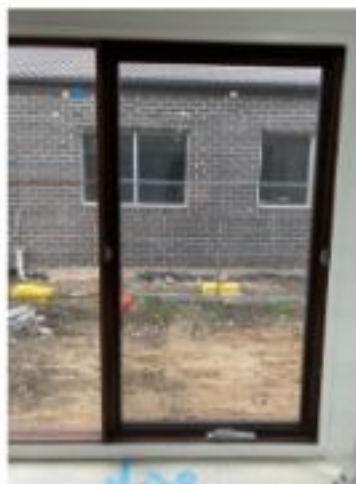
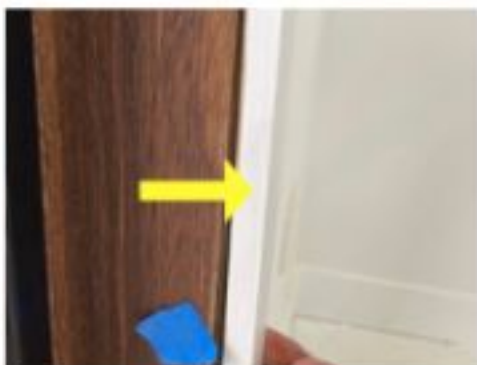
## Substandard Workmanship 2.07

Location: Ground Floor- Living/ Dining

Finding: Window Architrave- loose

Window Architrave- loosely fitted

3. Action: The builder to rectify.

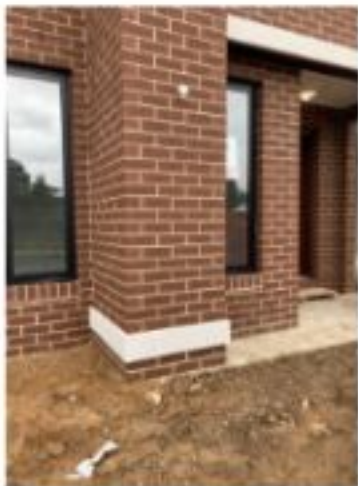
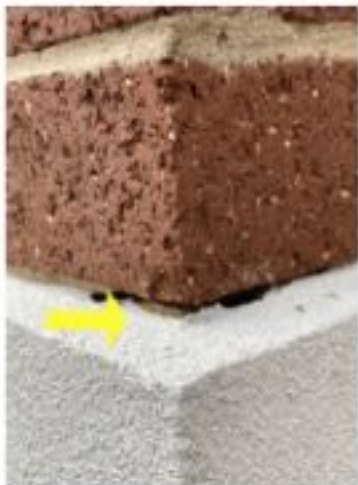
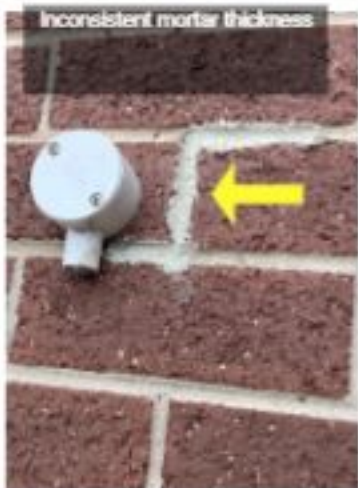
Location: All External Areas  
Finding: Defects on external brickwork

3. Action: The builder to rectify.

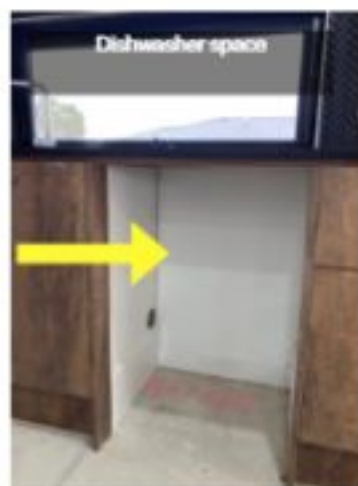
### Incomplete 3.02

Location: All areas

Following incomplete works noted during inspection. The builder should complete all work prior to final handover as per contract's inclusion list.

1. Heating/ cooling - Not commissioned at the time of inspection
2. Hot water not commissioned at the time of inspection
3. Oven, dishwasher, cooktop, hot water unit not installed at the time of inspection

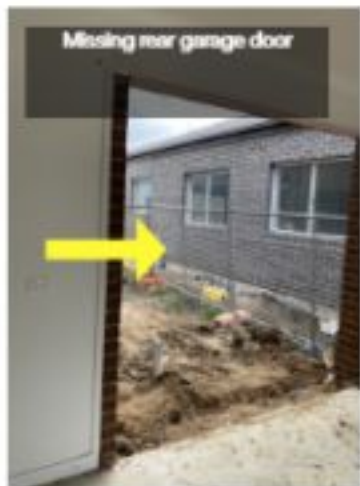
Finding: Missing door locks/ missing doors

1. Missing door locks- store room
2. Missing door to the laundry
3. Missing back door to the garage

Action: The builder to install door locks

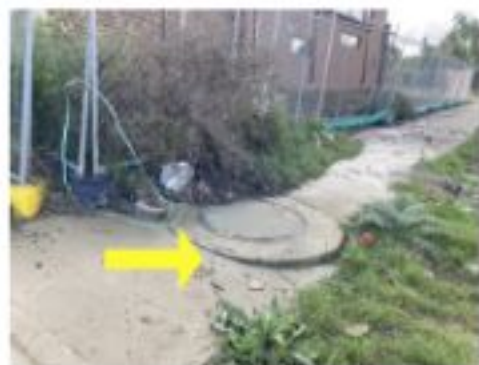
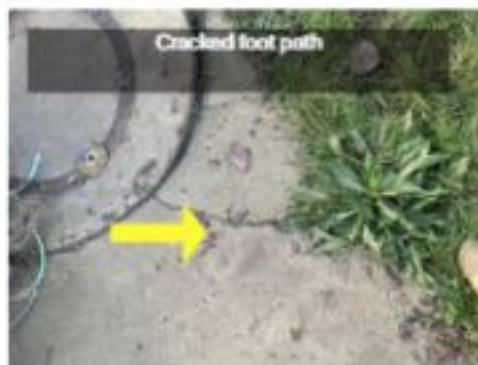
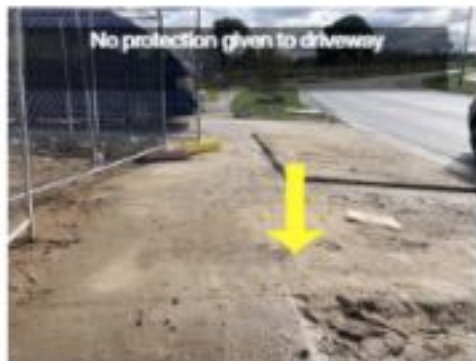
#### For Your Information 4.02

Location: External Area- South Elevation

Finding: Damage to VIC roads Assets

Concrete foot path has been damaged on south/ west corner.

The client must inquire from the builder whether this is covered by Asset protection insurance.
