# Sample Building Report For Customer Pre Inquiry

Inspection Date: 25 Sep 2025

Property Address: Sample Street Sample

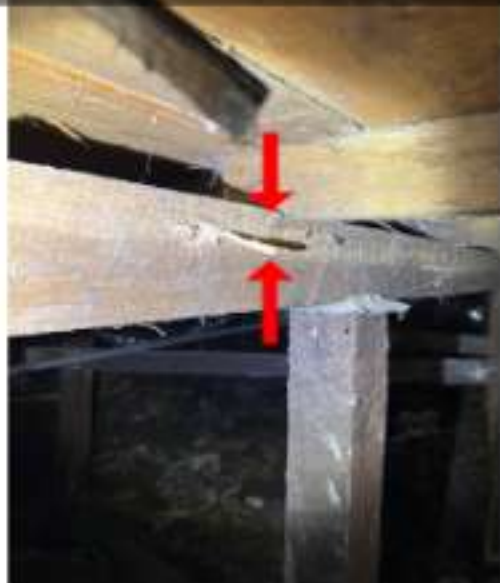
Half of timber bearer damaged by wood borer attack

Client to engage a licensed builder to inspect entire subfloor structure & make further advice before buying the property

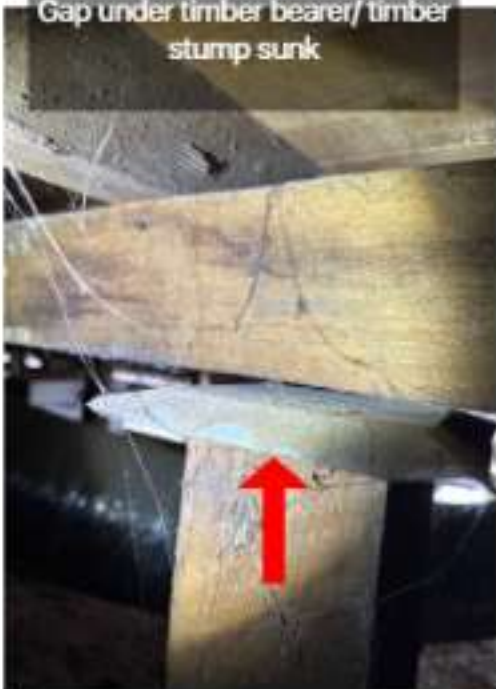
Timber stumps have sunk due high ground movement as a result of external surface water ingress & suspected underground pipe leak.

Gap under timber bearer/ timber stump sunk

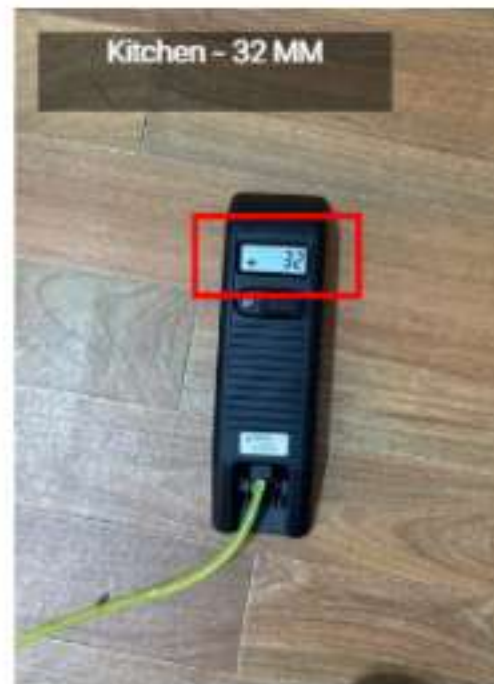
| All Internal Areas | Floor is out of level ( 53 MM deviation)- Major structural defect |

Victorian Building Authority's Guide to standards and tolerance- 2015- Section 2.08-The overall deviation of floor level to the entire building footprint shall not exceed 20 MM

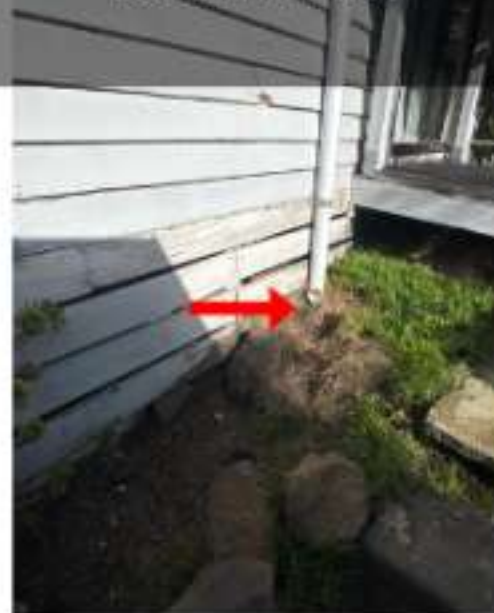
### Open ended down pipes discharged water in to subfloor foundation

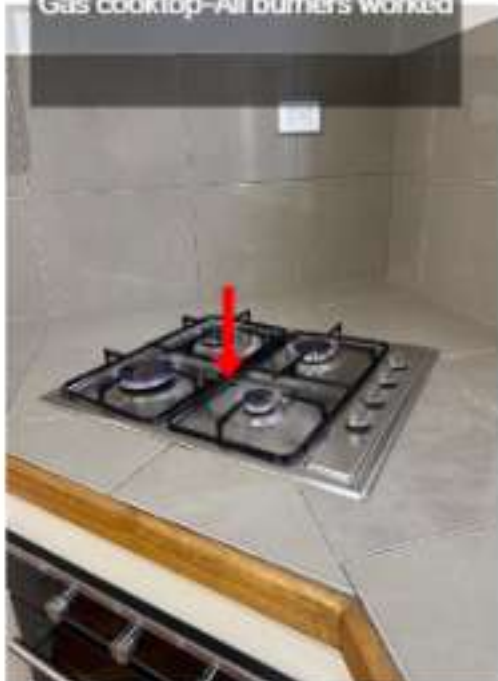
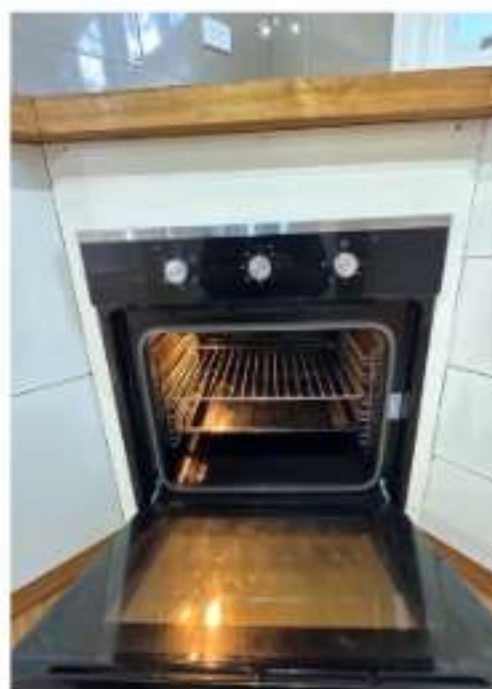
Gas cooktop-All burners worked

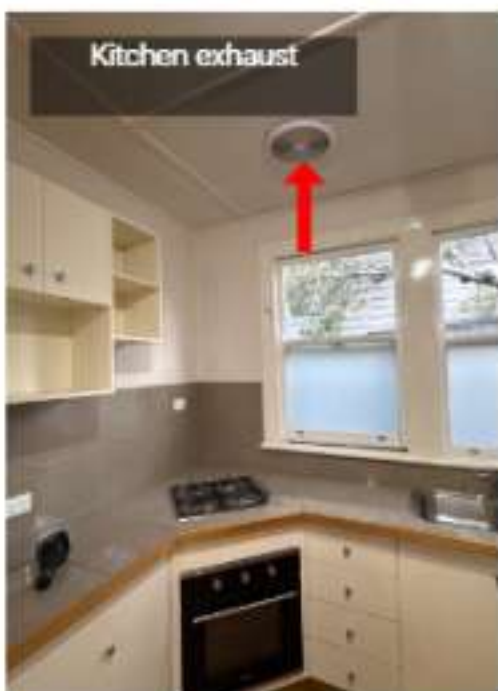
Kitchen exhaust fan was installed on ceiling. Recommend client to engage a kitchen ventilation contractor to install a kitchen range- hood. A health hazard.

Kitchen exhaust fan worked

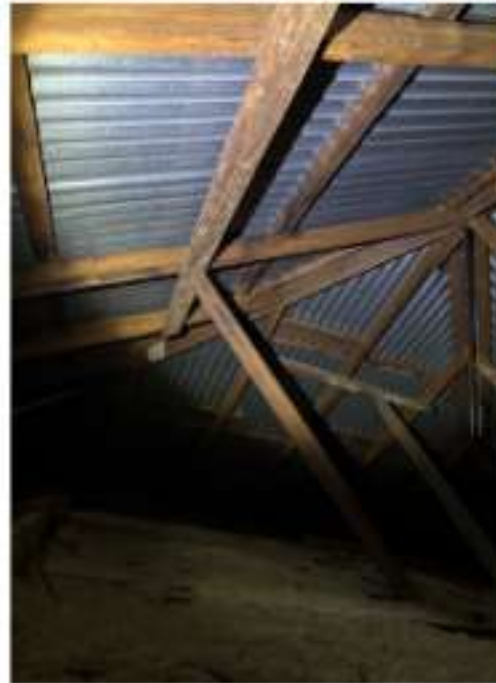
1. Kitchen & bathroom exhaust discharged in to unventilated roof void . Recommend client to engage a licensed tradesman to discharge exhaust out of building.

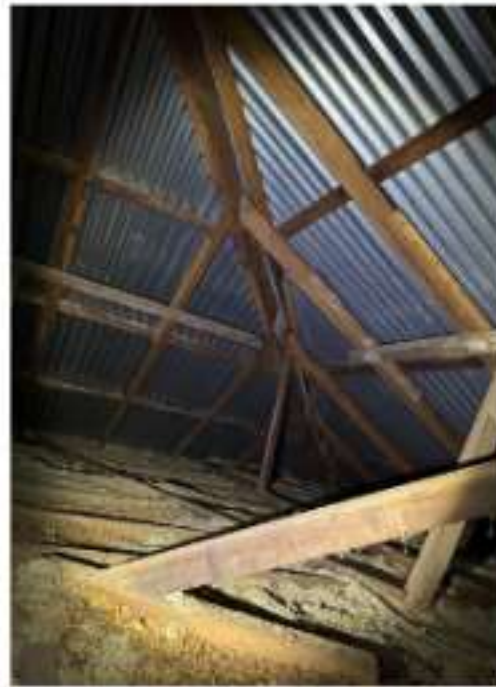
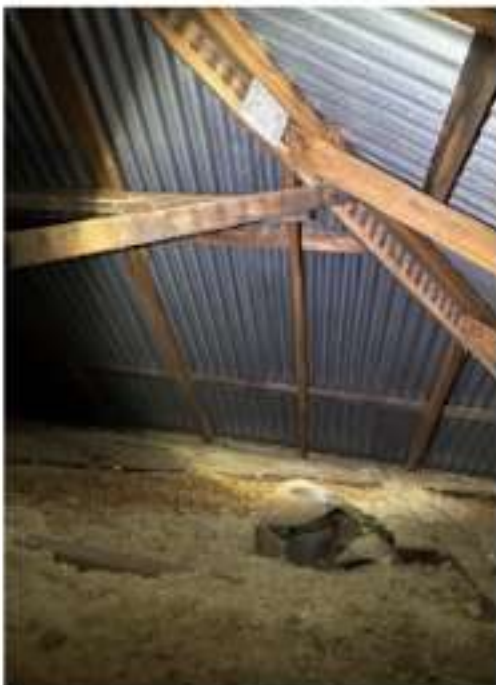
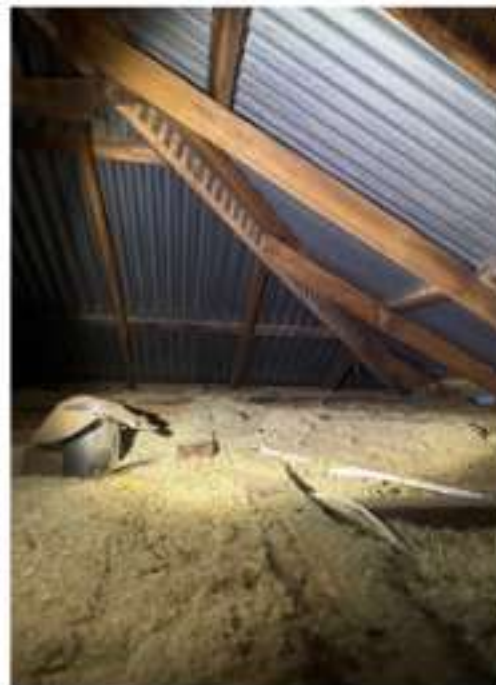
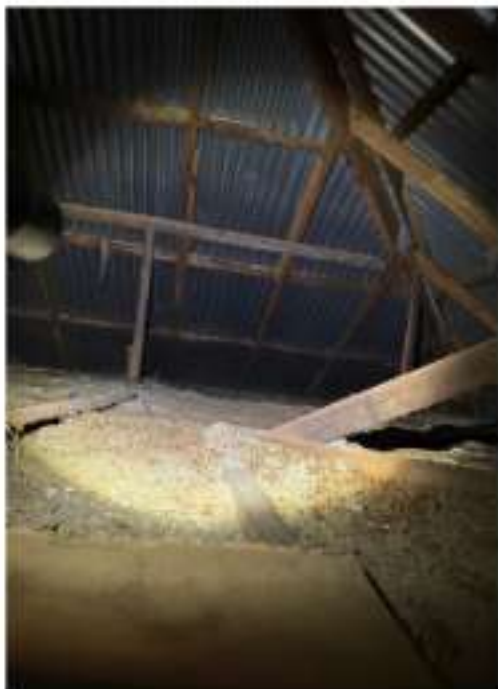
Additional photos are provided for your general reference.  
Following defects noted:
